2019 Nags Head Beach Renourishment Project

FINAL CONSTRUCTION REPORT

Volume 1 – Project Summary

Town of Nags Head

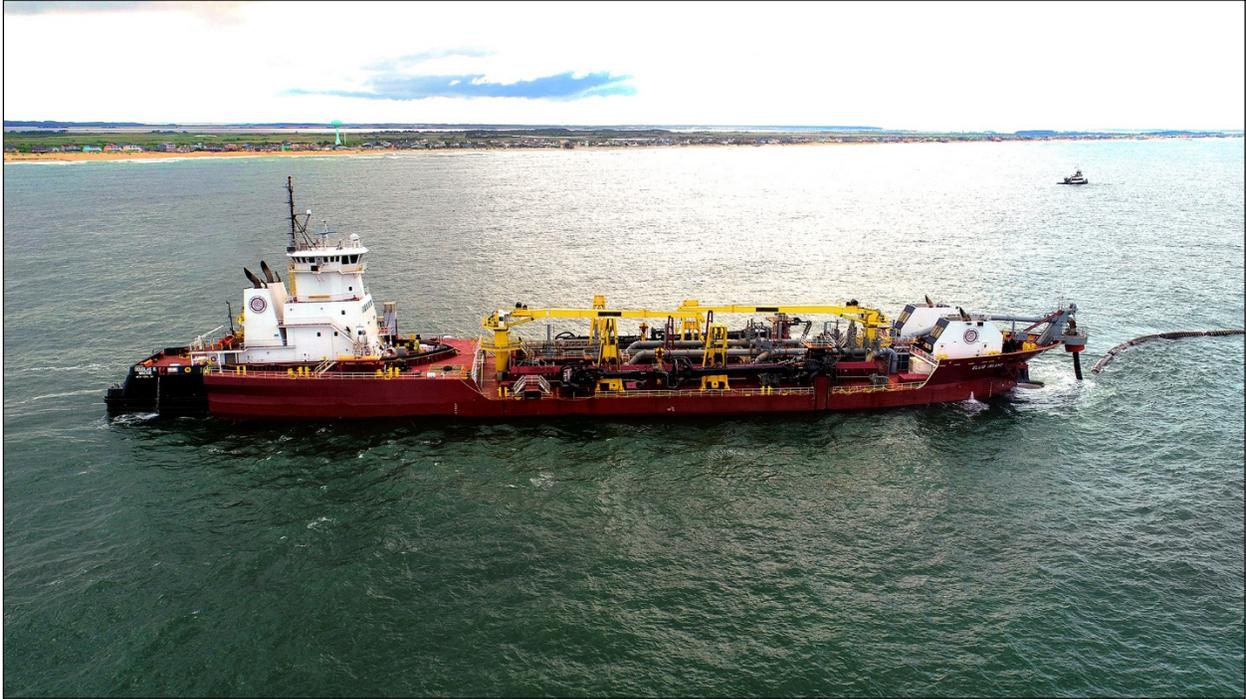
FIGURE 2.1. The two GLDD ocean-certified hopper dredges used in the 2019 Nags Head beach renourishment project. The *Ellis Island* is America’s largest hopper dredge with a maximum capacity of ~15,000 cy. The *Liberty Island* was used in the 2011 project. **[UPPER]** *Ellis Island* **[LOWER]** *Liberty Island* (Lower photo provided by GLDD).

Name	Dimensions (ft)			Capacity (cy)	For the Nags Head 2019 Project			
	Breadth	Length	Draft		Total Days	Total Loads	Total Volume (cy)	Average Capacity (cy) per Load
<i>Ellis Island</i>	92	480	30	14,800	47 days (05/01–06/16)	172	1,765,360	~10,500
<i>Liberty Island</i>	59	325	28	6,540	83 days (05/28–08/18)	518	2,234,640	~4,300

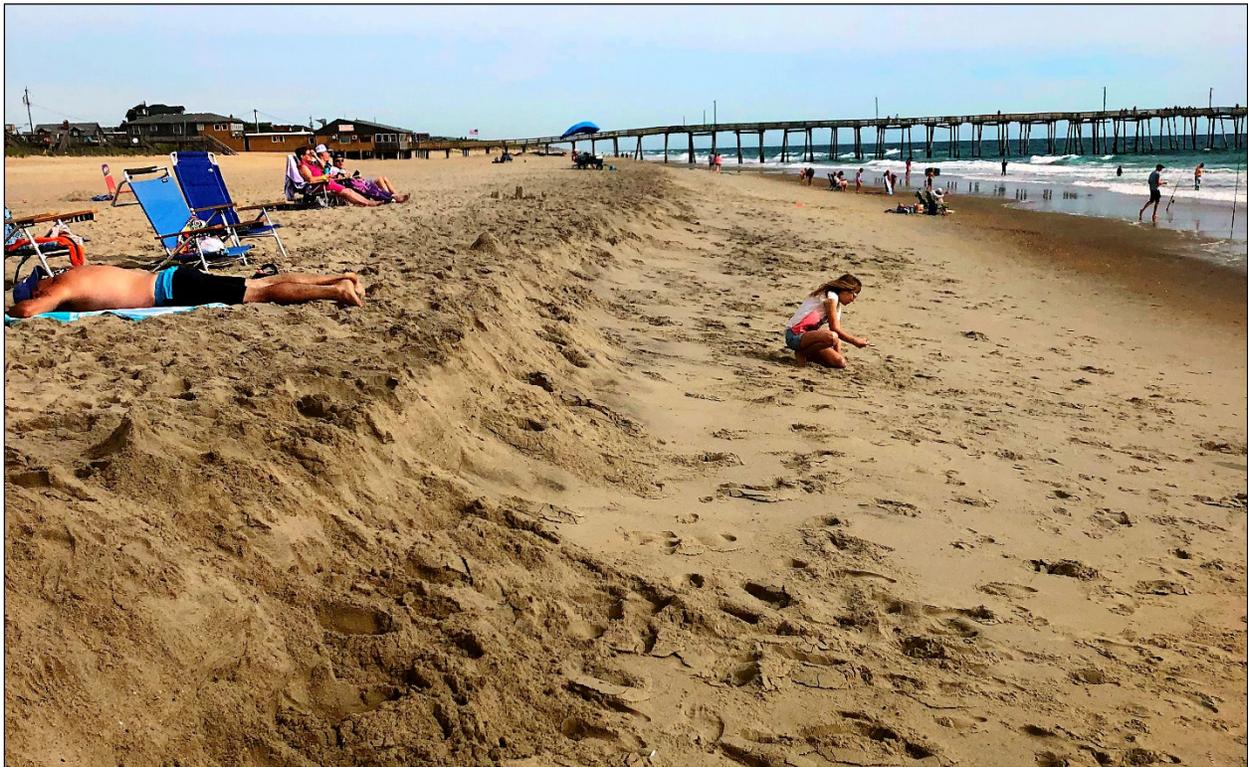
FIGURE 2.3. Escarpments formed along the nourished beach south of the Outer Banks Fishing Pier on 16 June 2019. [Source: D Ryan, Town Engineer of Nags Head]

Escarpments greater than 18 inches formed several times during construction. One group of significant escarpments was observed around 16 June 2019 after some brisk winds from the south-southwest blew toward Nags Head for a few days. Wave action had cut back the nourishment berm and left escarpments that were 2–3 ft high at the edge of the surf along the nourished beach south of the Outer Banks Fishing Pier (Figure 2.3). Beachgoers, lifeguards, and the town staff also noticed such escarpments. Another group of significant escarpments occurred on 16 August 2019 along the nourished beach in the historic district (Figure 2.4).

escarpments along most of the Nags Head oceanfront. These newly formed escarpments healed naturally within several days of formation. CSE representative inspected the project area on 27 August 2019 and confirmed that there were no escarpments remaining, and all previously identified problematic areas appeared to return to normal compared to their adjacent areas. The Town of Nags Head signed off its acceptance of the beach renourishment project by 28 August 2019, and GLDD demobilized the last few pieces of equipment by 30 August 2019, marking the final completion of the 2019 Nags Head beach renourishment project.

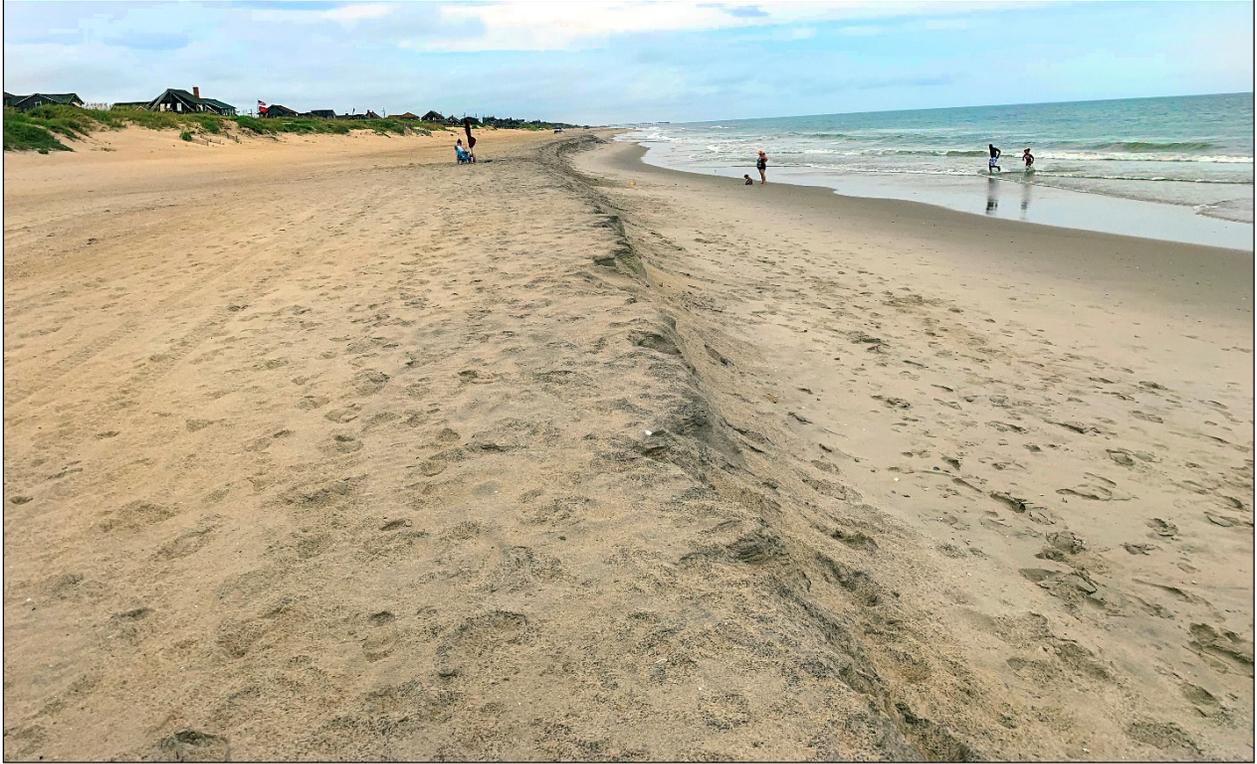
FIGURE 2.4. Another group of escarpments formed along the nourished beach in the historic district along the north half of Nags Head on 16 August 2019. [Source: C. Ogburn, Town Manager of Nags Head]

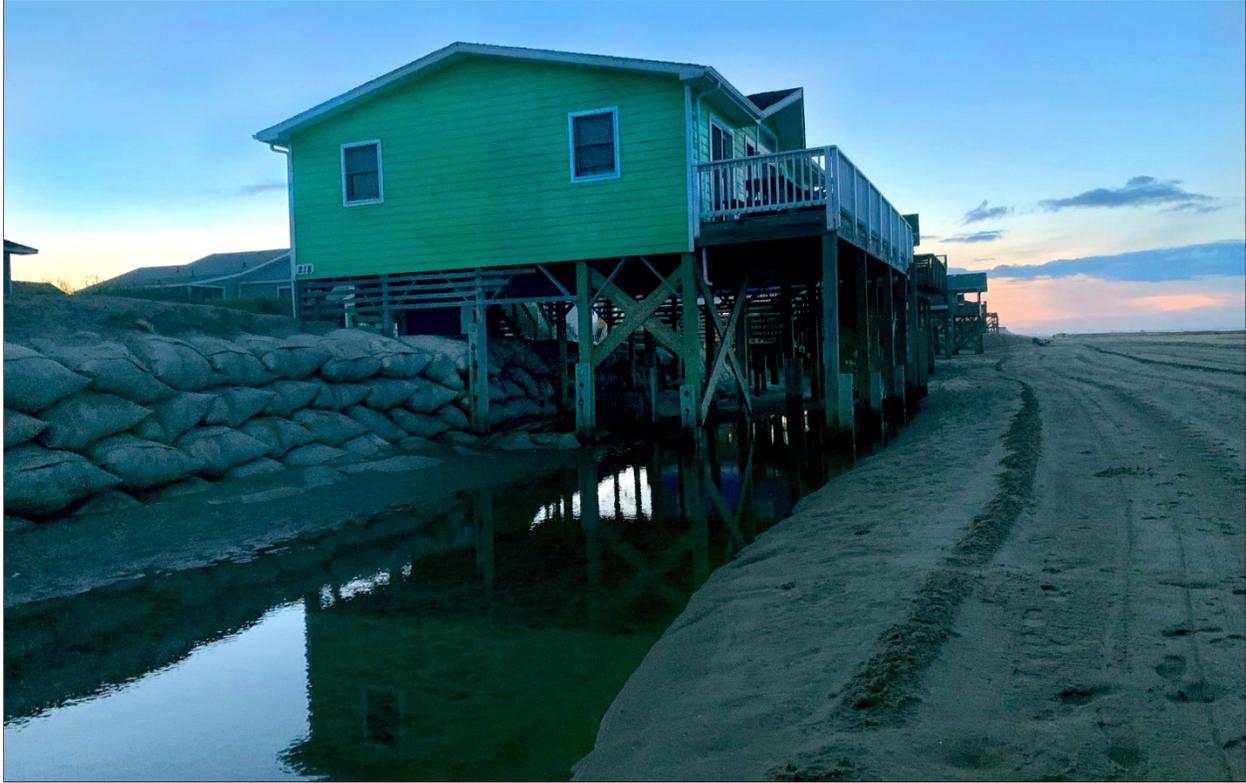
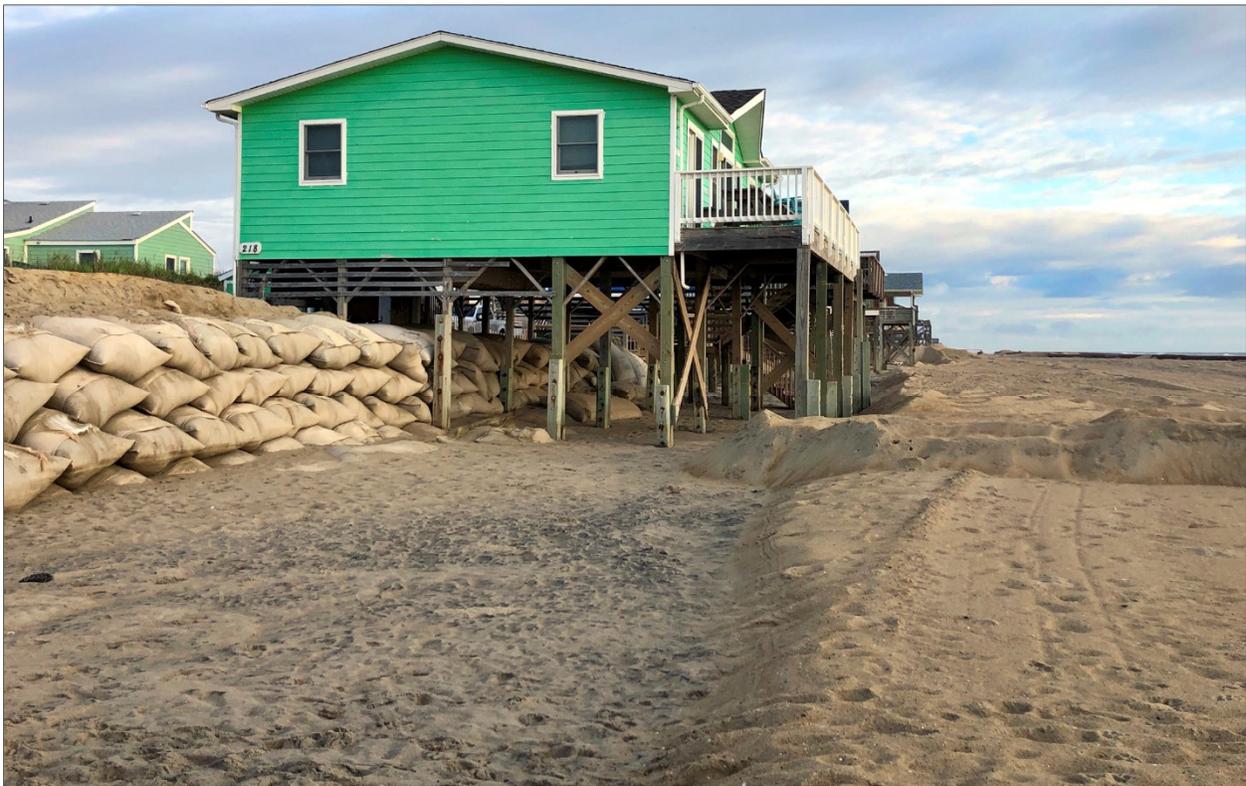
FIGURE 4.3. Ponding occurred after spring tides under some houses along South Nags Head near Pioneer Street and drained naturally after tides receded. [UPPER] Photo on 9 May 2019. [LOWER] Photo on 14 May 2019.

During construction, “ponding” on the nourished beach or underneath houses was observed several times. Such ponding was caused by wave overtopping the berm crest during a higher than normal tide. CSE’s nourishment design called for a construction berm at +6 ft NAVD, which approximates the average natural berm elevation for Nags Head. As the fill equilibrates during fair weather conditions, the crest may build higher than the construction berm. Such natural adjustment occurred at several localities leaving the middle of the berm slightly lower than the seaward crest so ponding occurred on the beach or under some houses where the ground elevation was lower than the adjacent areas. As the tide receded, the ponds drained completely, as seen in Figures 4.3 and 4.4.

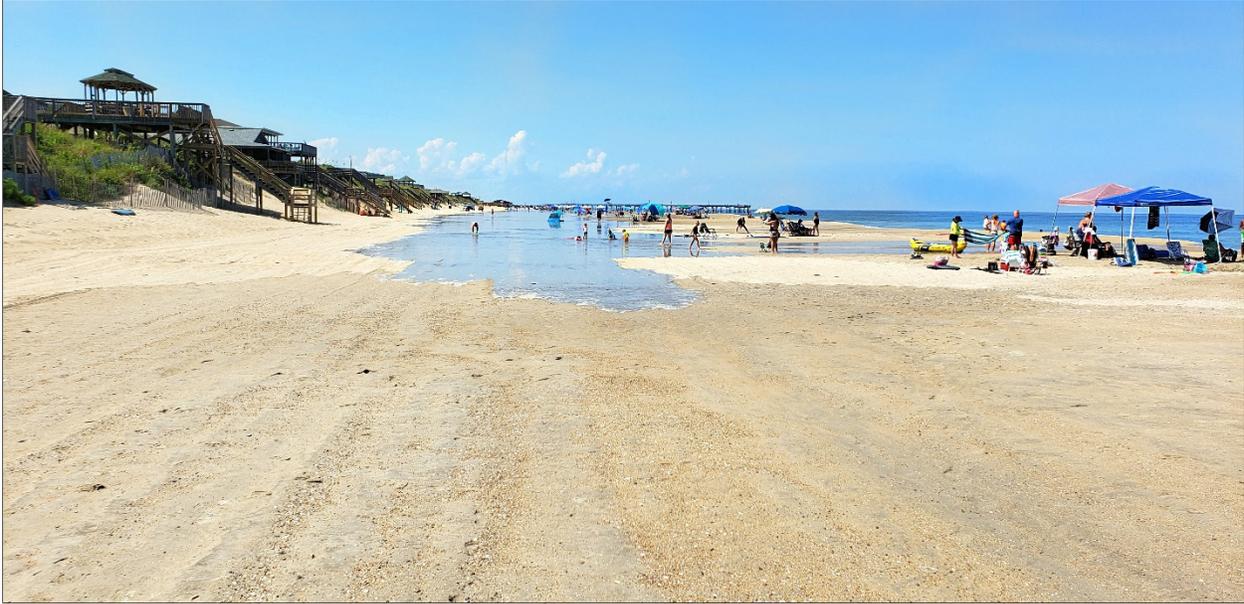
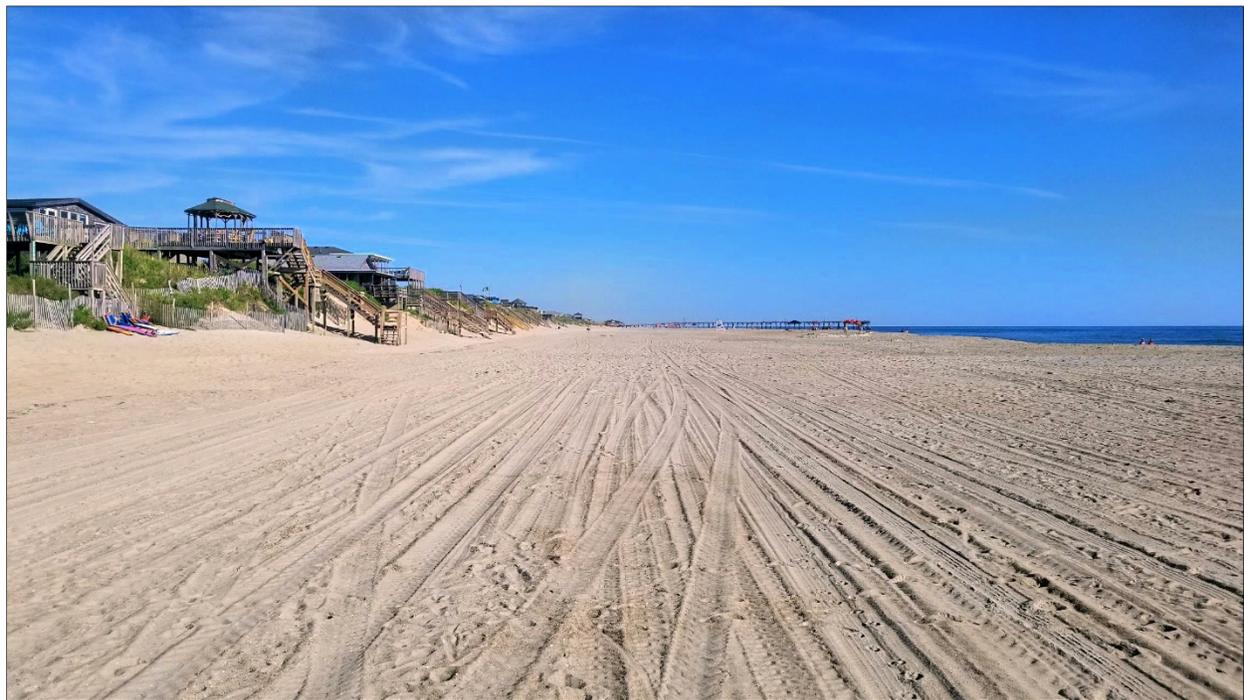
FIGURE 4.4a. Ponding occurred after spring tides on the beach along North Nags Head near Conch Street Public Beach Access and drained naturally after tides receded. **[UPPER]** Photo on 8 August 2019 looking north. **[LOWER]** Photo on 11 August 2019 looking north.

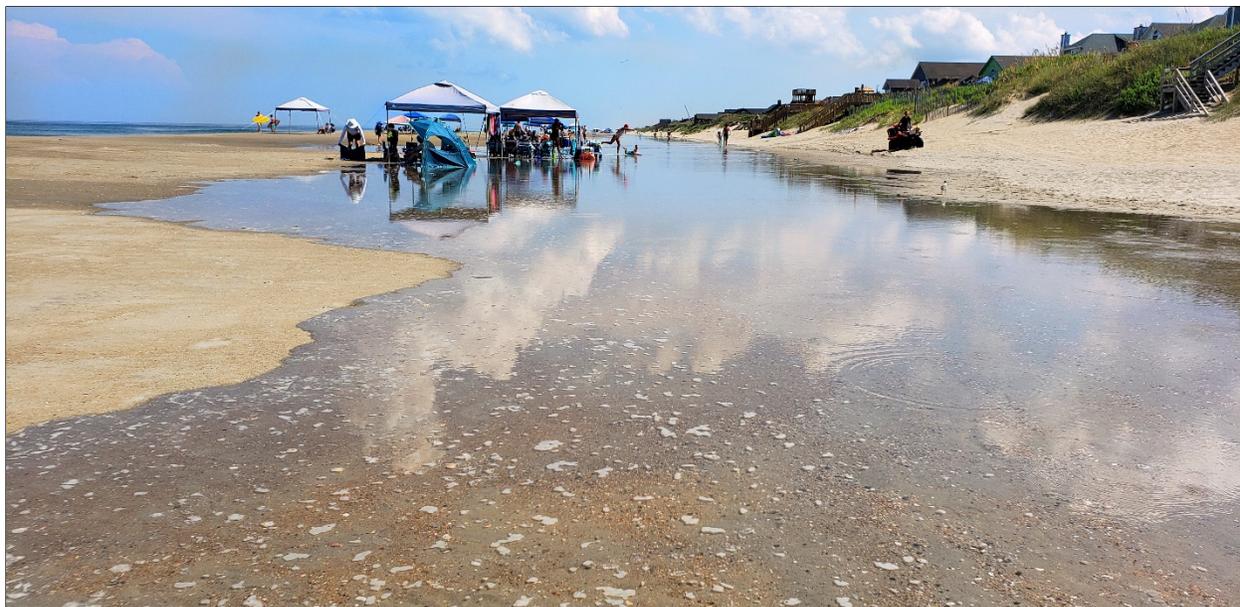
FIGURE 4.4b. Ponding occurred after spring tides on the beach along North Nags Head near Conch Street Public Beach Access and drained naturally after tides receded. **[UPPER]** Photo on 8 August 2019 looking south. **[LOWER]** Photo on 11 August 2019 looking south.

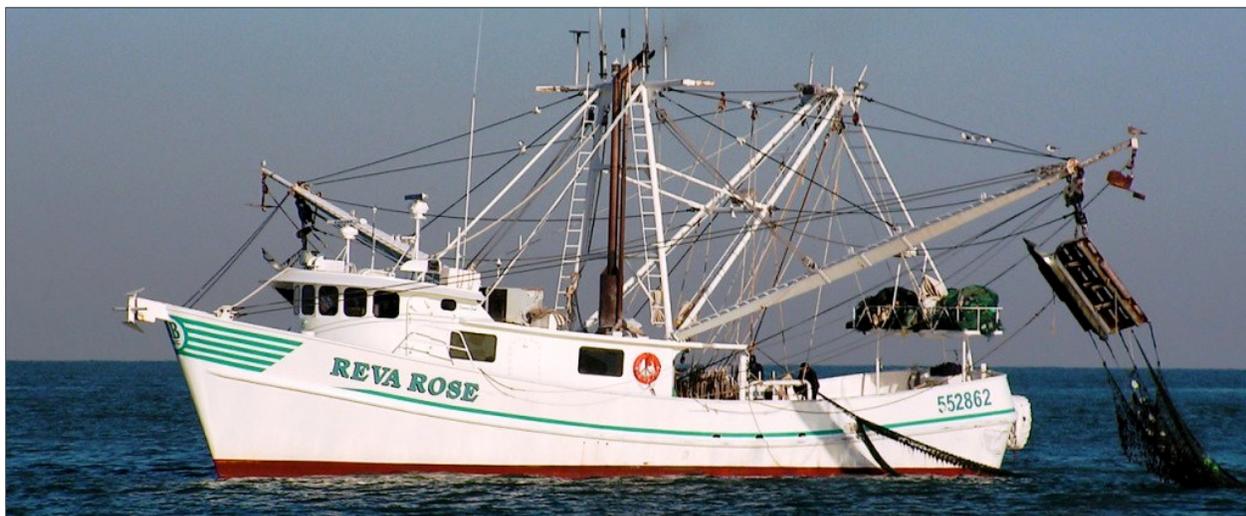
FIGURE 6.2. Trawling Vessel *Reva Rose* used during the 2019 Nags Head Renourishment project.

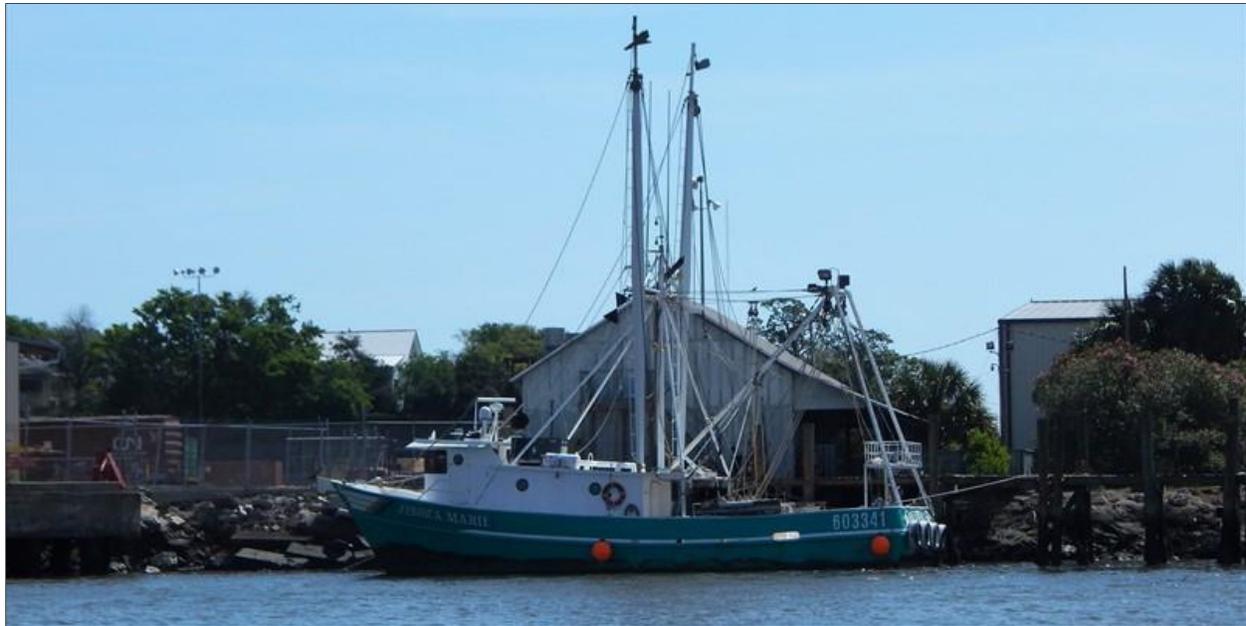
FIGURE 6.3. Trawling Vessel *Jessica Marie* used during the 2019 Nags Head Renourishment project.

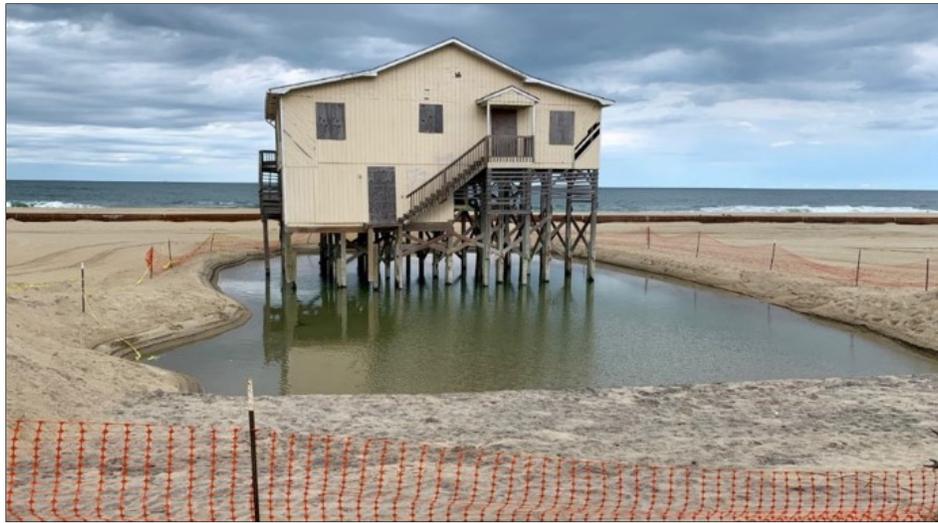
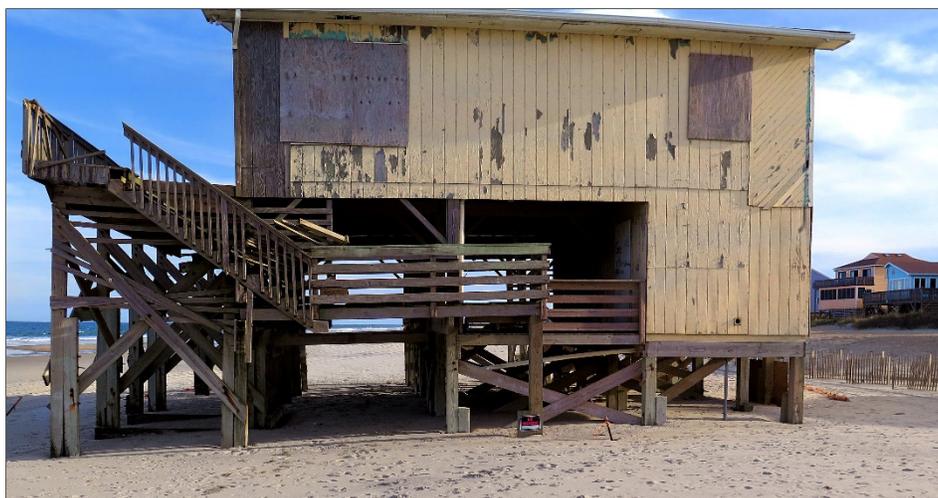
FIGURE 8.3. Aerial photos of the area near Station 994+00. **[UPPER]** Ground photo was taken on 14 May 2019. Four days after nourishment was completed in this area and also after spring tides, a ponding area was formed under and around the house. Safety fence was installed by the Contractor around the ponding area. **[MIDDLE]** Aerial photo was taken on 14 May 2019 showing the footprint of the ponding area relative to the properties behind the condemned, yellow house. **[LOWER]** Ground photo was taken on 15 October 2019 showing the pond has been filled naturally.

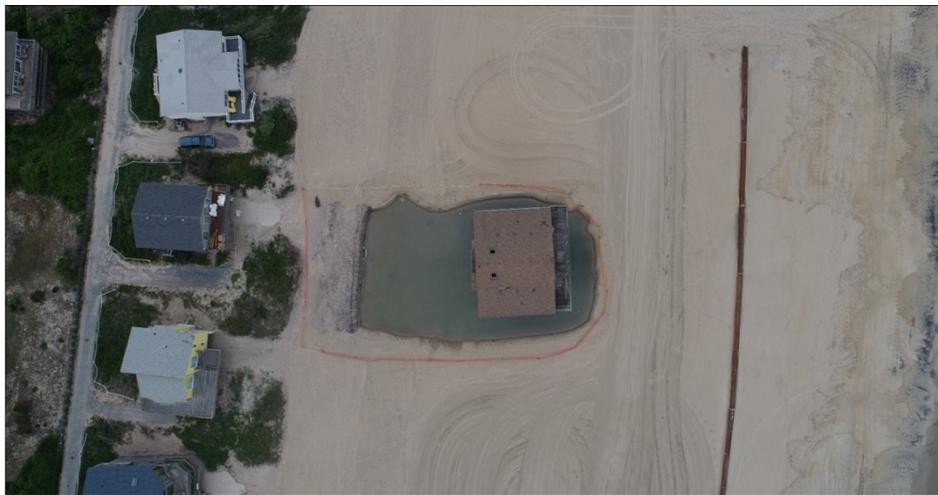
Wind blowing sand into the pond and wave overtopping the berm shifted sand under the house causing the ponding area to gradually reduce over time. Finally, fall nor'easters eventually pushed sand into the pond making the area dry as of mid-October (five months after the nourished sand was placed in this area). Figure 8.3 includes a series of photos showing the transformation of this area.

Figure 8.2 illustrates beach profiles before and after nourishment at Seagull Drive at Station 994+00, where a condemned house was sitting in the surf before renourishment. As state regulations prohibited the placement of nourishment sand over exposed sandbags and under houses, the project had to work around this structure. This resulted in no sand placement in the low areas around the house, thus leaving a pond not only under the house but also landward of the house. It was unsafe to survey the ground elevation under the house after dredging, but it was estimated based on the before-dredging survey that the water depth could be as deep as 8 ft. GLDD immediately installed orange safety fencing and warning signs around the pond area. This pond raised public safety concerns and also interrupted normal passage on the beach behind the house. NCDCM evaluated the situation and issued The Town of Nags Head a permit modification for filling the area behind the house so that the ponding area could be minimized and passage on the beach landward of this house would not be interrupted.

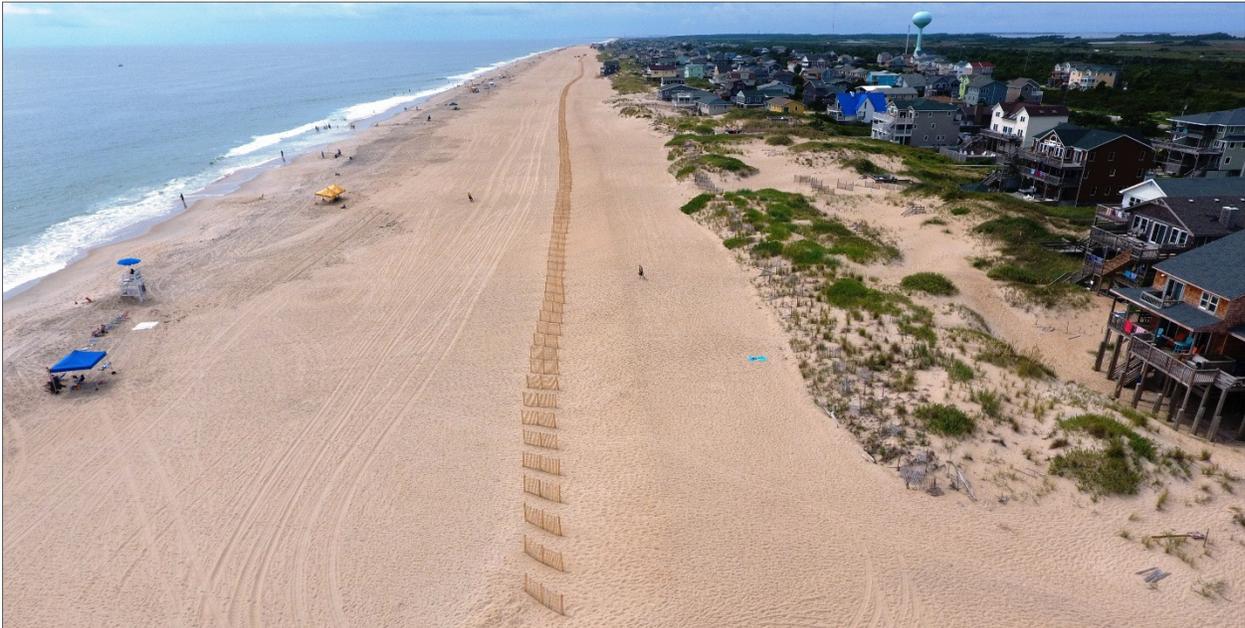
FIGURE 9.1. Sand fencing installed by Coastal Transplants. The photo was taken on 2 August 2019 from Juncos Street Public Beach Access looking south.

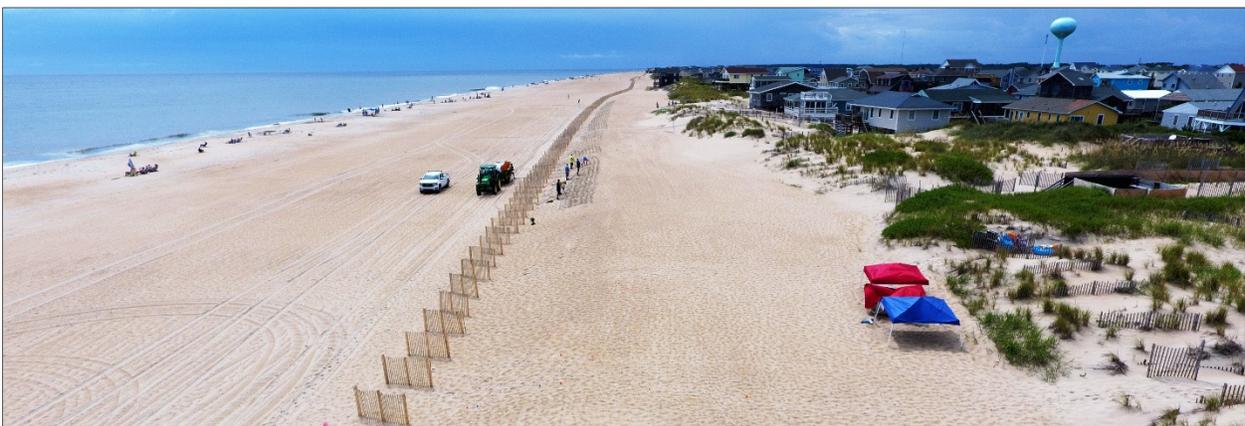
FIGURE 9.2. Dune vegetation planted by Coastal Transplants. The photo was taken on 16 August 2019 from Juncos Street Public Beach Access looking south.

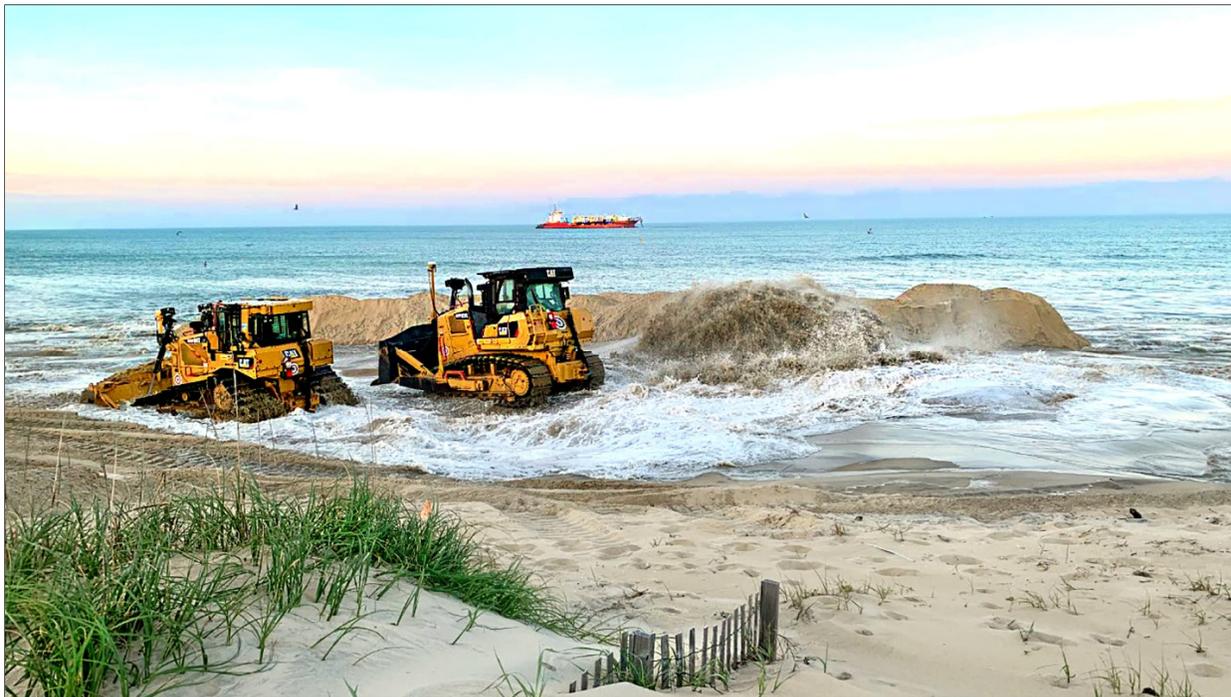
PHOTO 1. The dredge *Ellis Island* delivered her first load around 7:00 pm on 1 May 2019. The discharge point was at Station 975+50 south of Limulus Street beach access.

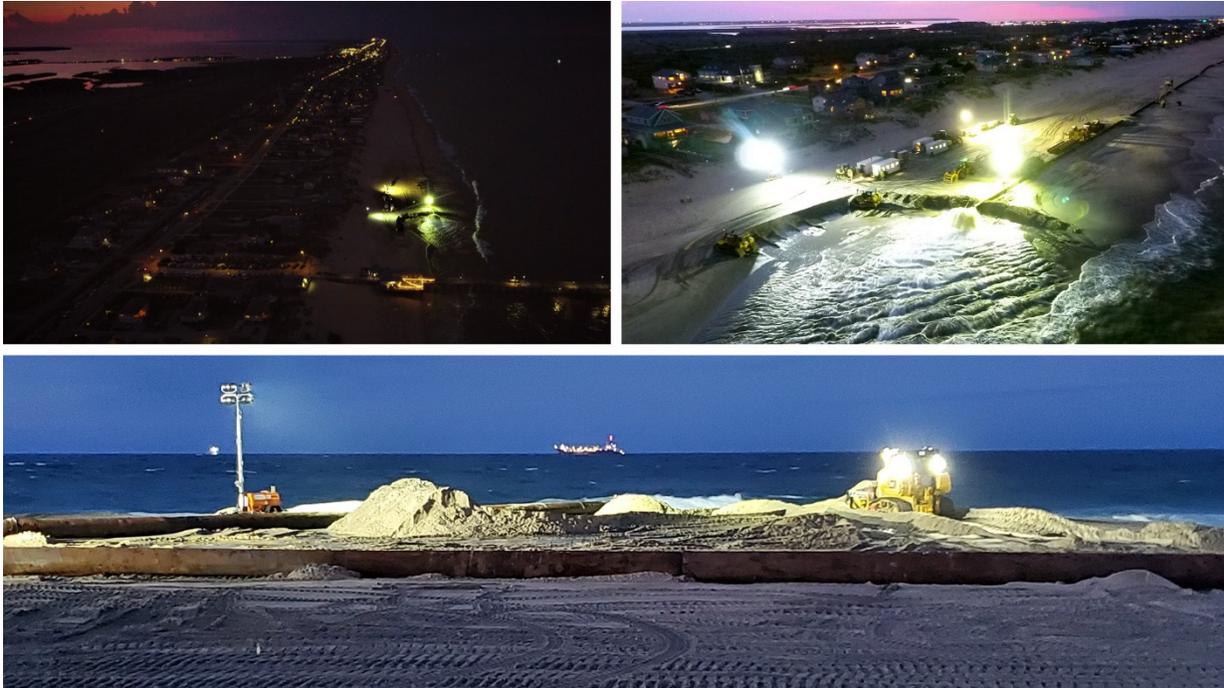
PHOTO 3. Pumping operations were conducted 24/7 (including nights and holidays) as long as the weather conditions allowed.

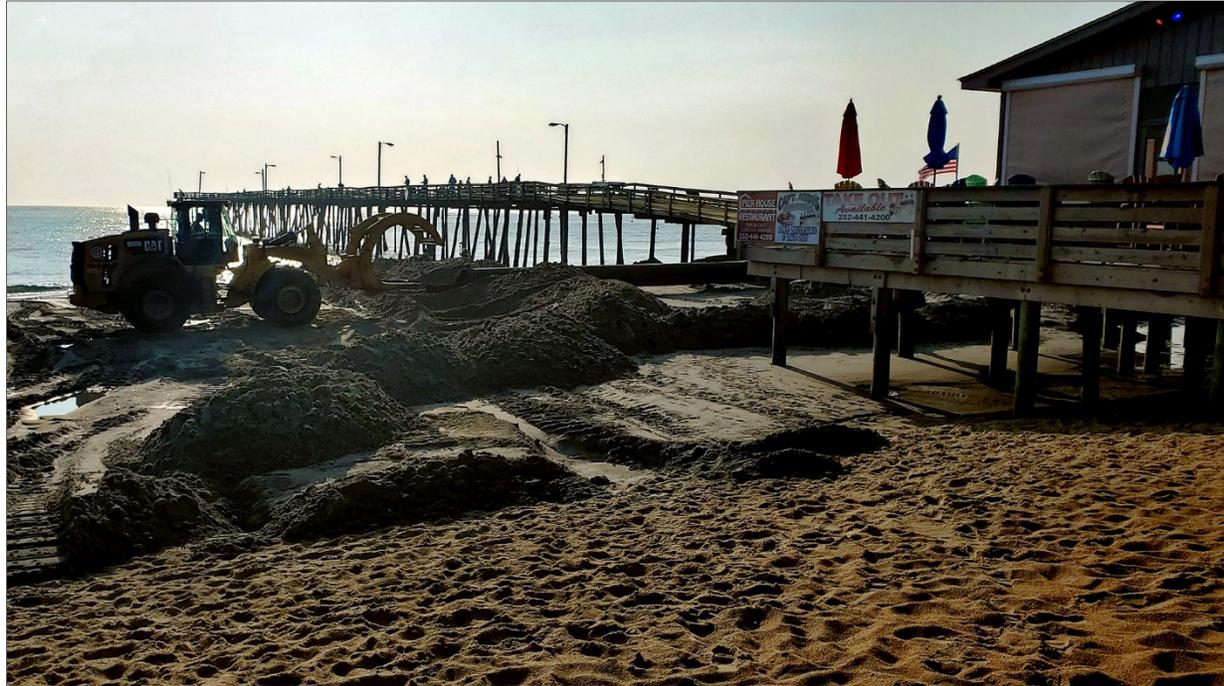
PHOTO 4. Pumping through Nags Head Fishing Pier on 31 May 2019 via the *Liberty Island*.

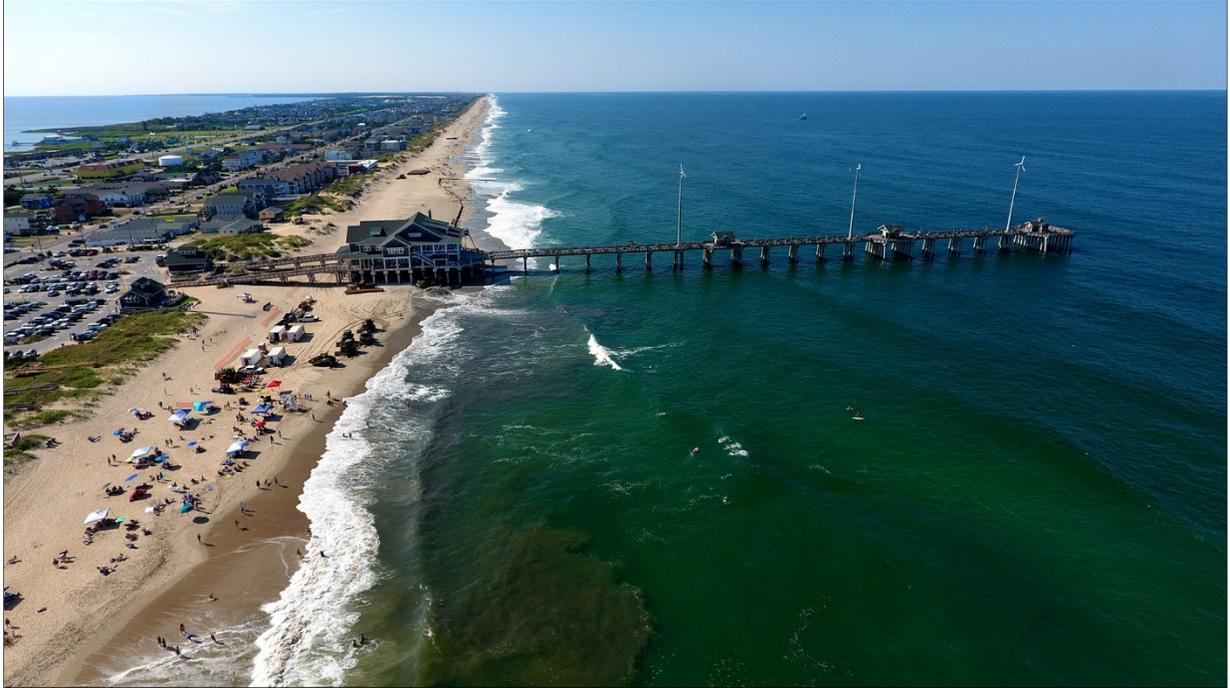
PHOTO 5. Pumping through Jennette's Pier on 28 July 2019 via the *Liberty Island*.

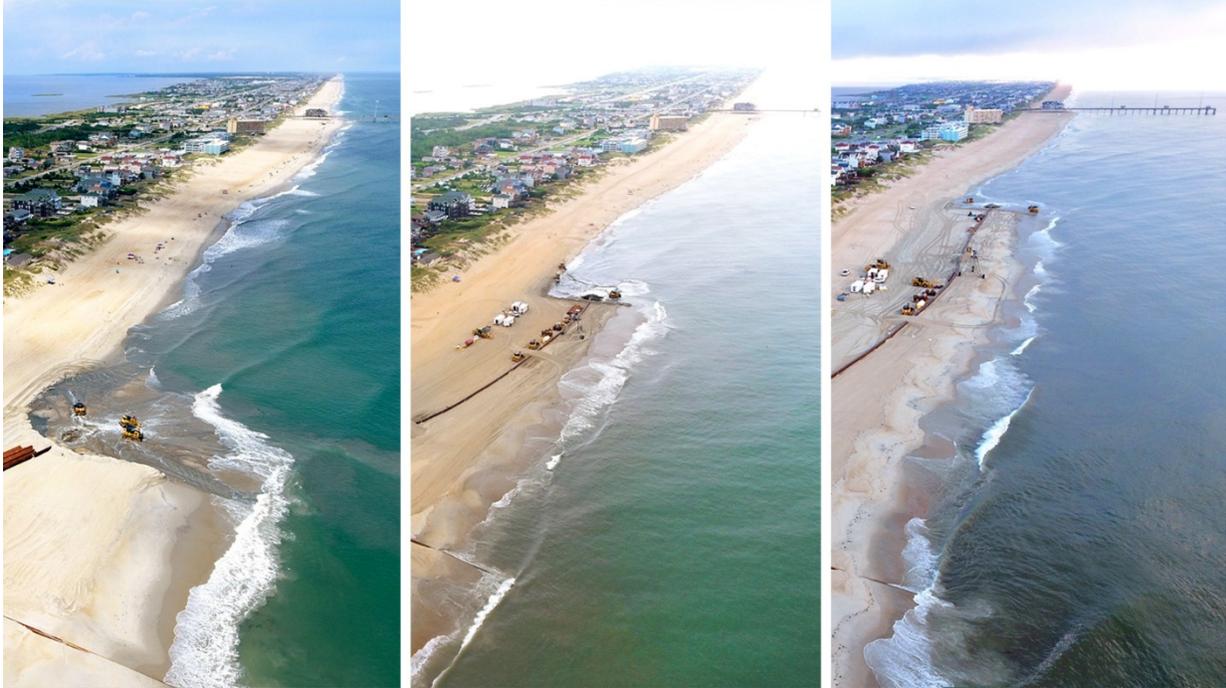
PHOTO 7. The last few days of pumping showing the work progress on the beach. From left to right, photos were taken on August 15, 16, and 17 (respectively).

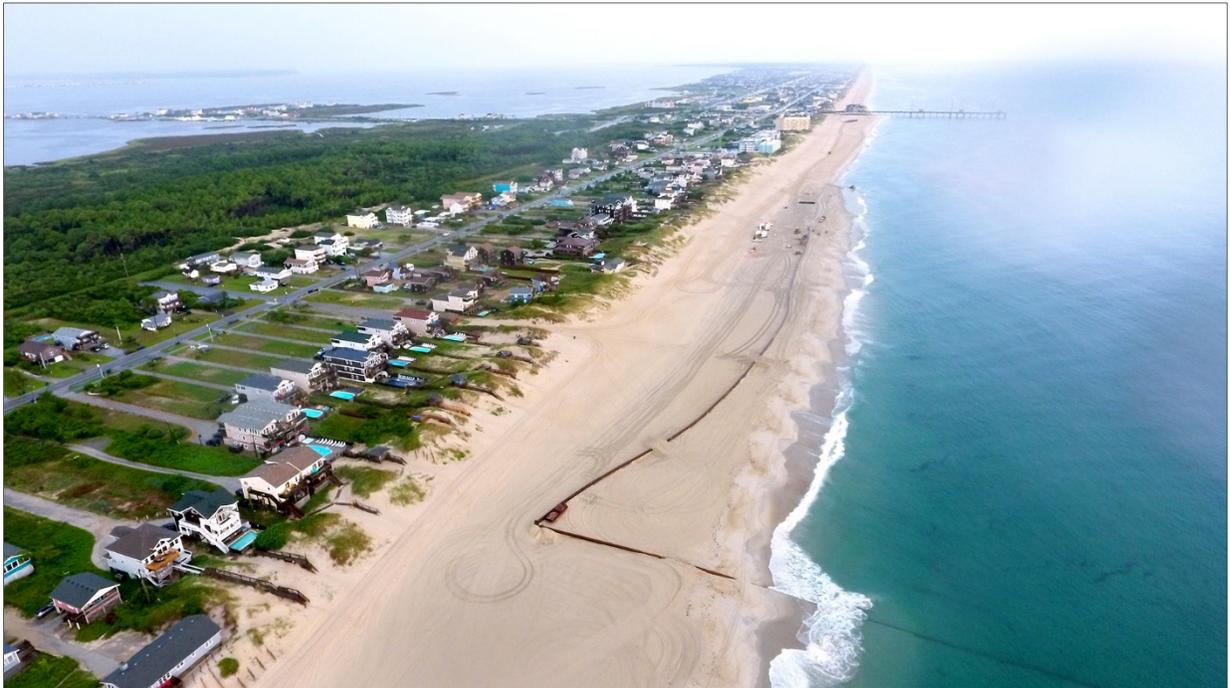
PHOTO 8. Last day of pumping on 18 August 2019 via the *Liberty Island*.

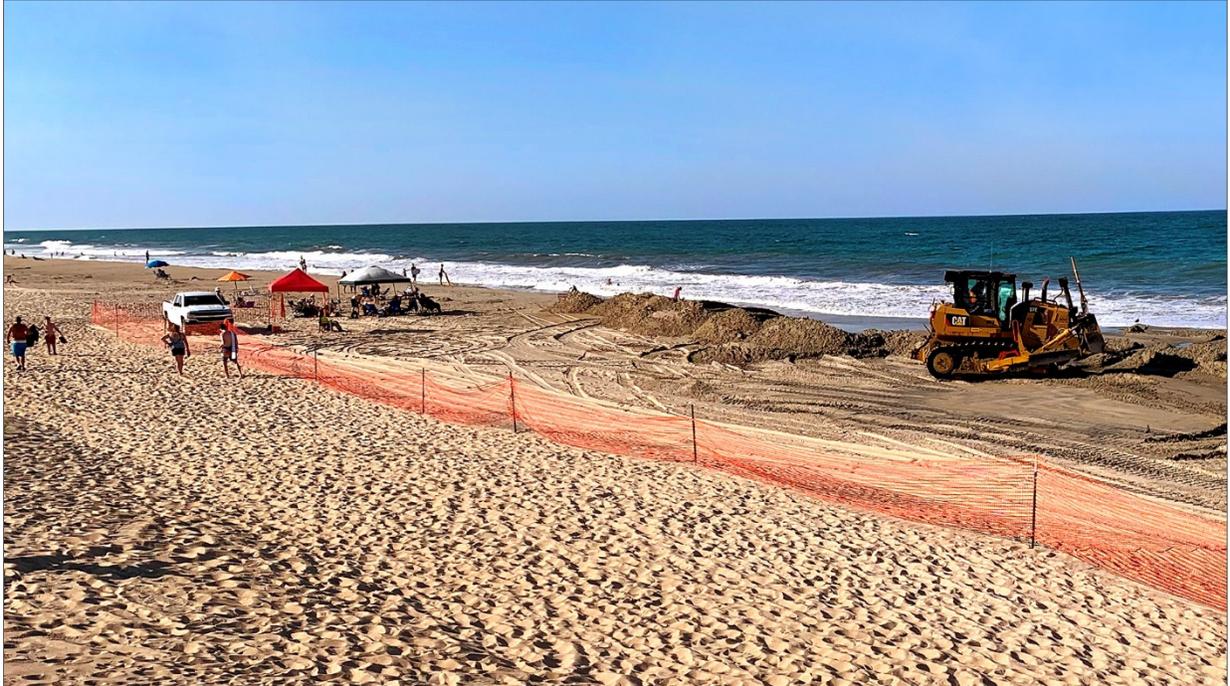
PHOTO 9. Wherever deemed to be safe, the back beach was opened to the public during pumping. No safety incidents occurred during the entire 110 days of construction.

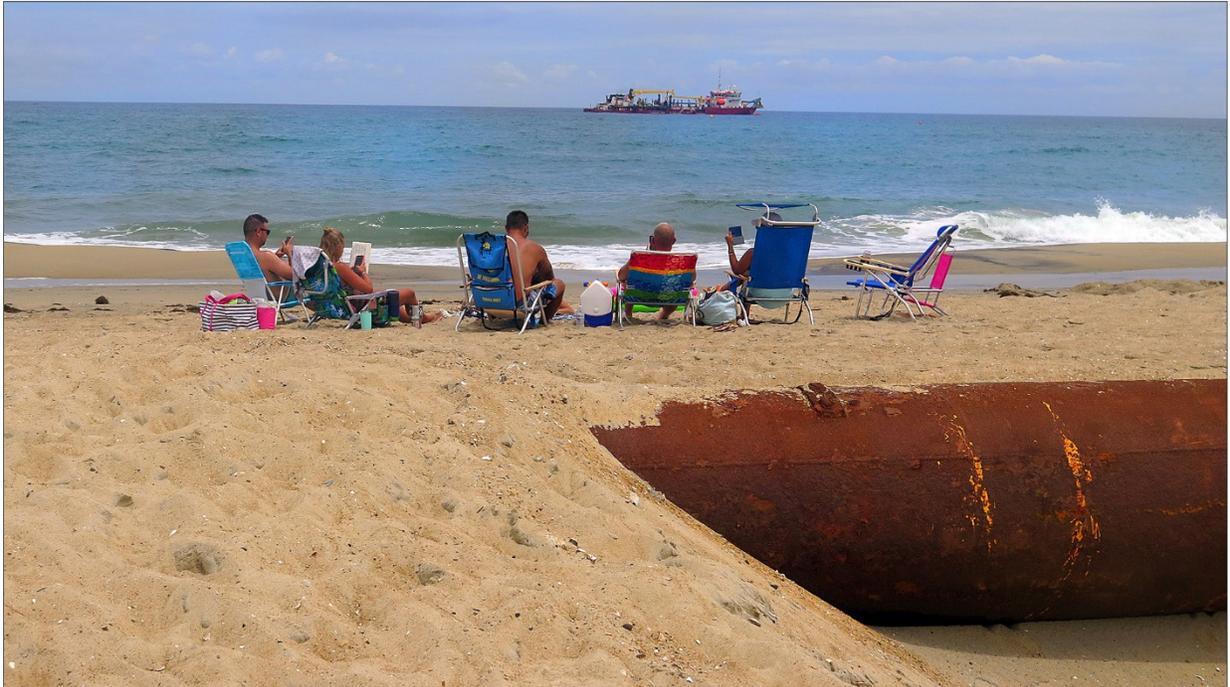
PHOTO 10. Sand ramps were built over the shore pipes after a section of beach was nourished and opened to the public for ocean access.

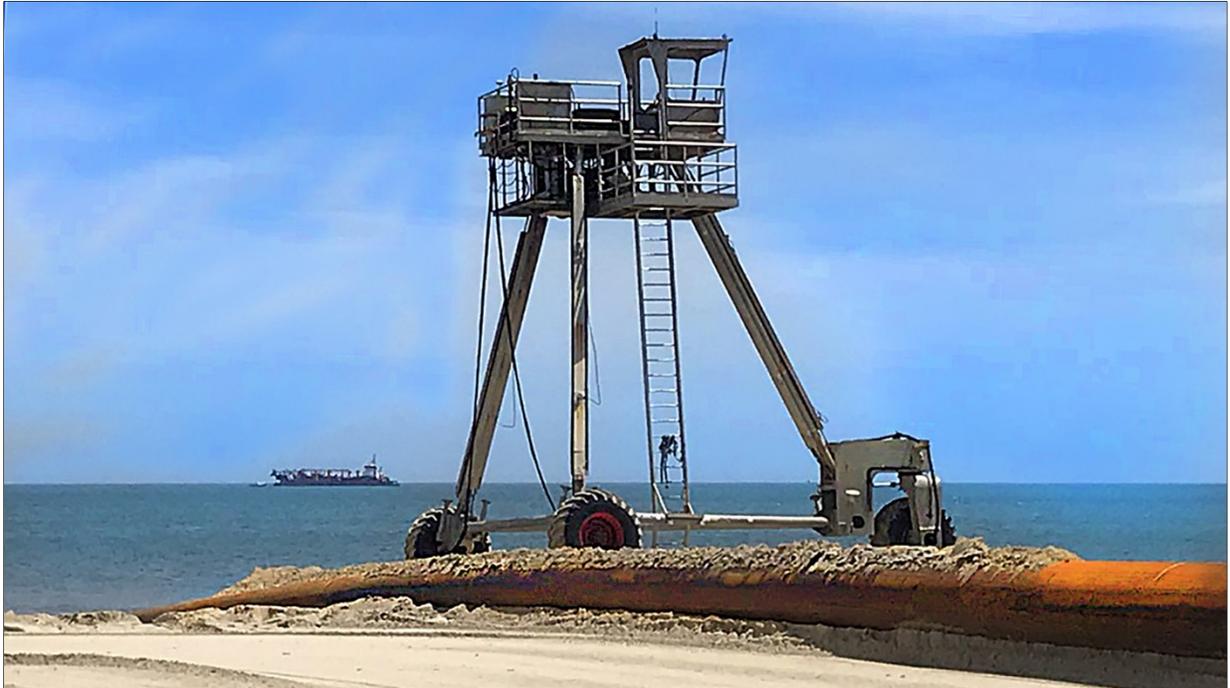
PHOTO 11. The Coastal Research Amphibious Buggy (CRAB) used by the Contractor to measure the sand volume placed on the beach.

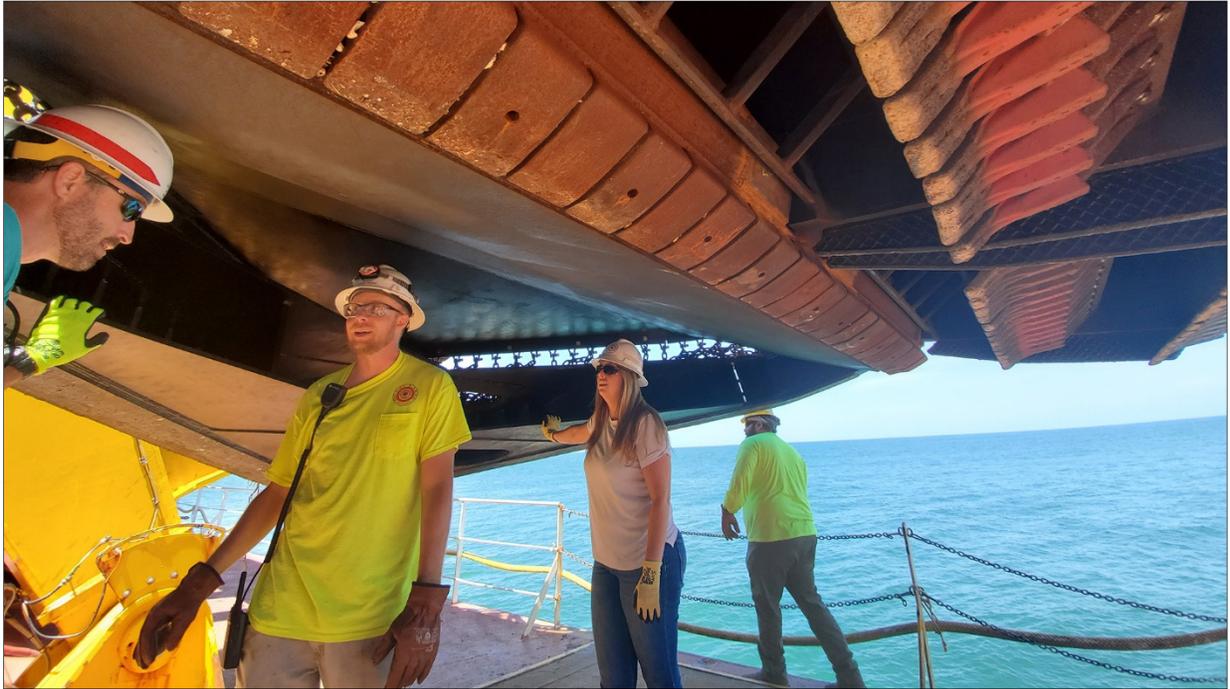
PHOTO 12. The USACE Project Manager, Josh Pelletier (left on the photo) inspected the dredge *Ellis Island* on 1 May 2019. GLDD’s Quality Control Managers, Christy DiFelice (second from right) and Mario Martinez (first on the right), and Site Manager, Jeremy Remme (second from left) accompanied the inspection.

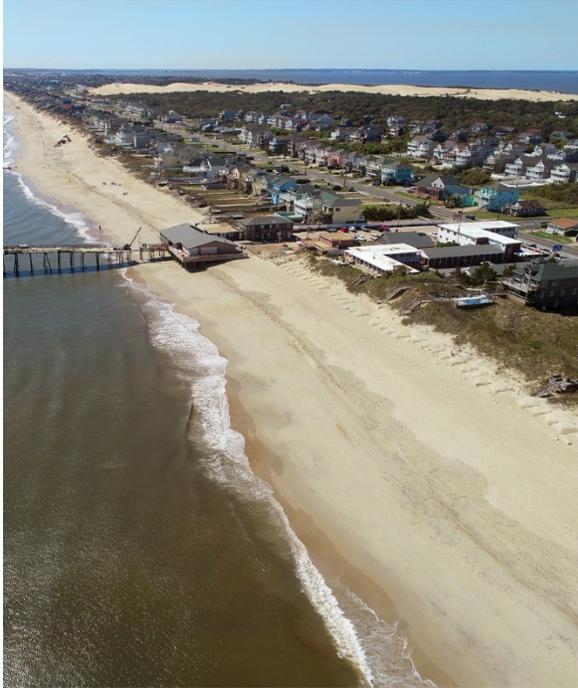
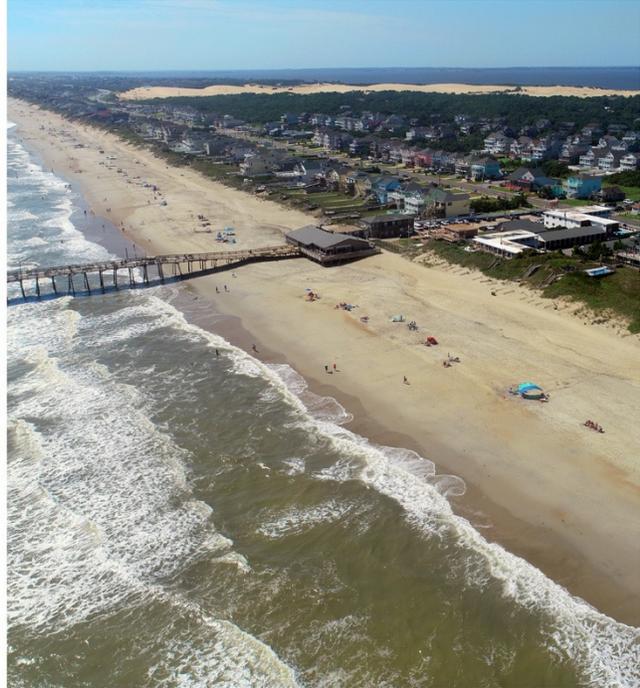
PHOTO 17. Beach condition comparison near the Outer Banks Fishing Pier before and after the 2019 renourishment project. **[LEFT]** Photo was taken on 17 April 2019. **[RIGHT]** The photo was taken on 29 August 2019.
