2019 Nags Head Beach Renourishment Project

FINAL CONSTRUCTION REPORT

Volume 1 – Project Summary

Town of Nags Head

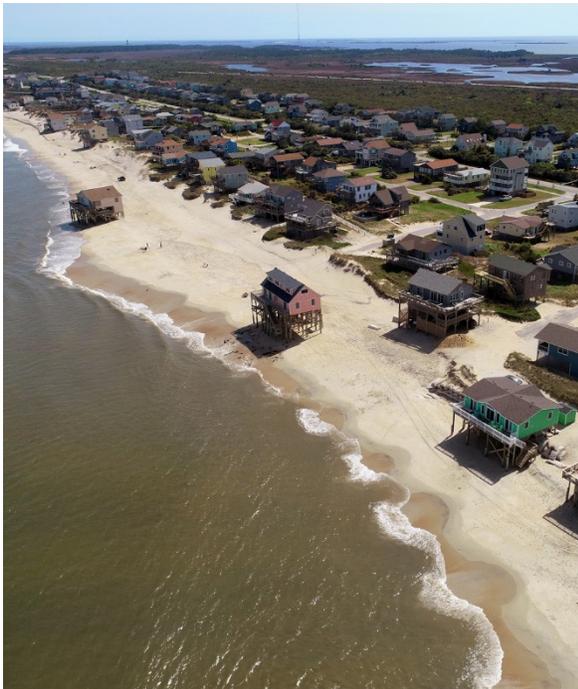
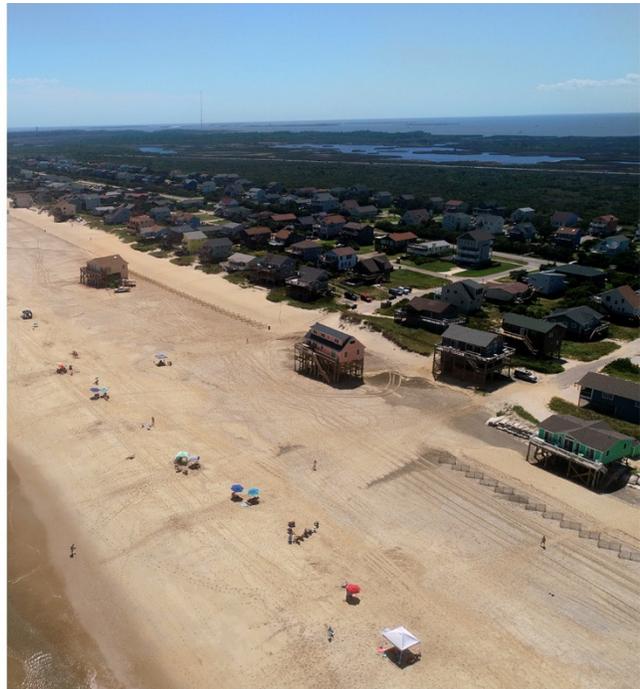
PHOTO 18. Beach condition comparison at the south end of Nags Head before and after the 2019 renourishment project looking south. **[LEFT]** Photo was taken on 17 April 2019. **[RIGHT]** The photo was taken on 29 August 2019.

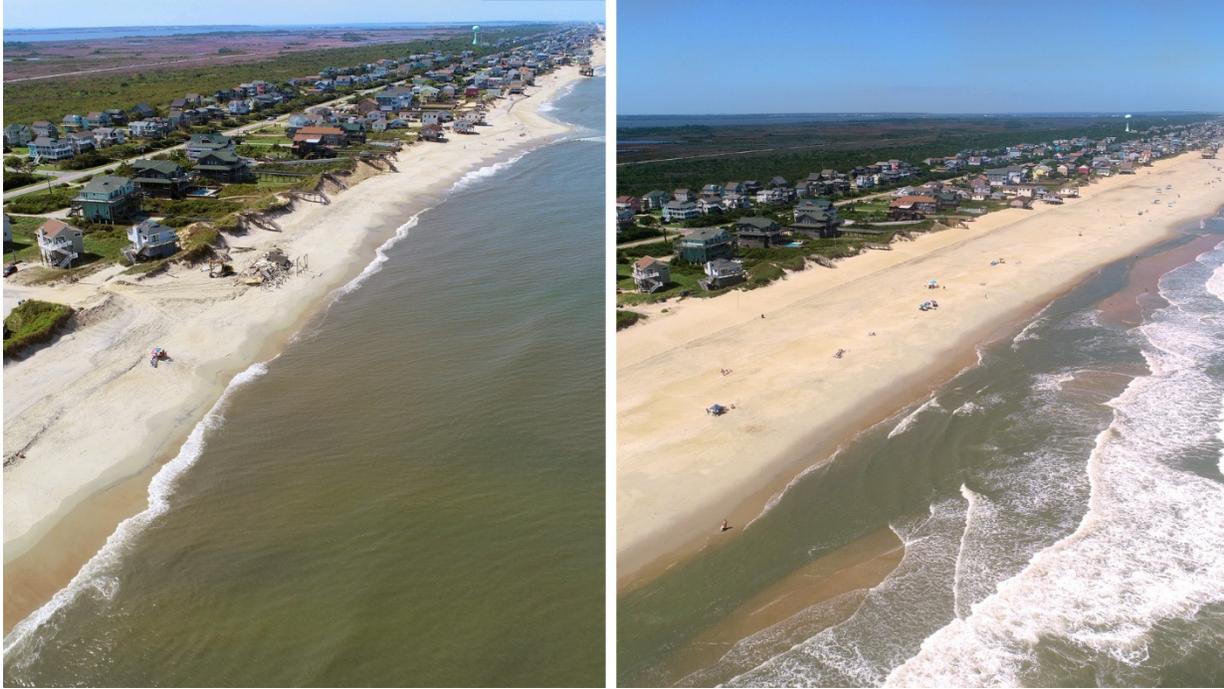
PHOTO 19. Beach condition comparison at the south end of Nags Head before and after the 2019 renourishment project from the southern limit of the project area looking north. **[LEFT]** Photo was taken on 17 April 2019. **[RIGHT]** The photo was taken on 29 August 2019.

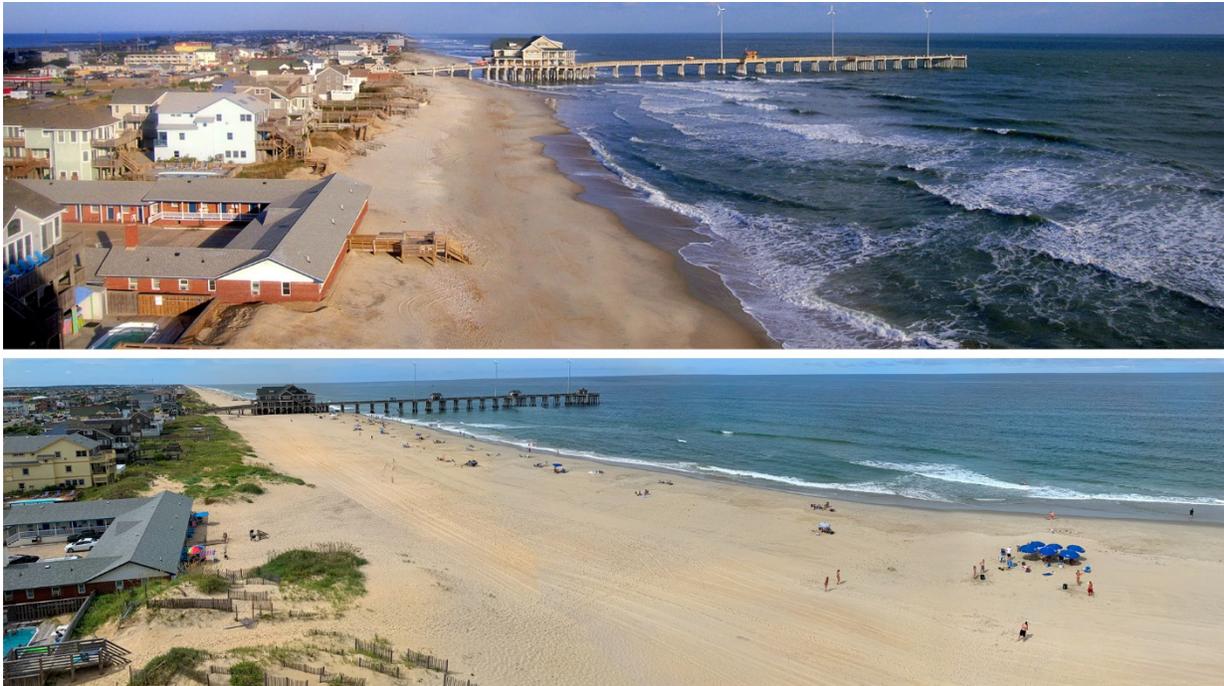
PHOTO 20. Photos taken on the rooftop of the Comfort Inn at Nags Head. **[UPPER]** Photo taken on 18 November 2010 before the initial 2011 nourishment. **[LOWER]** The photo was taken on 3 August 2019 after the 2019 renourishment.
