# STORMWATER PILOT PROJECT FOR NCDOT MAINTAINED OCEAN OUTFALLS AND ASSOCIATED OUTLETS OCEAN OUTFALL MASTER PLAN

June 2016

North Carolina Department of Environmental Quality  
Division of Water Resources  
217 West Jones Street  
Raleigh, NC 27601

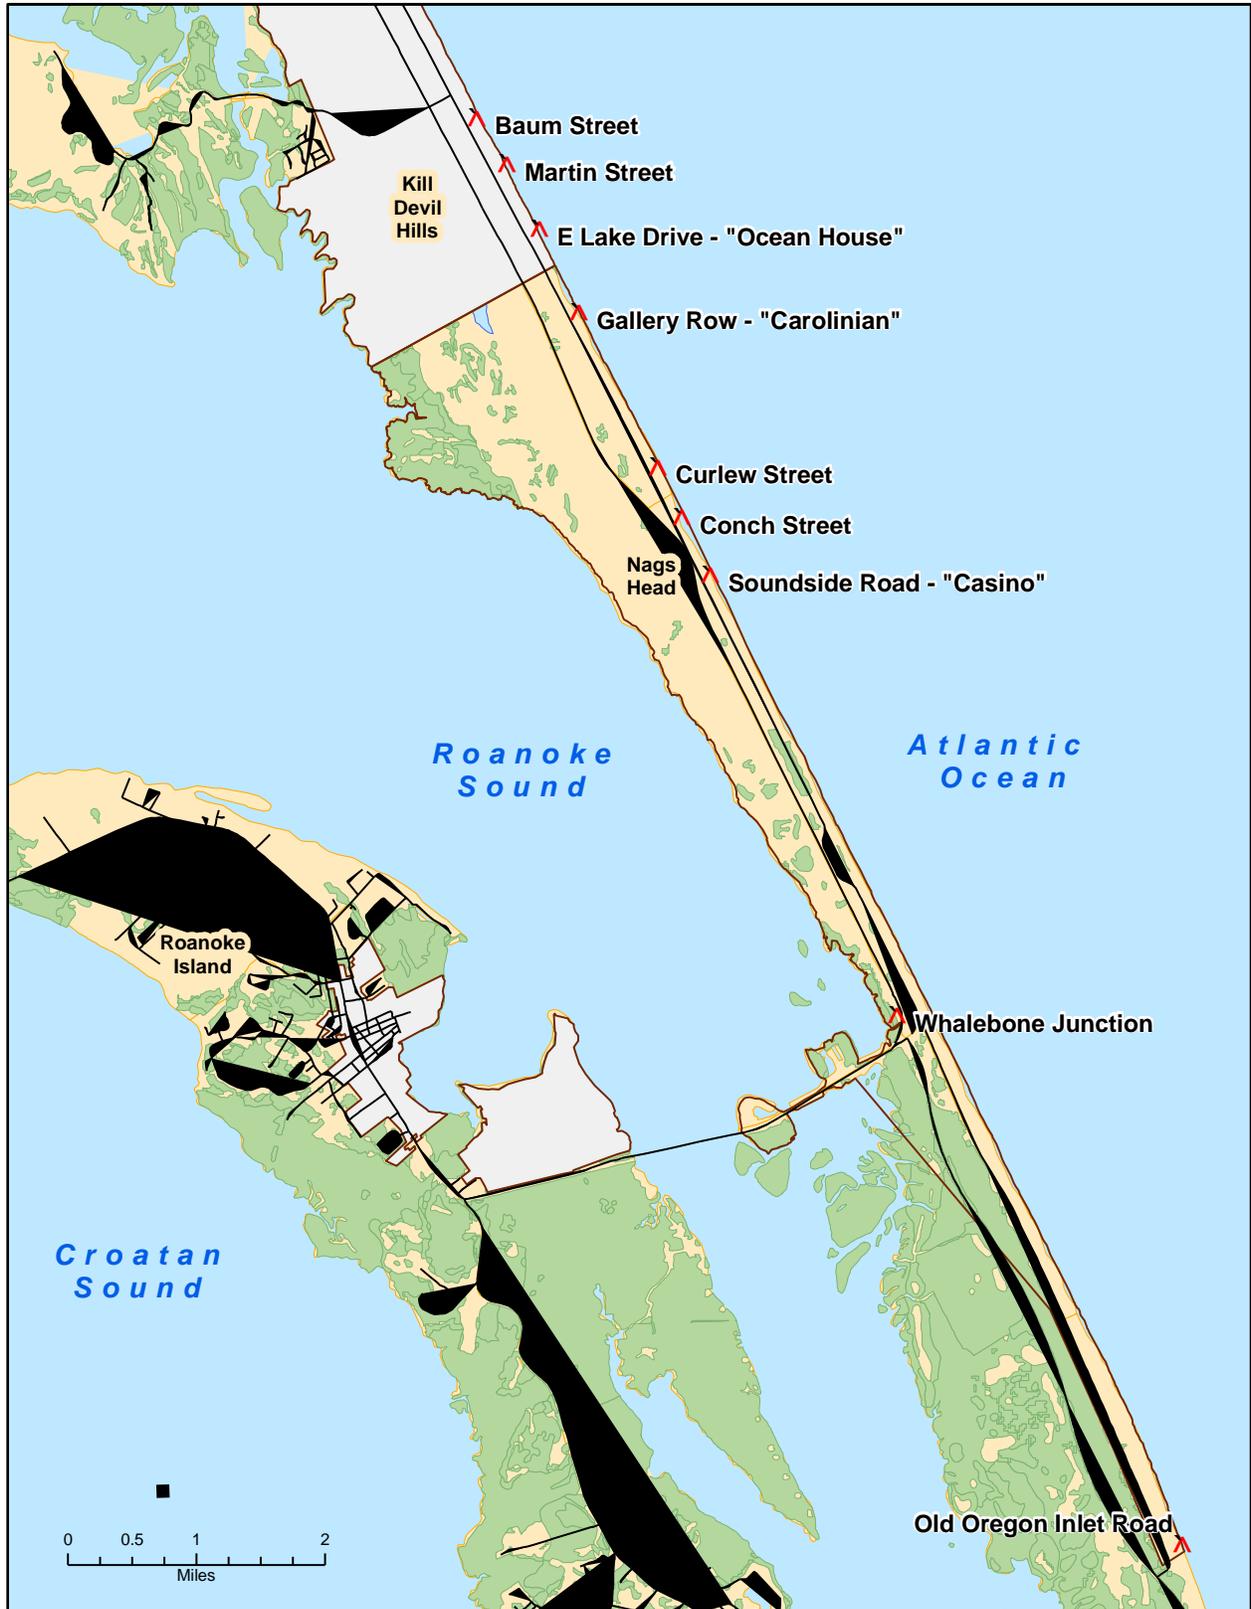
Figure 1. Location of Dare County Ocean Outfalls

**Figure 1** shows the location of the eight Dare County outfalls maintained by NCDOT as well as the Oregon Avenue outfall maintained by the Town of Kill Devil Hills. In 2009, an additional outfall (not shown on **Figure 1**) with an outlet to the Albemarle Sound near Whalebone Junction was added to this study. The primary purpose of the NCDOT outfalls is to provide drainage of state maintained highways, however, local low land areas have been connected to the outfall systems. As the area continues to increase in development density, stormwater quantity and quality have become progressively more difficult to manage. During the 2004 hurricane season, three storms produced over ten inches of rainfall in the area, leading to standing water for more than 30 days in some communities.

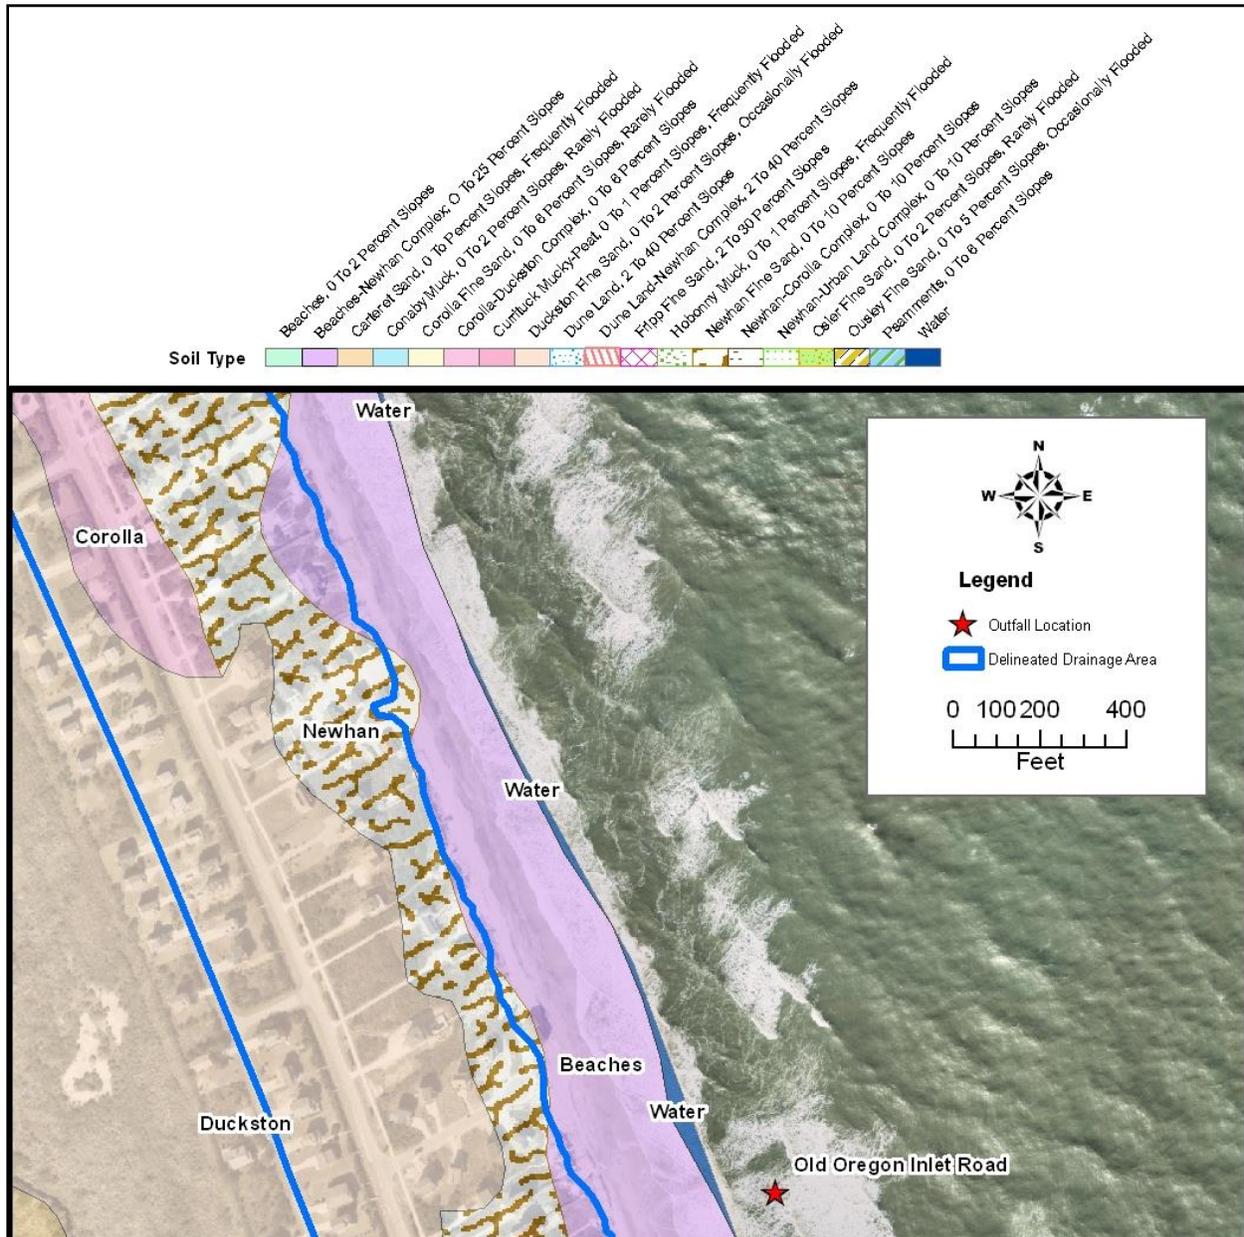
Soils data were developed by the US Department of Agriculture-Natural Resources Conservation Service and obtained by NCSU researchers. The soils information was provided in GIS format. **Figure 3** presents a sample of the soils data. The predominant soil types are Newhan, Fripp and Corolla sands, generally with 0 to 10 percent slopes.

**Figure 3. Example Soil Type Data**

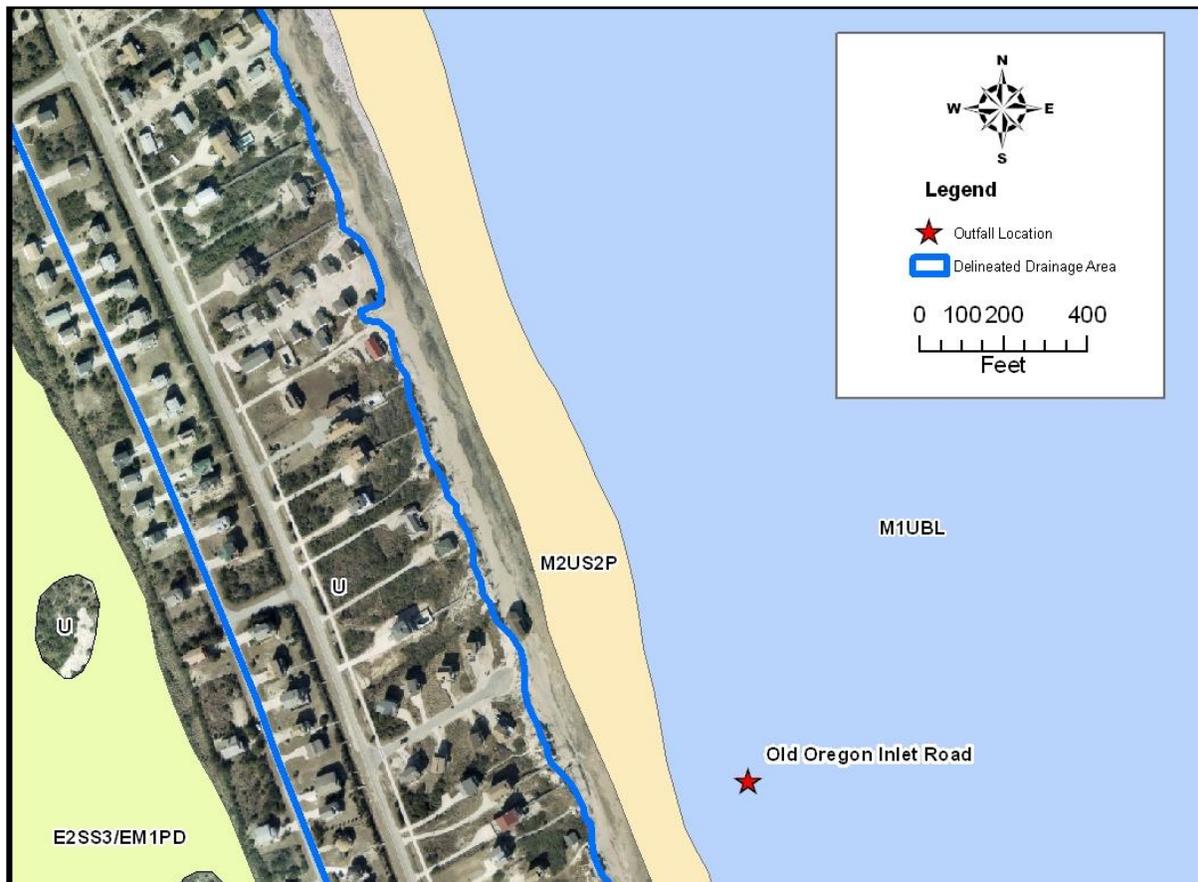
National Wetlands Inventory data were obtained from the US Fish and Wildlife Service’s online mapping tool. Digital data for the study area were provided in GIS format, and a sample is presented in **Figure 4**. Although wetlands frequently occur along the barrier island, only five identified wetland areas were within the outfall drainage areas, for a total of approximately 2 acres of wetlands or 0.2 percent of the total drainage areas overall (almost all contained within the Martin Street outfall watershed). It should be noted that the National Wetlands Inventory database is useful for identifying larger scale wetland areas, but additional smaller localized wetland areas may exist as well.

**Figure 4. Example National Wetlands Inventory Data**

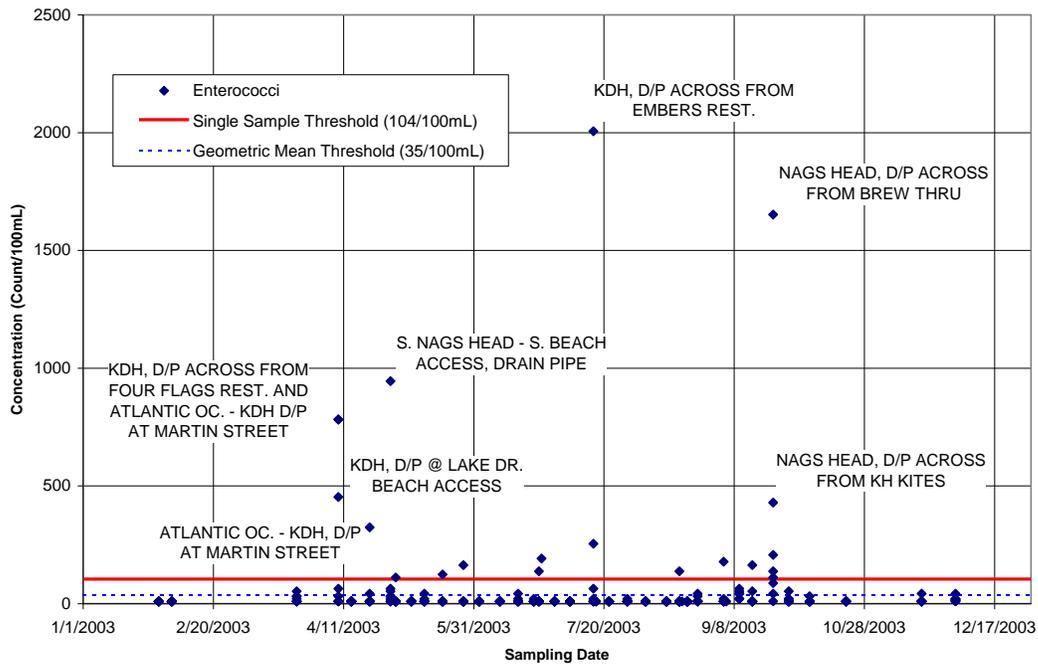
Figure 5. 2003 Water Quality Sampling Data at Outfall Locations

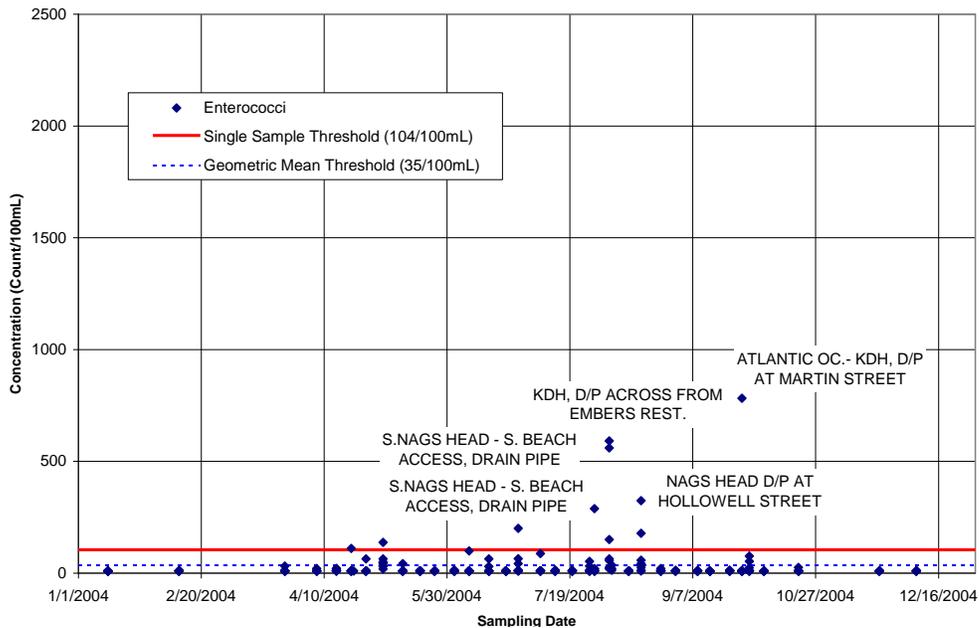
Figure 6. 2004 Water Quality Sampling Data at Outfall Locations

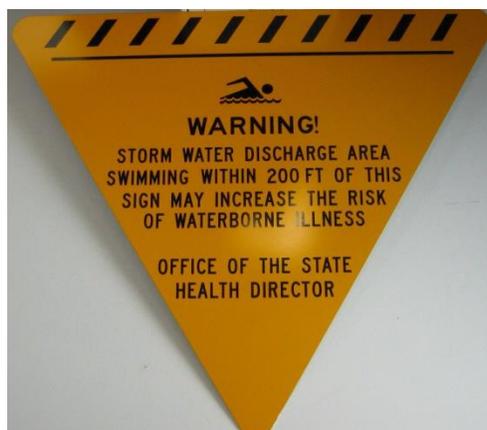
RWQ also developed new signage that will be permanently posted at the Dare County outfalls (**Figure 7**). This signage indicates that swimming is not recommended within 200 feet of the outfalls at any time. The wording was developed in this way because the Dare County outfalls frequently have a base flow discharge. Alternative signage is being placed on southern beaches that do not have a base flow discharge. Those signs state that if a discharge is present, swimming is not recommended within 200 ft of the outfall. The signage was developed in conjunction with local stakeholders and is in place to protect public health while minimizing unwanted publicity from press releases associated with new postings.

**Figure 7. RWQ Sign Placed at Dare County Outfall Sites**

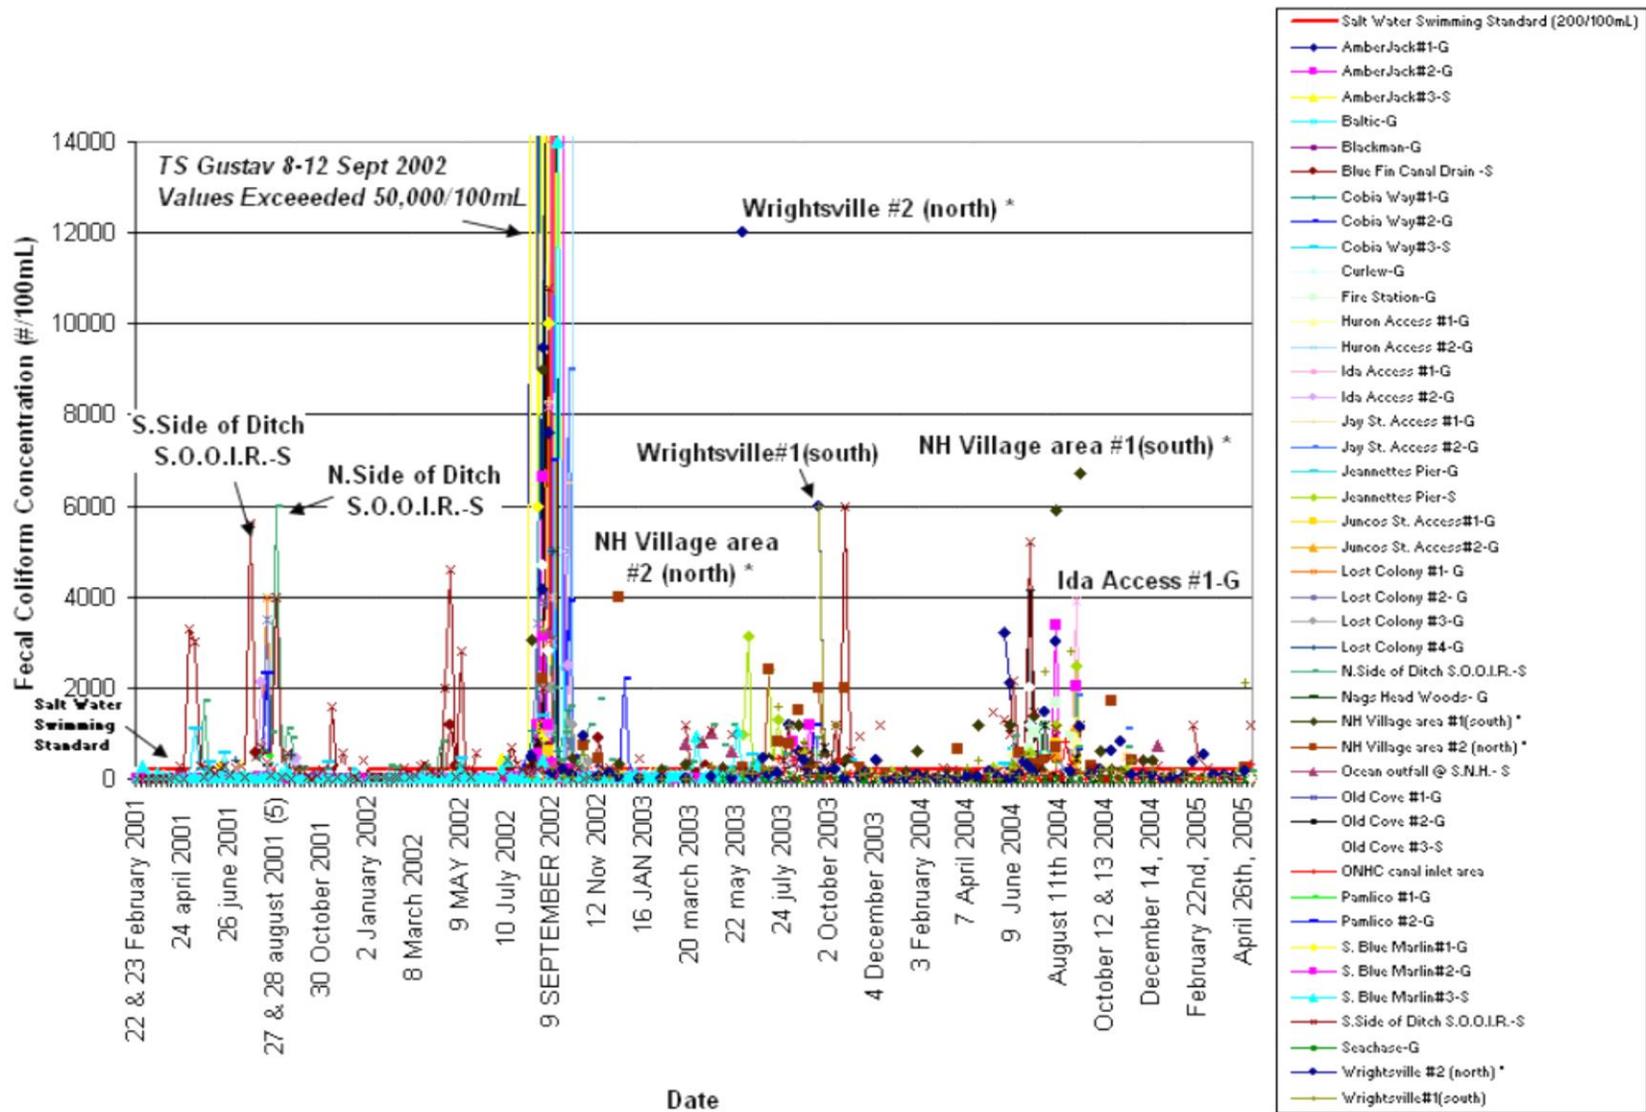
It should be noted that the marine recreational water fecal coliform single sample standard of 200 CFU or MPN per 100 mL was the existing standard in place when collection of these data began in 2002. In October 2002, to maintain compliance with the USEPA per the BEACH Act, the NC Recreational Water Quality Section within NCDENR began using enterococci as the FIB. The USEPA recommended recreational water quality standards, which are a geometric mean of 35 MPN or CFU per 100mL for 5 samples collected over a 30-day period, and 104 MPN or CFU per 100mL for a single sample. These are the standards that remain in place currently.

Figure 8. Nags Head Septic Health Initiative Sampling Data

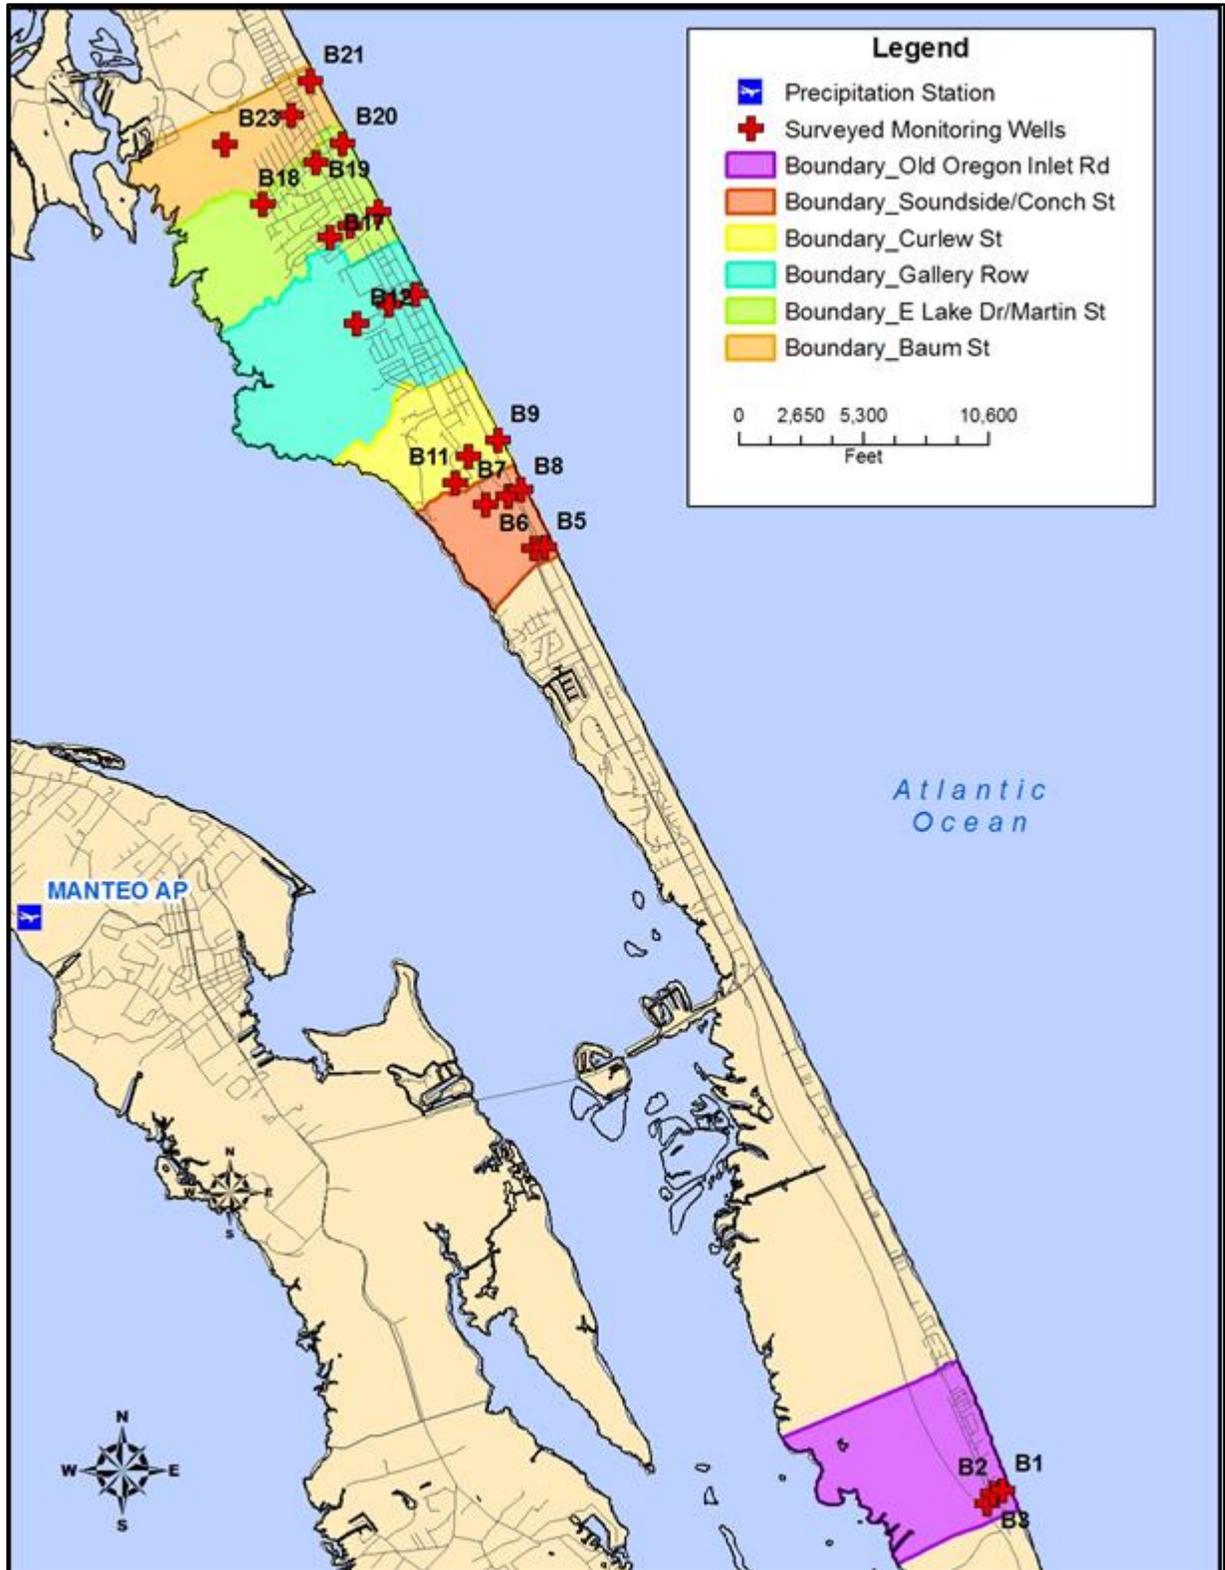
The groundwater monitoring wells collected and recorded data every 30 minutes. Data was then downloaded at approximately 3 month intervals for use. A more detailed description of the data and findings from the groundwater monitoring can be found in Section 2.4.

Figure 12. Ocean Outfall Sub-watersheds and Surveyed Monitoring Wells

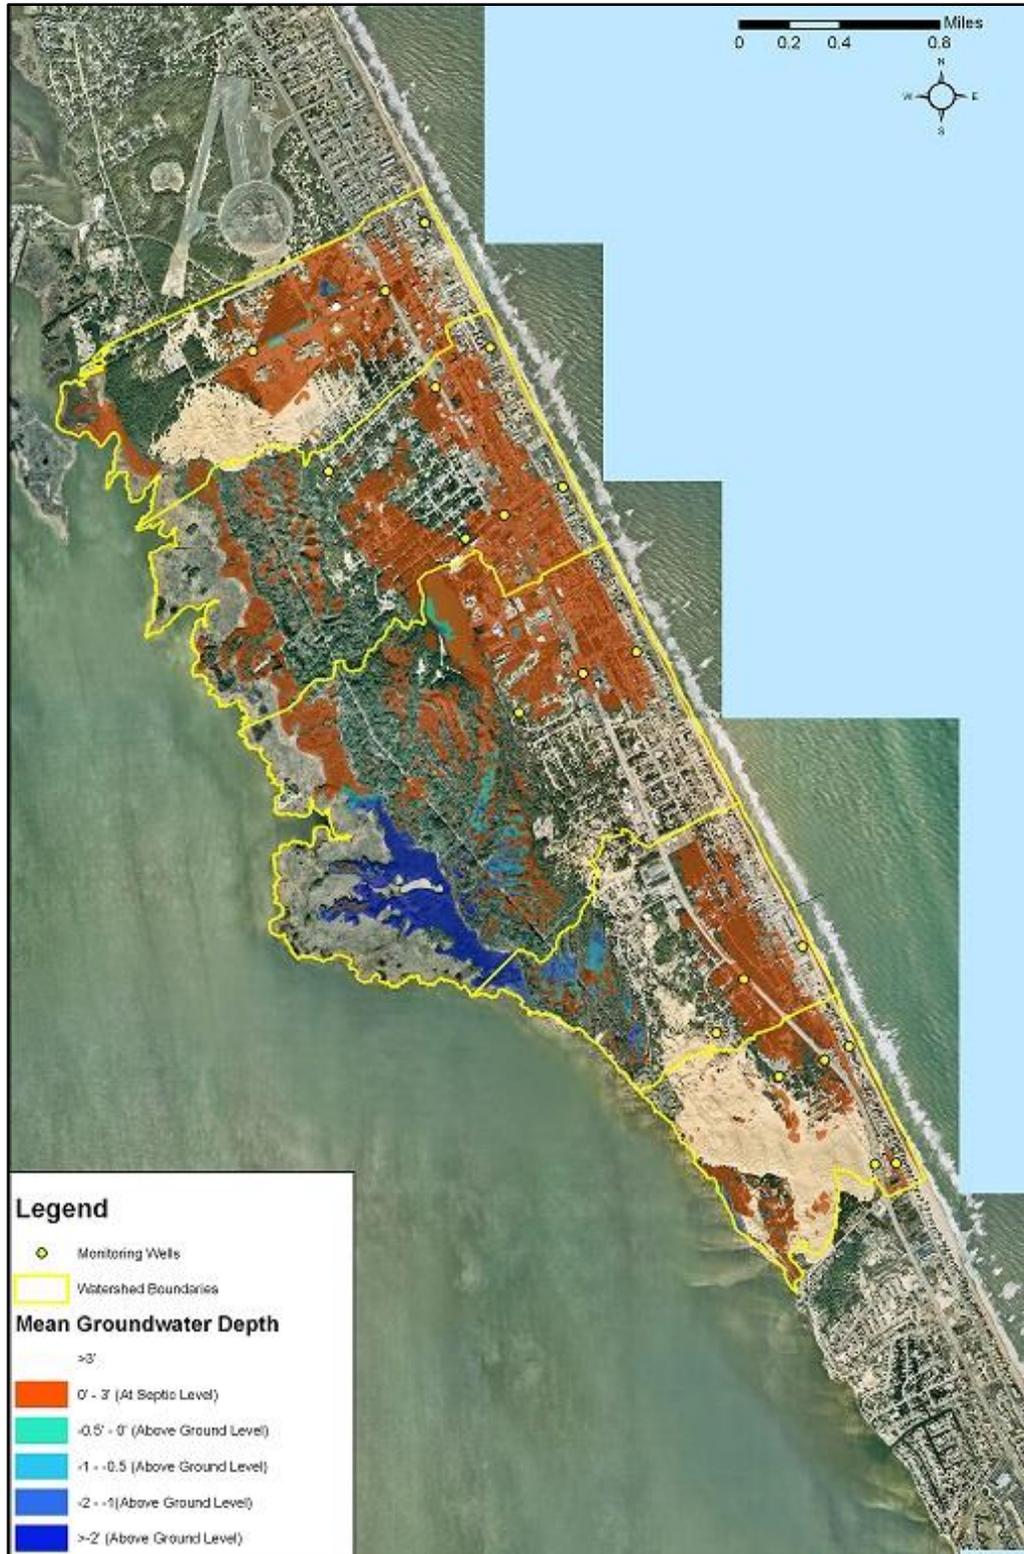
Figure 13. Mean Groundwater Levels from Monitoring Wells

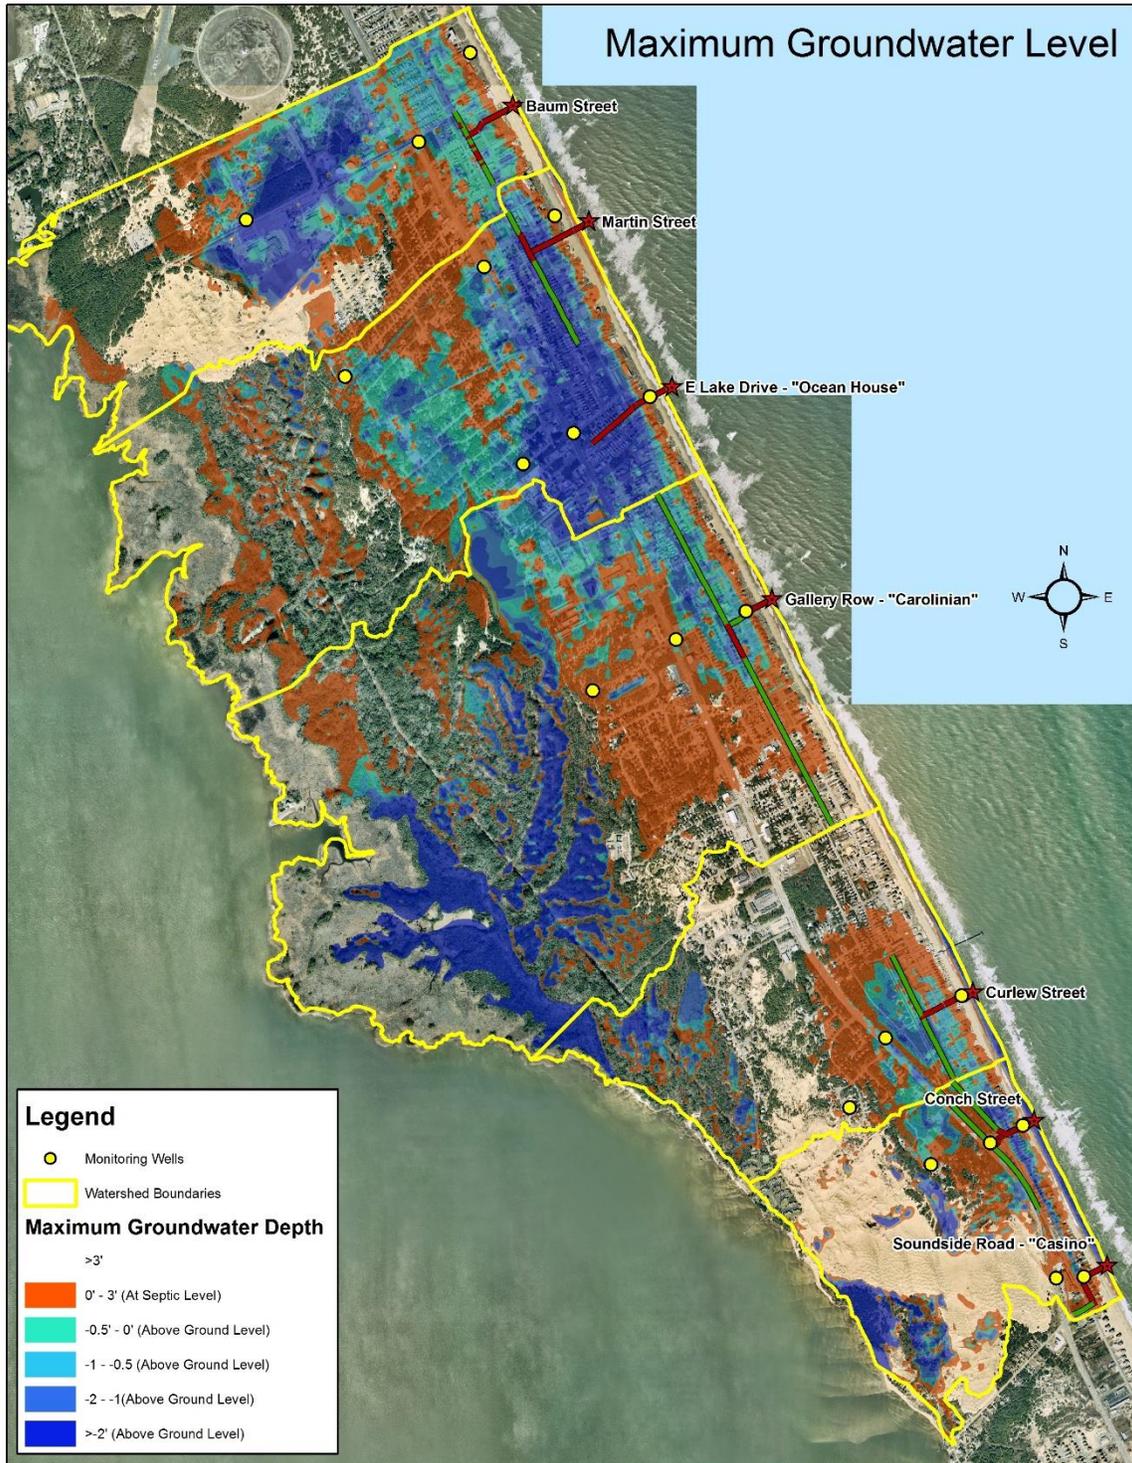
Figure 16. Maximum Groundwater Levels from Monitoring Wells

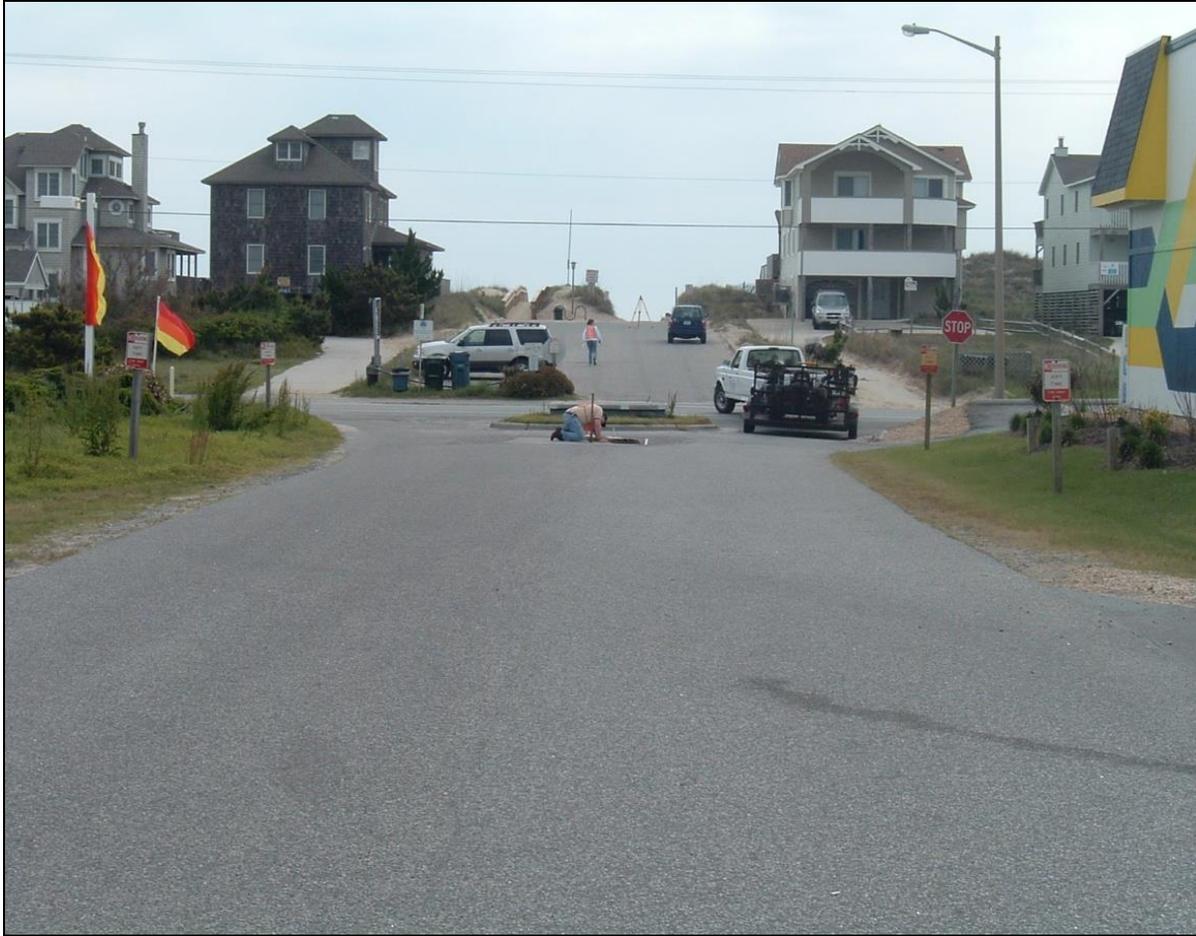
The combined vault system resulted in an underground structure approximately 62 feet long and 16 feet wide. A cutaway showing the distribution of filter arrays along the floor of the primary vault is shown in **Figure 18**, and a plan view of the design of the Conch Street BMP with illustration of flow routing is shown in **Figure 19**.

Figure 17. Conch Street Outfall Alignment Under Beach Access

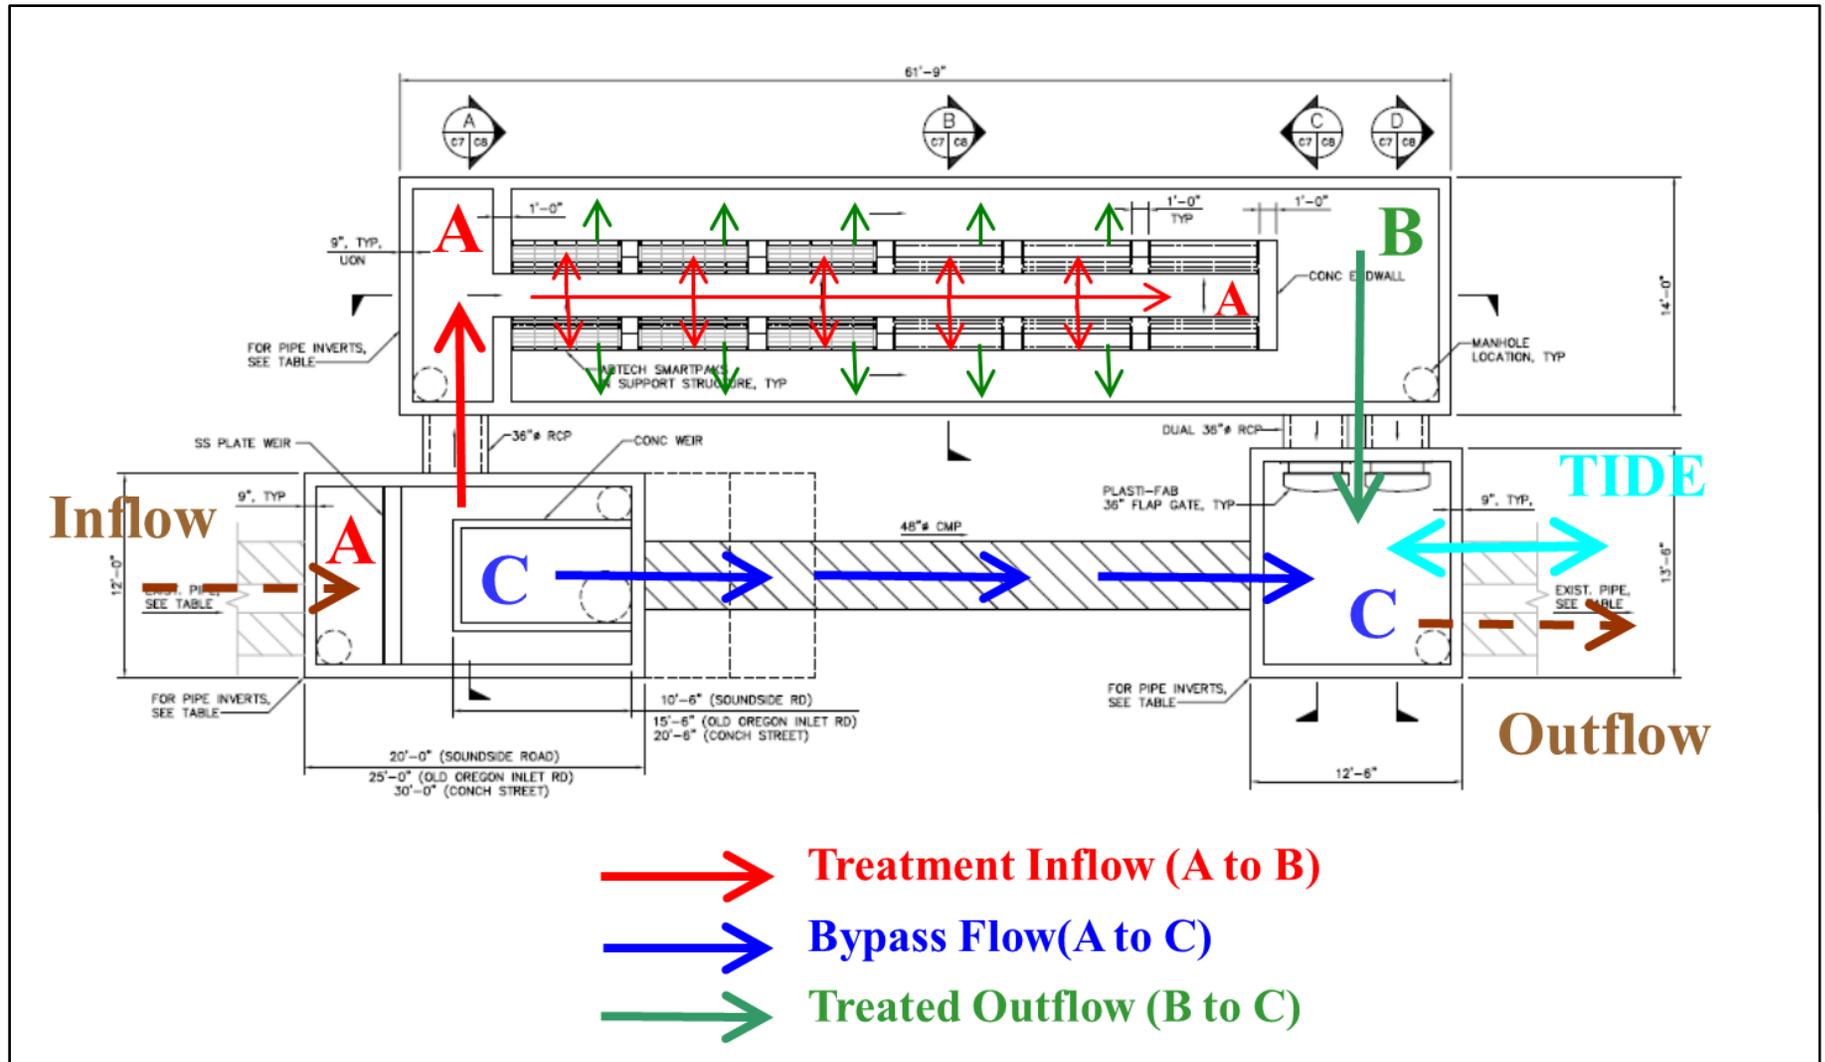
Figure 19. Plan View of Conch Street BMP Design with Routing Model Illustrated

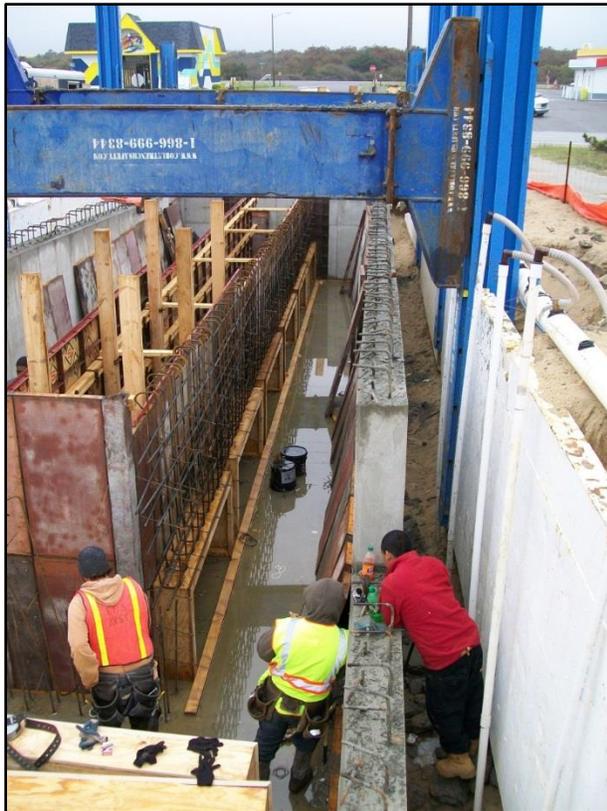
**Figure 20. Construction of the Conch Street BMP**

Design work was completed on the vault and final permits for construction were obtained in August 2008. The initial effort to bid the project out was rejected because only two bidders submitted, and October 2008 the rebid process resulted in a winning construction bid from the firm of George Raper & Sons at \$780,937. The Abtech Smart Pak filter media was purchased separately for \$273,000, resulting in a total construction cost of \$1,053,937. **Figure 20** and **Figure 21** illustrate the construction process. The BMP was completed and influent was released into the vault in December 2009. **Figure 22** shows the top of the completed Conch Street BMP with the top of the vault surrounded by the pervious grid pavers of the rebuilt parking lot.

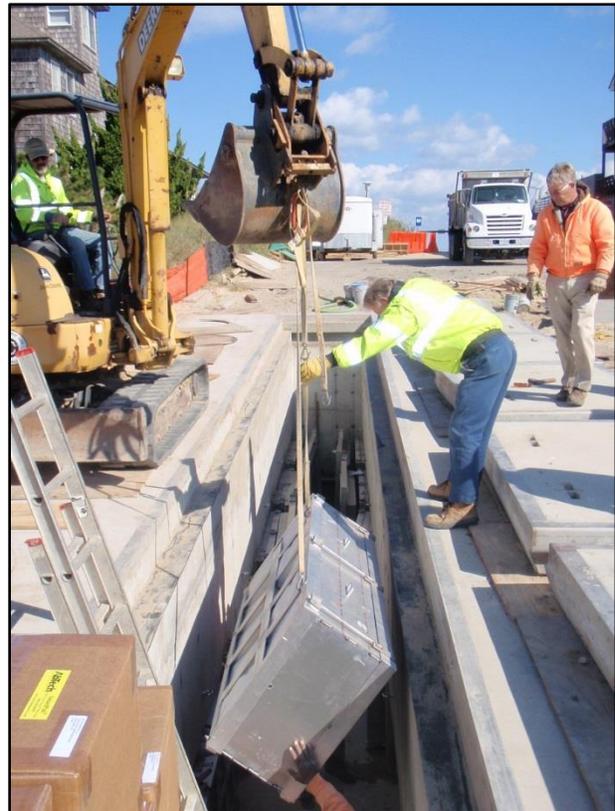
**Figure 21. Construction of the Conch Street BMP**

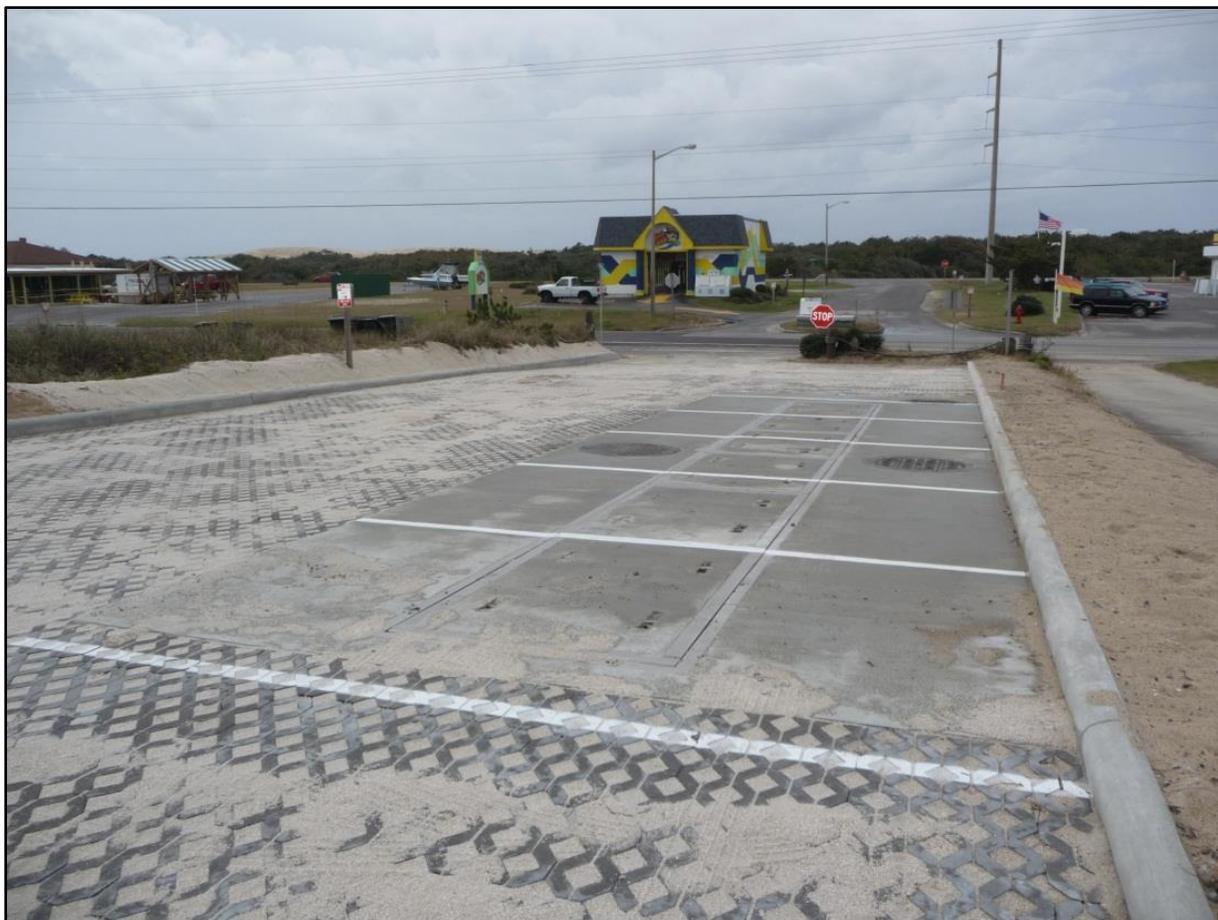
**Figure 22. Completed Conch Street BMP and Restored Parking Lot**

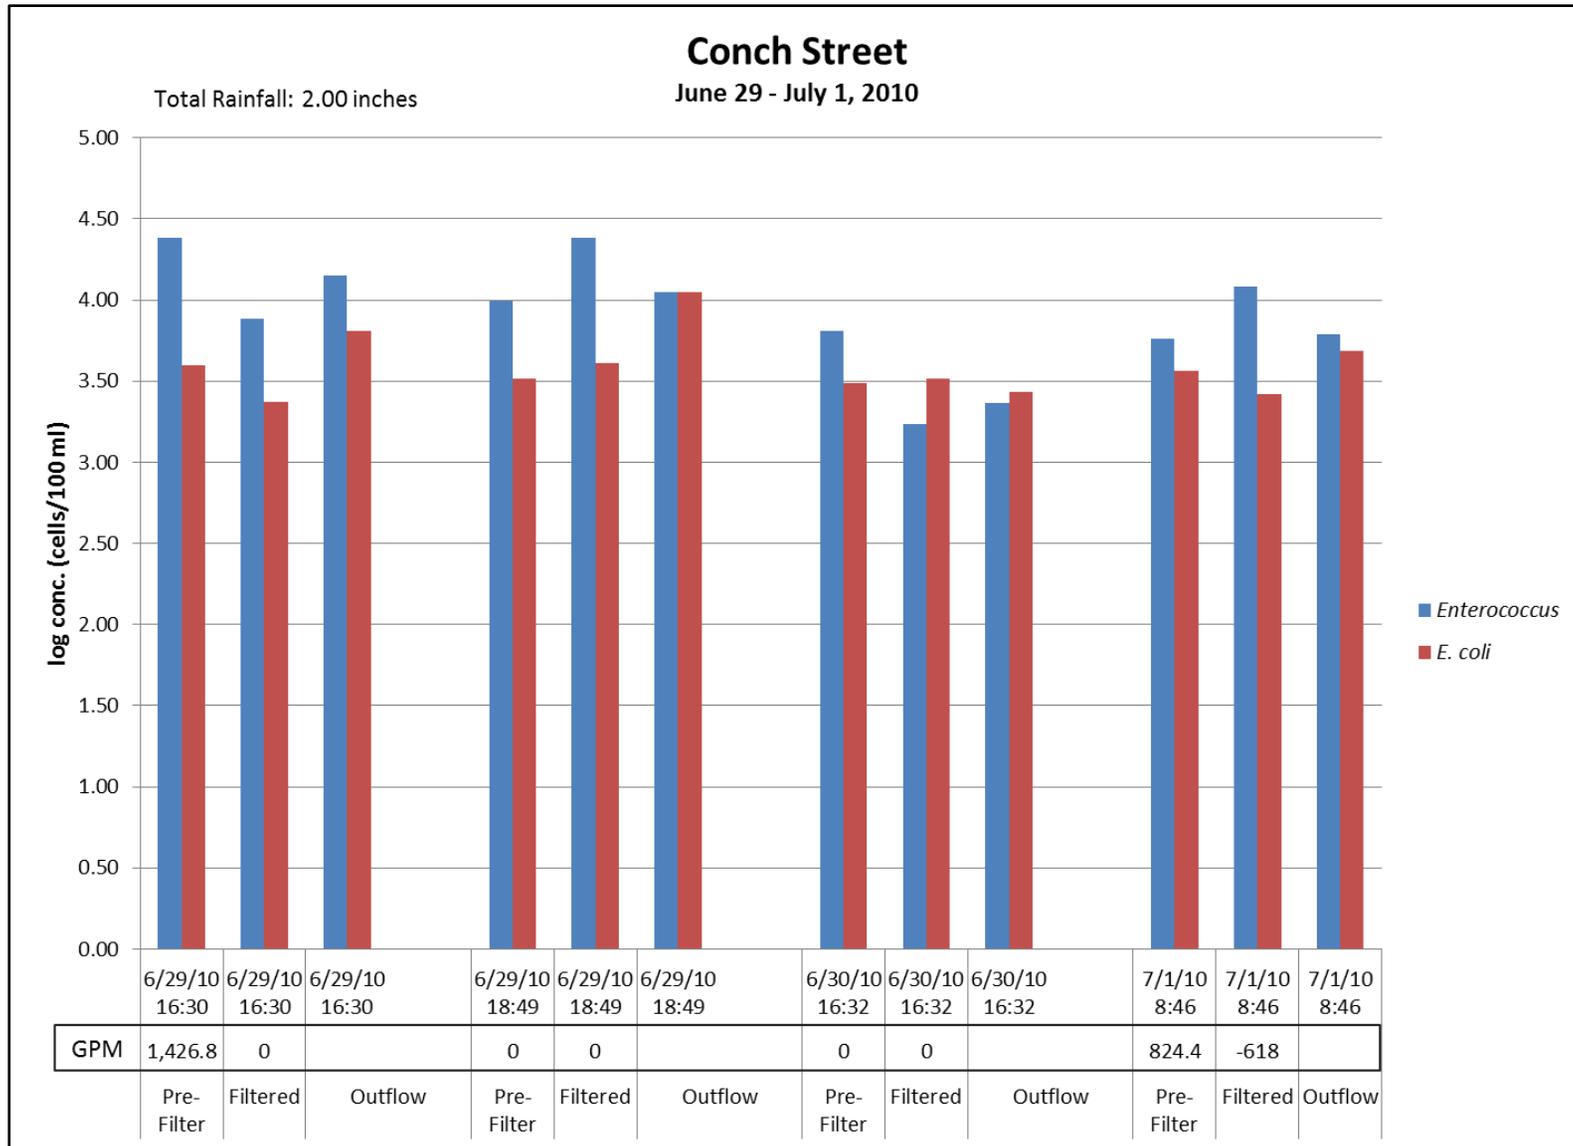
During the storm of June 29, 2010 – July 1, 2010 there was 2.00 in of rainfall over a period of 72 hours. At the Conch Street Outfall, four sampling events were collected. The results from this sampling event are also illustrated graphically in **Figure 23** below. In the interest of space and formatting, the graphic illustrations of data for subsequent storms are shown in Appendix A. During the sampling events, *Enterococcus* concentrations ranged from 1,725 – 24,196 (mean 10,476) MPN 100 ml<sup>-1</sup> and *E. coli* concentrations ranged from 2,359 – 11,199 (mean 4,298) MPN 100 ml<sup>-1</sup>, with all *Enterococcus* values exceeding the state single sample maximum (SSM) of 104 MPN 100 ml<sup>-1</sup>, before, during and at the outflow of the BMP filtered pipe. At the first sampling time point, flow was measured at 1,427 gpm (3.18 cfs) and by the last sampling point, flow had receded to 824 gpm (1.85 cfs). Regardless of tide or flow, *Enterococcus* and *E. coli* concentrations at the outfall were similar to or above concentrations (all within 0.5 log<sub>10</sub> greater or less) entering the BMP filter. In all four rounds of sampling during the event *E. coli* concentrations in the outflow were greater than, or approximately equal to those present in the influent, but two of the sampling events showed reductions in *Enterococcus* with discharge concentrations equal to 79% of incoming stormwater levels (21% reduction), on average.

**Figure 23. Conch Street BMP Monitoring Results for June 2010 Storm Event**
