# STORMWATER PILOT PROJECT FOR NCDOT MAINTAINED OCEAN OUTFALLS AND ASSOCIATED OUTLETS OCEAN OUTFALL MASTER PLAN

June 2016

North Carolina Department of Environmental Quality  
Division of Water Resources  
217 West Jones Street  
Raleigh, NC 27601

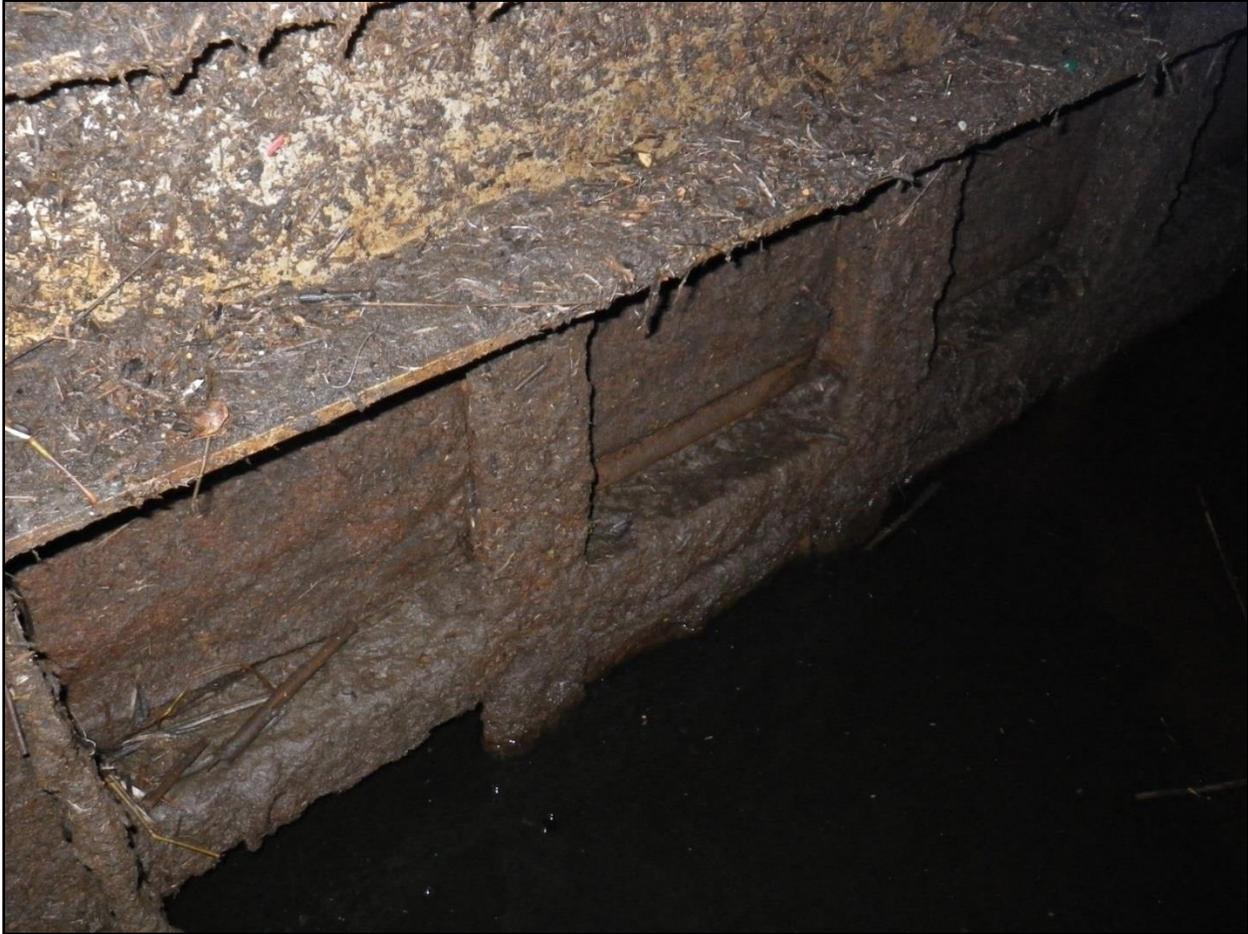
The main purposes of the maintenance event were to clean the sediment from the vault sand change out the treatment media. Given the high cost of the AbTech Smart Pak sponges, the existing sponges deployed in the original loading of the vault were tested for viability and reused when possible. Approximately one third of the individual Smart Paks were reused from the original set, leaving two thirds of the treatment media array that had to be replaced with new Smart Paks. Fees and expenses for the maintenance event totaled \$212,048, including \$155,859 in expenses for the new treatment media. The maintenance event took four full days.

**Figure 24. Conch Street BMP Treatment Media with Sediment Deposition**

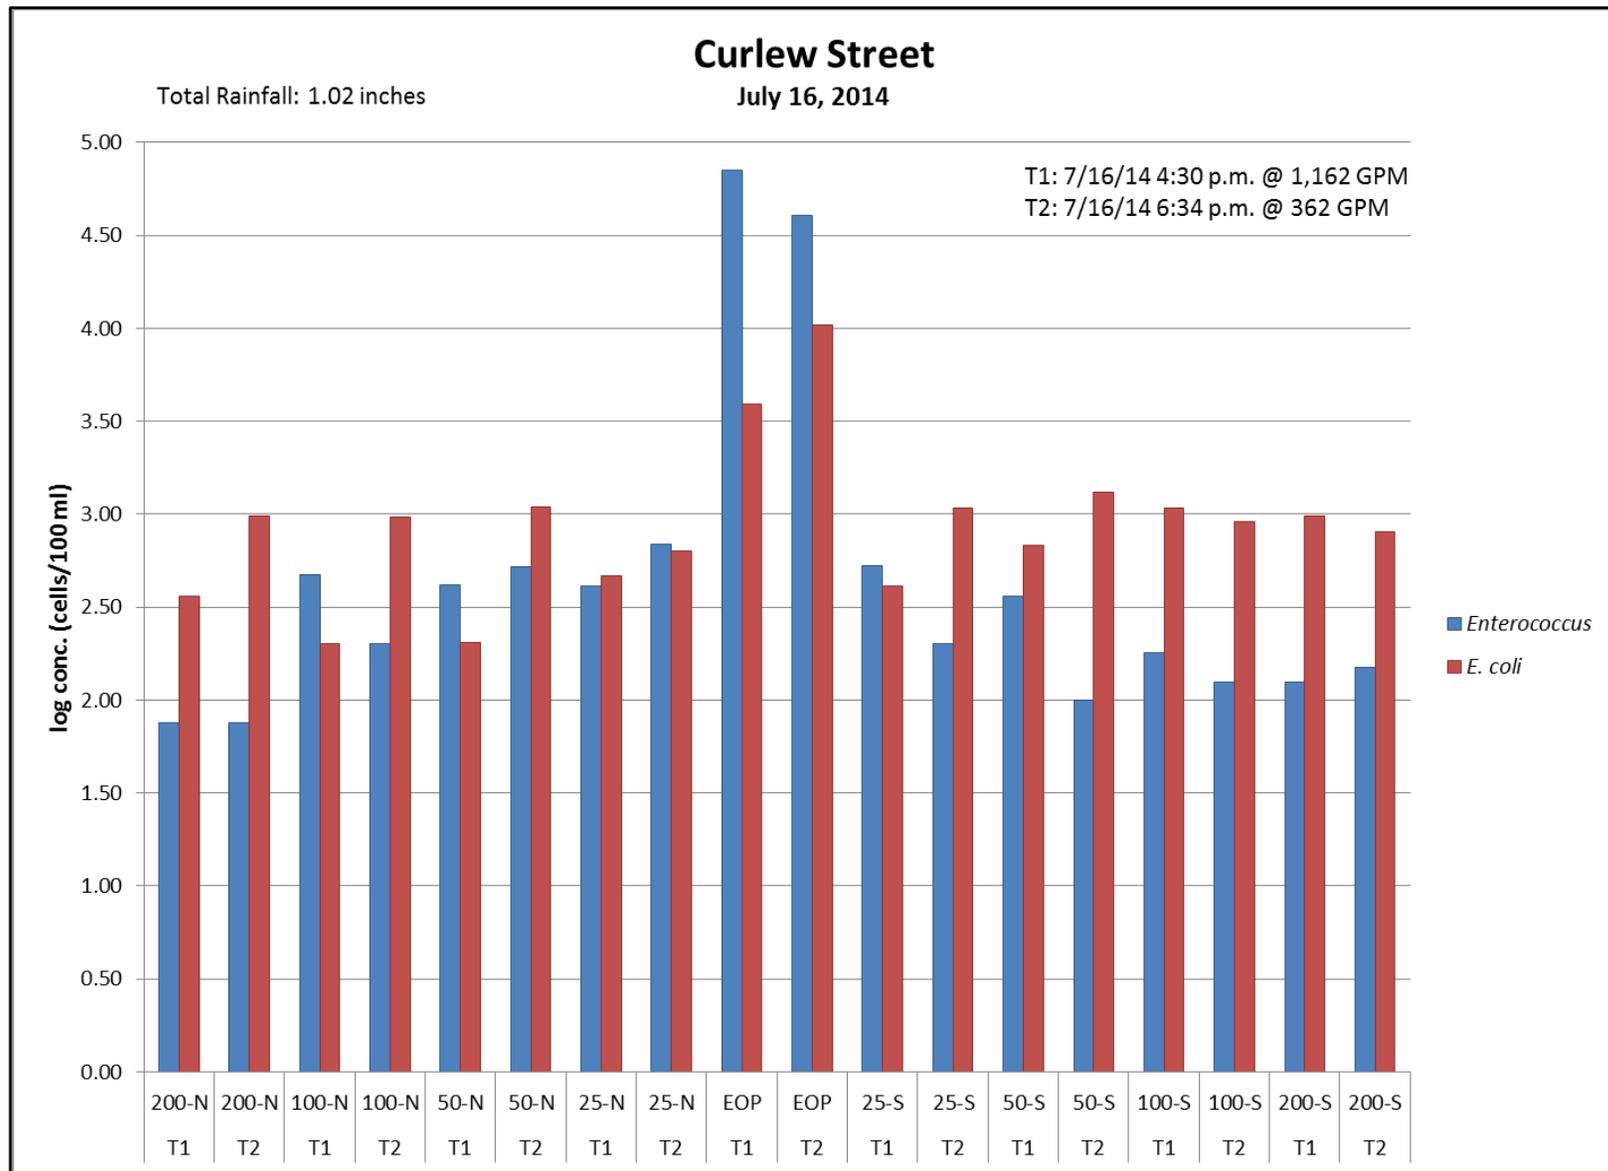
During the storm of July 16, 2014 there was 1.02 in of rainfall over two hours. At the Curlew Street Outfall, two sampling events over the course of the storm. The sampling was conducted at the end of the outfall pipe and 25m, 50m, 100m, and 200m in the north and south direction from the outfall pipe. The results from this sampling event are also illustrated graphically in **Figure 25** below. In the interest of space and formatting, the graphic illustrations of data for subsequent storms are shown in Appendix B. The flow for time point 1 (T1) was 1,162 gpm (2.59 cfs) and subsided to 362 gpm (0.81 cfs) at time point 2 (T2), two hours later. Even though the duration of this storm was short, the second sampling point indicated a strong influence of stormwater contamination up and down coast with concentrations of *Enterococcus* remaining above the state water quality threshold of 104 MPN  $100\text{ ml}^{-1}$ , respectively, at distances of 100 meters upstream and 200 meters downstream from the end of the outfall pipe. The second sampling point showed a log increase in *E. coli* concentrations at the northern most sampling points (100m and 200m up coast). The *Enterococcus* and *E. coli* concentrations were highest at the end of the pipe (4.85  $\log_{10}$  and 3.59  $\log_{10}$  for T1; 4.61  $\log_{10}$  and 4.02  $\log_{10}$ , respectively). Even though a clear impact of the storm water inputs at the Curlew Street site exists from this up coast and down coast storm assessment, it is possible that additional stormwater influences are being observed from nearby (Conch Street) locations and is evident for all the storm samples collected during additional storms. The mean *E. coli* concentration was 1592  $100\text{ ml}^{-1}$ , ranging from 200 – 12,590  $100\text{ ml}^{-1}$ . The mean *Enterococcus* concentration was 7,009  $100\text{ ml}^{-1}$ , ranging from 50 – 86,640  $100\text{ ml}^{-1}$ . The highest concentrations occurred at the outfall at the end of the pipe.

Figure 25. Upcoast/Downcoast Monitoring Results for Curlew Street Outfall, July 2014

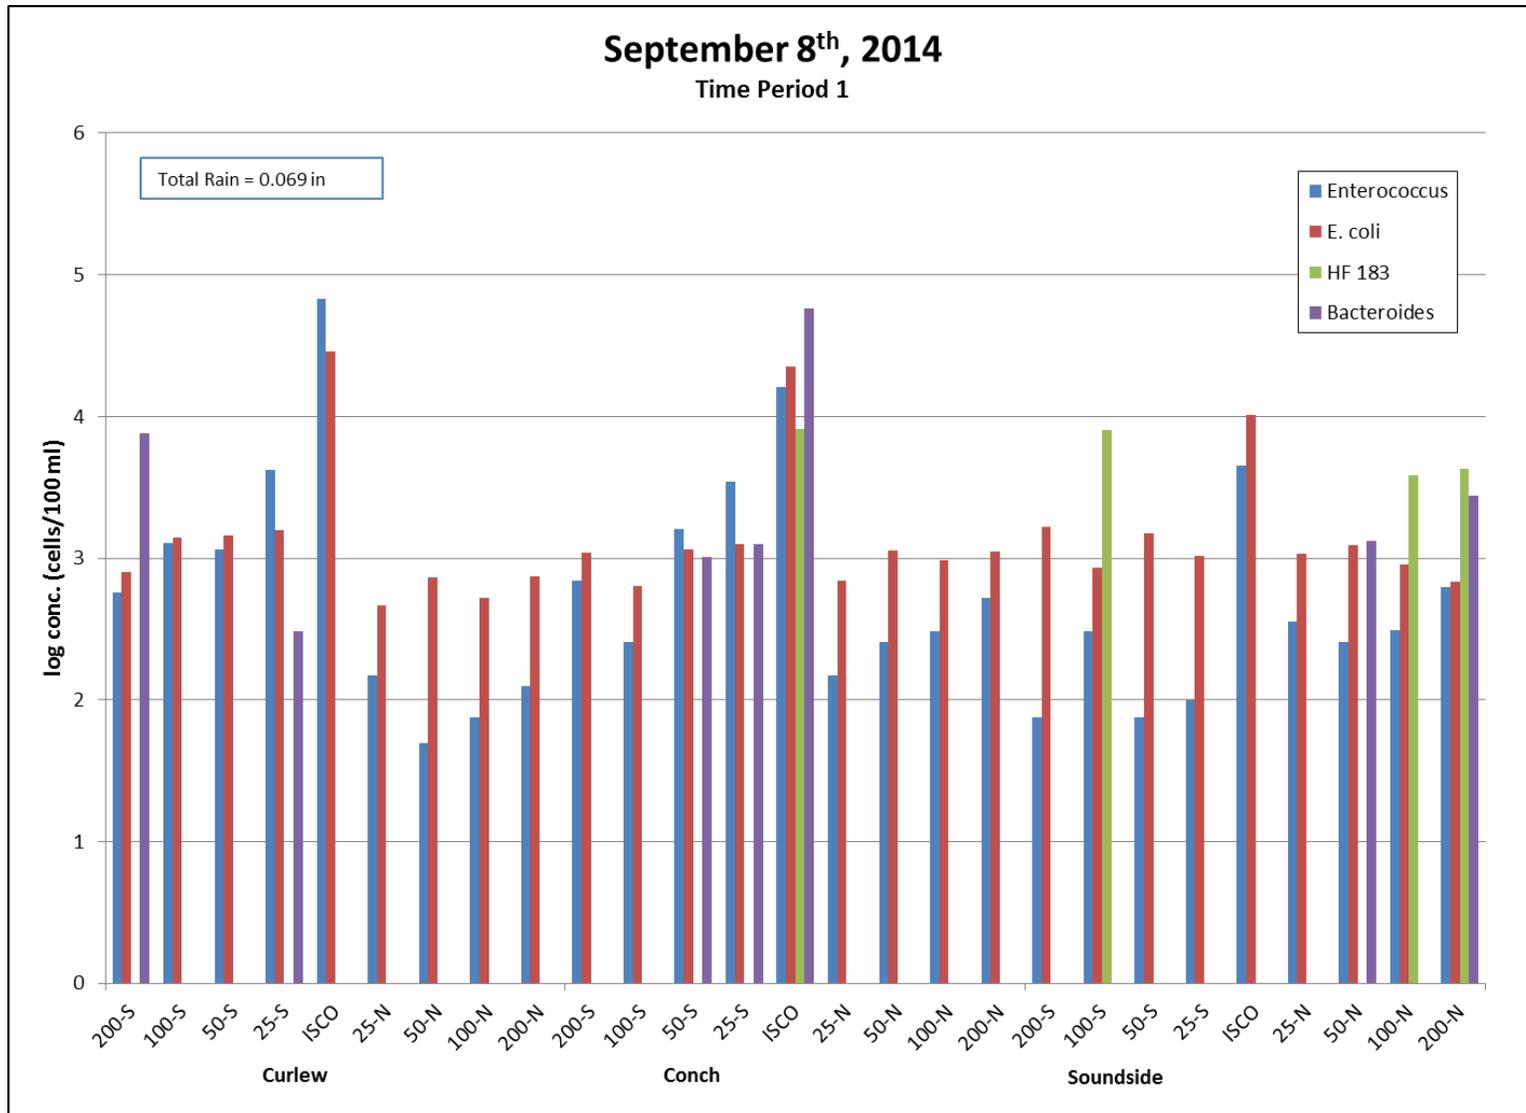
Human fecal contamination, as determined via the quantification of HF183 molecular marker, has been quantified in stormwater discharge at distances away from the pipe exceeding 100 m. This human specific marker has been related to risk in swimmers.

Figure 26. Upcoast/Downcoast Monitoring Results for September 2014 Storm Event – Time 1

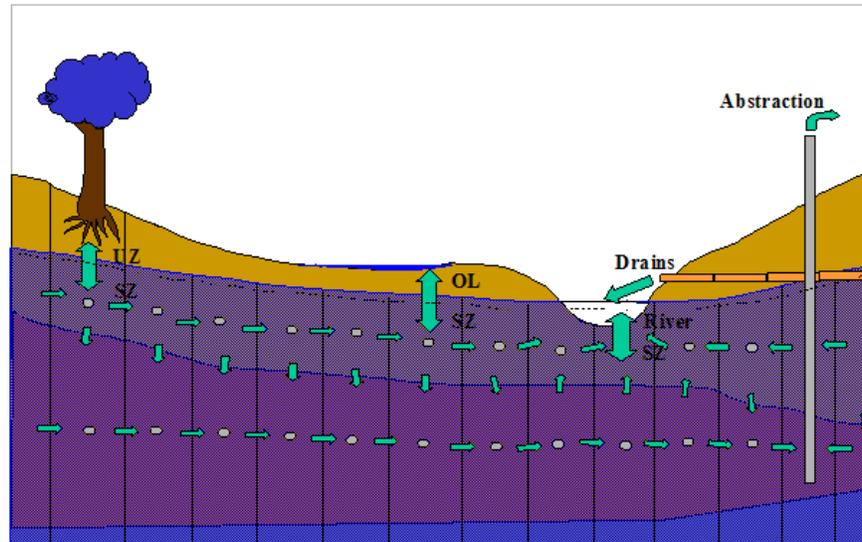
**Figure 28. Interrelation of MIKESHE Submodels**

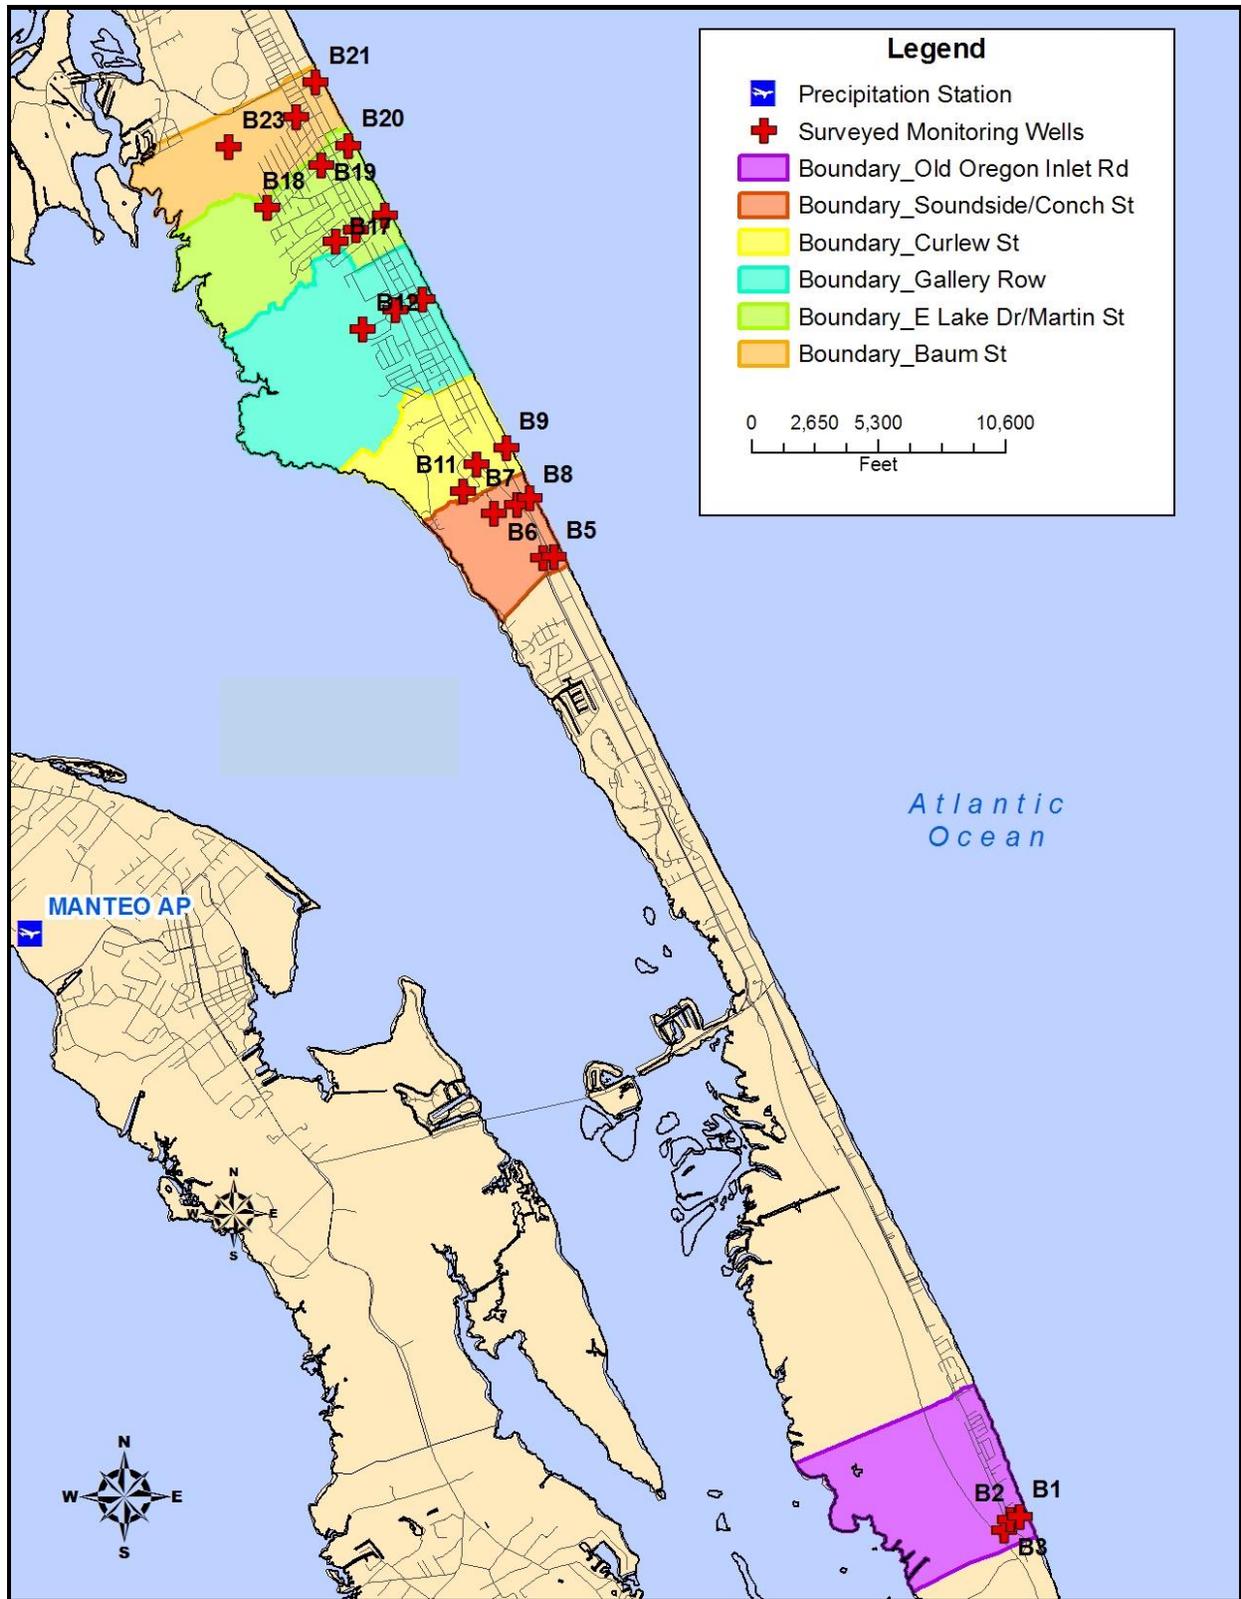
Data collected from the detailed geotechnical and survey investigations were used to help build the proposed MIKESHE/MIKE11 models. The outfall watersheds were split up to six sub-watersheds to speed model run times: Old Oregon Inlet Road, Soundside/Conch Street, Curlew Street, Gallery Row, East Lake Drive/Martin Street, and Baum Street. However, it should be noted that these delineations are based on topography and field reconnaissance only and that potential groundwater influences are not included. **Figure 29** shows the delineated six sub-watersheds along with the surveyed monitoring wells to be used in the MIKESHE model calibration.

Figure 29. MIKESHE Sub-watershed and Surveyed Monitoring Wells

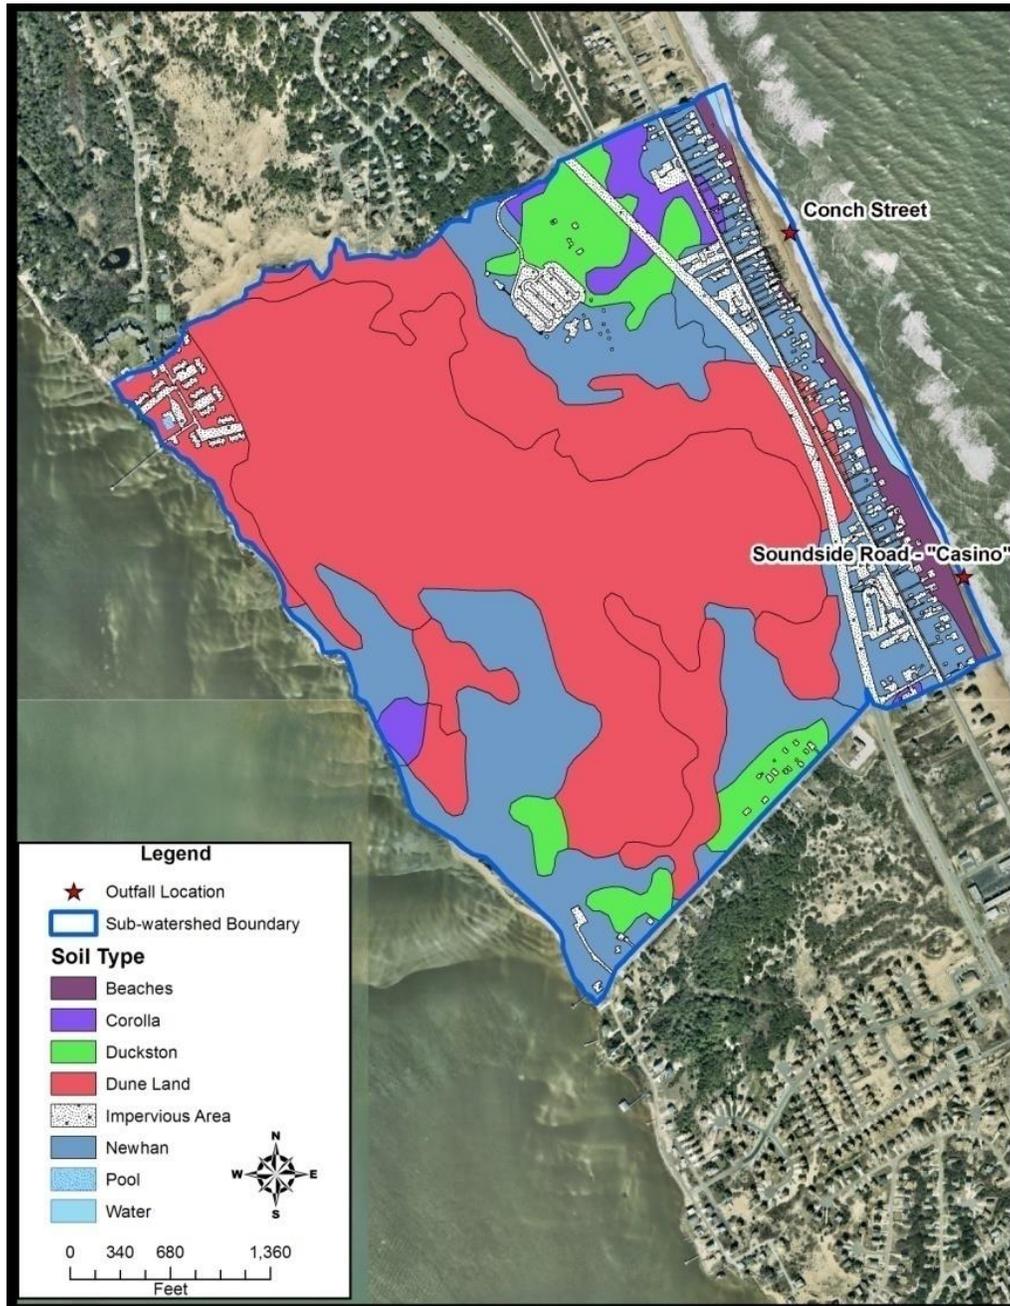
The surface soils (unsaturated zone) model was the next submodel to be included in the overall MIKESHE setup. The datasets outlined in data collection phase were the main input used to create maps and soil parameters required by the submodel. After lumping like soil groups together and including a separate soil type for impervious areas, the map outlined in **Figure 32** was created for Soundside/Conch Street subdomain.

**Figure 32. Example Soil Type Data for Soundside/Conch Street**

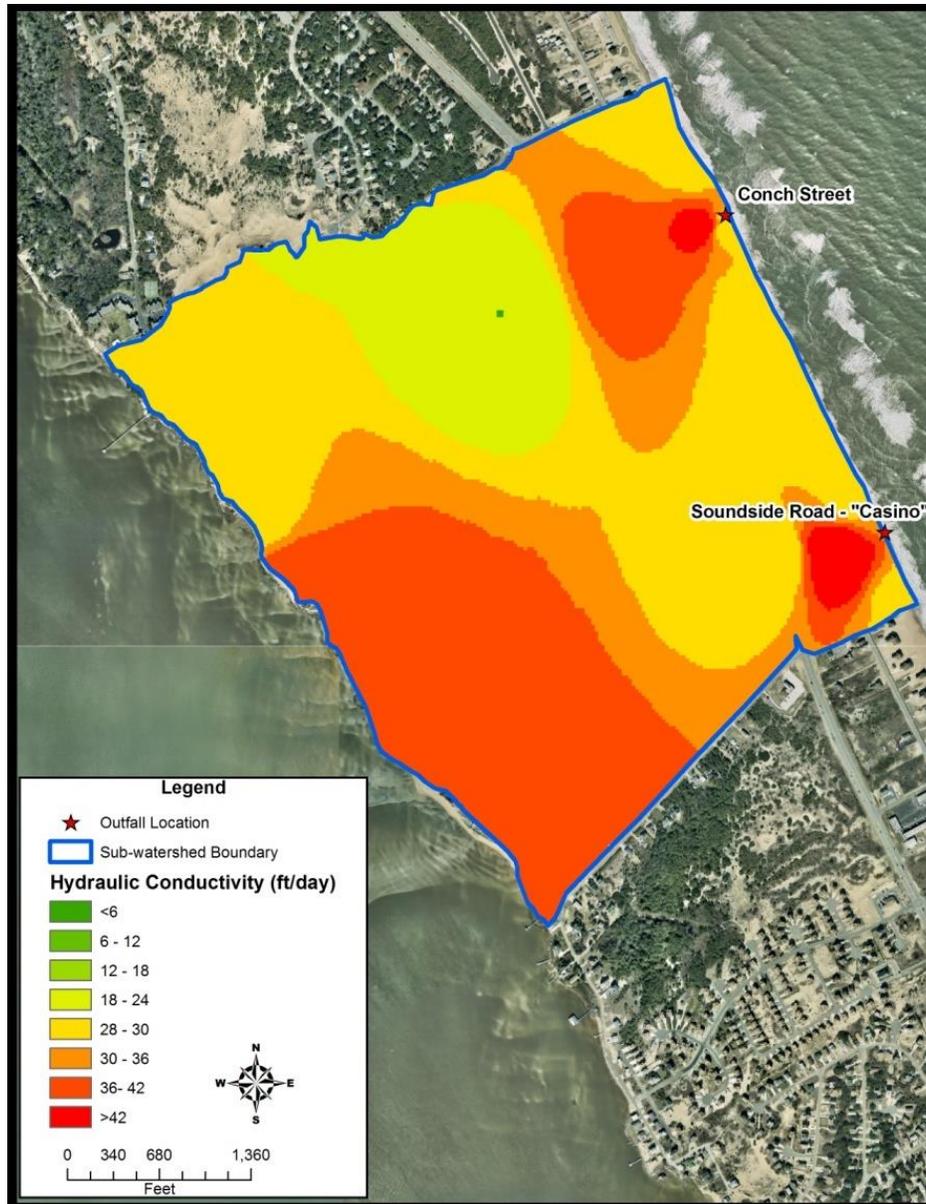
<b>Monitoring Well I.D.</b>	<b>Hydraulic Conductivity (K) (ft/day)</b>
B2	44.61
B3	39.00
B4	25.54
B5	46.42
B6	18.47
B7	40.36
B8	43.42
B9	26.03
B10	47.25
B11	22.83
B12	15.85
B13	28.47
B14	21.85
B15	14.15
B16	19.26
B17	34.65
B18	20.48
B19	24.58
B20	38.40
B21	33.69
B22	15.72
B23	20.70
B24	43.61

**Figure 33. Example Horizontal Hydraulic Conductivity Data for Soundside/Conch Street**

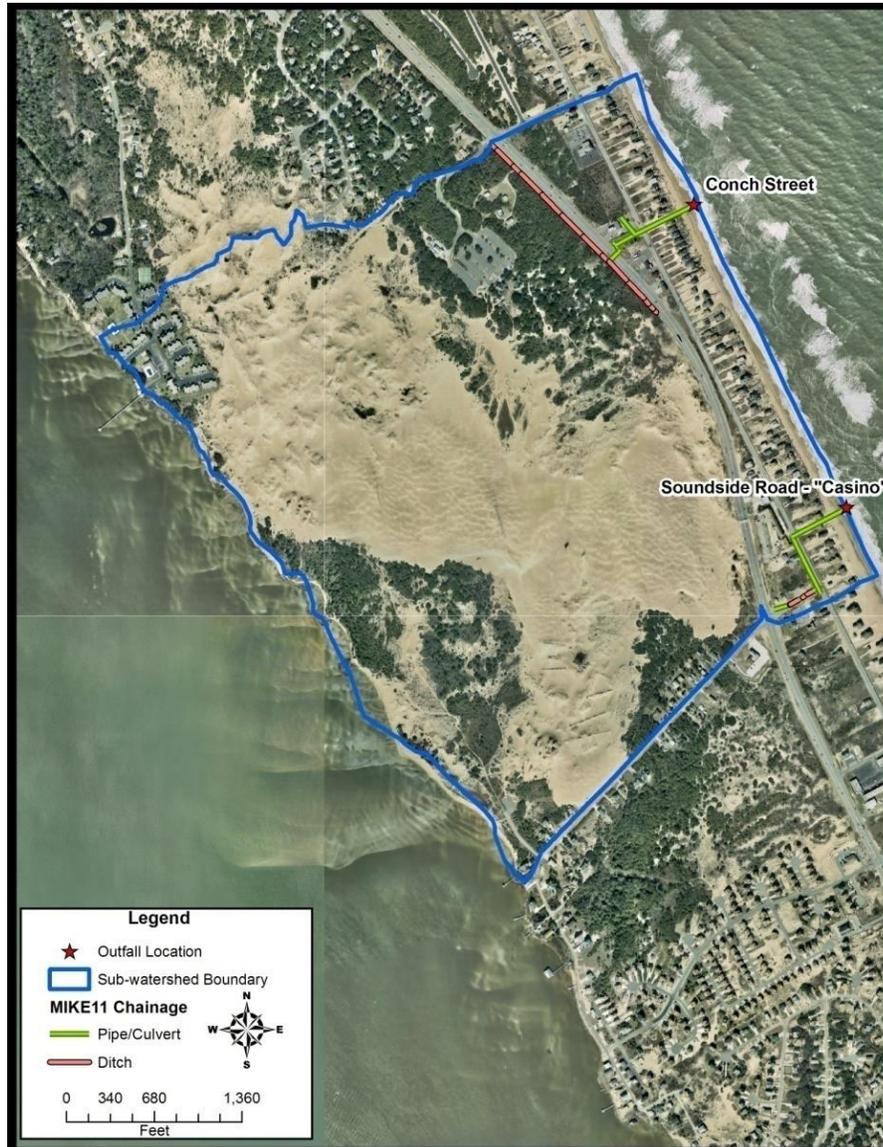
The one-dimensional MIKE11 for each outfall was determined based on a limited field survey completed on May 16-18, 2005, by NCDOT. **Figure 34** shows the sketch for Soundside/Conch St Outfall and the channel/pipe network simulated using MIKE11 within MIKESHE.

**Figure 34. Example MIKE11 One-Dimensional Model for Soundside/Conch Street**

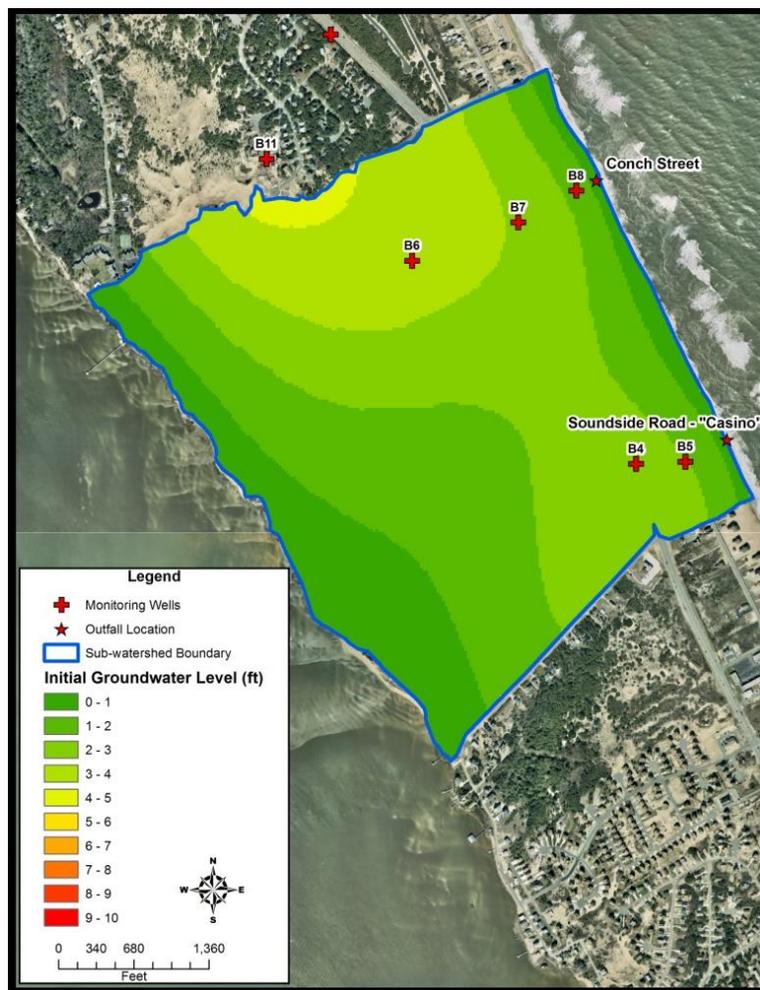
Initial groundwater level grids were generated using the measured groundwater level from the monitoring wells. **Figure 35** shows an example of initial groundwater level for Soundside/Conch Street sub-watershed. **Figure 36** presents the comparison between the measurements and modeled groundwater levels for wells B4 to B8 which located in Soundside/Conch Street sub-watershed. Overall, there is very good agreement between the model and observed results.

**Figure 35. Initial Groundwater Level Data for Soundside/Conch Street, Tropical Storm Ernesto**

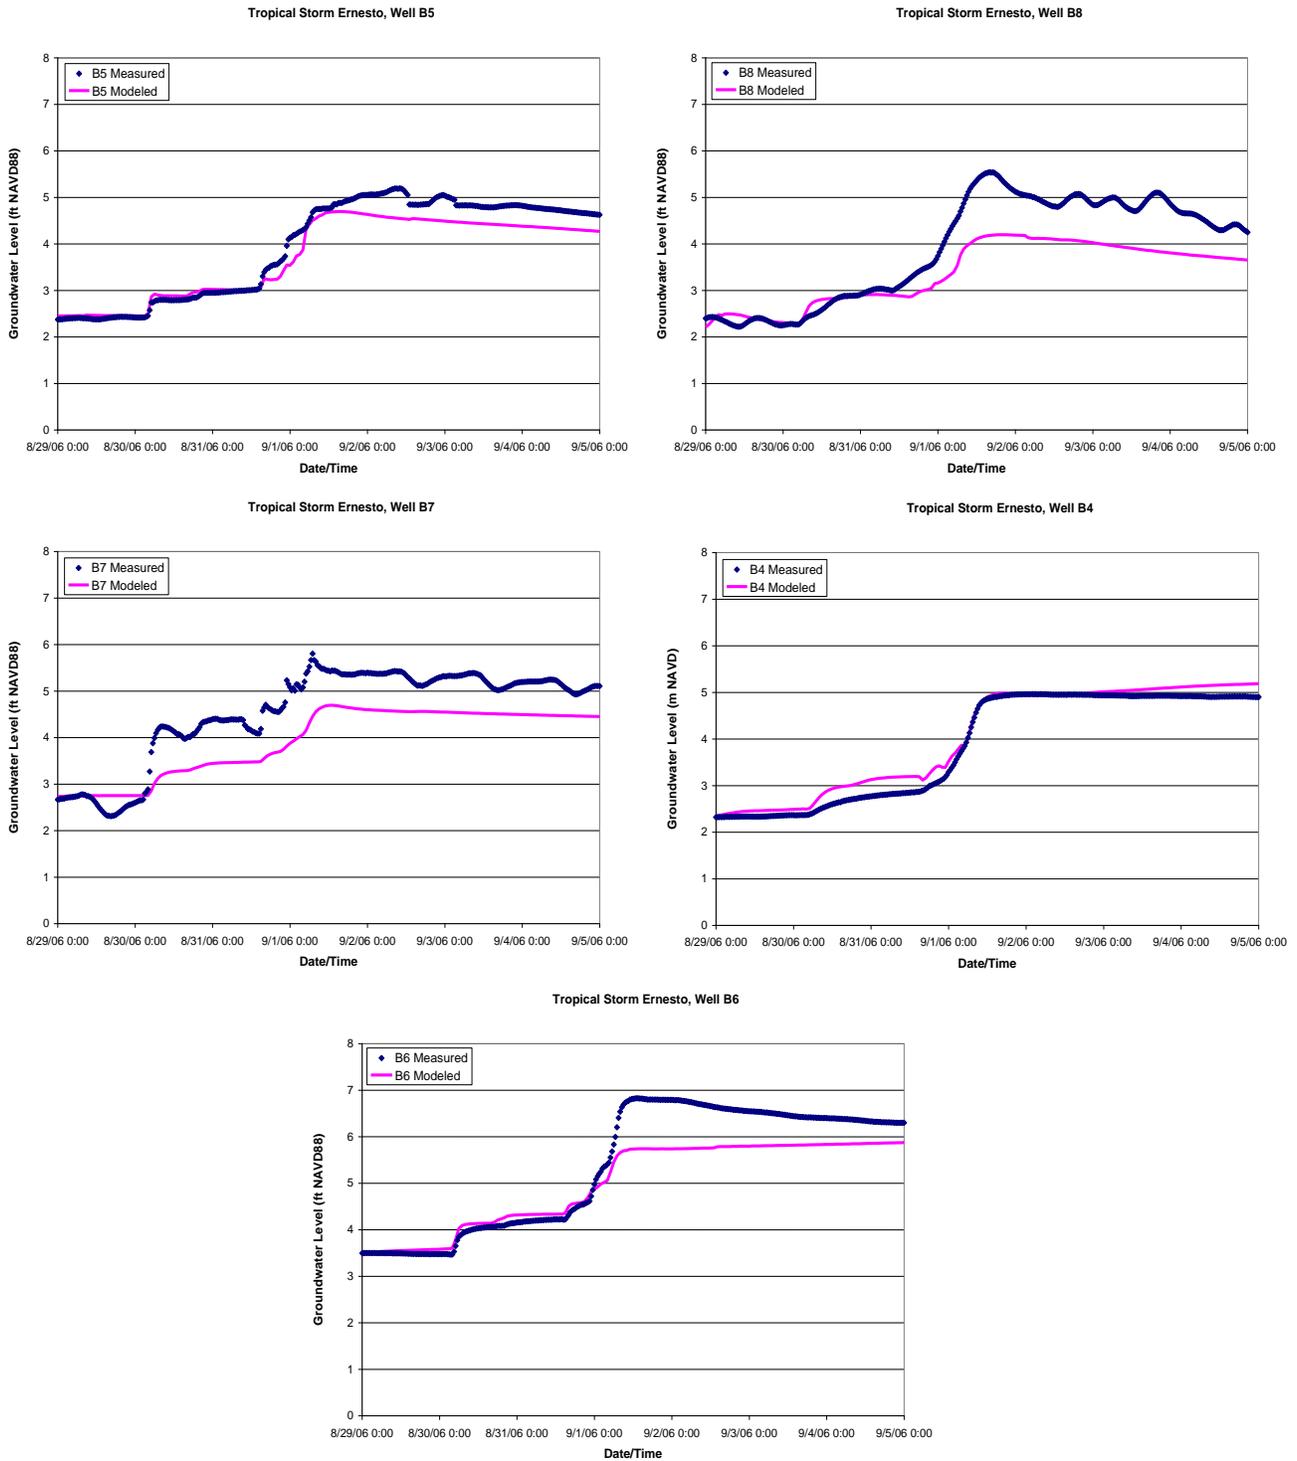
Figure 36. Groundwater Comparison Results from Calibration Run, Tropical Storm Ernesto

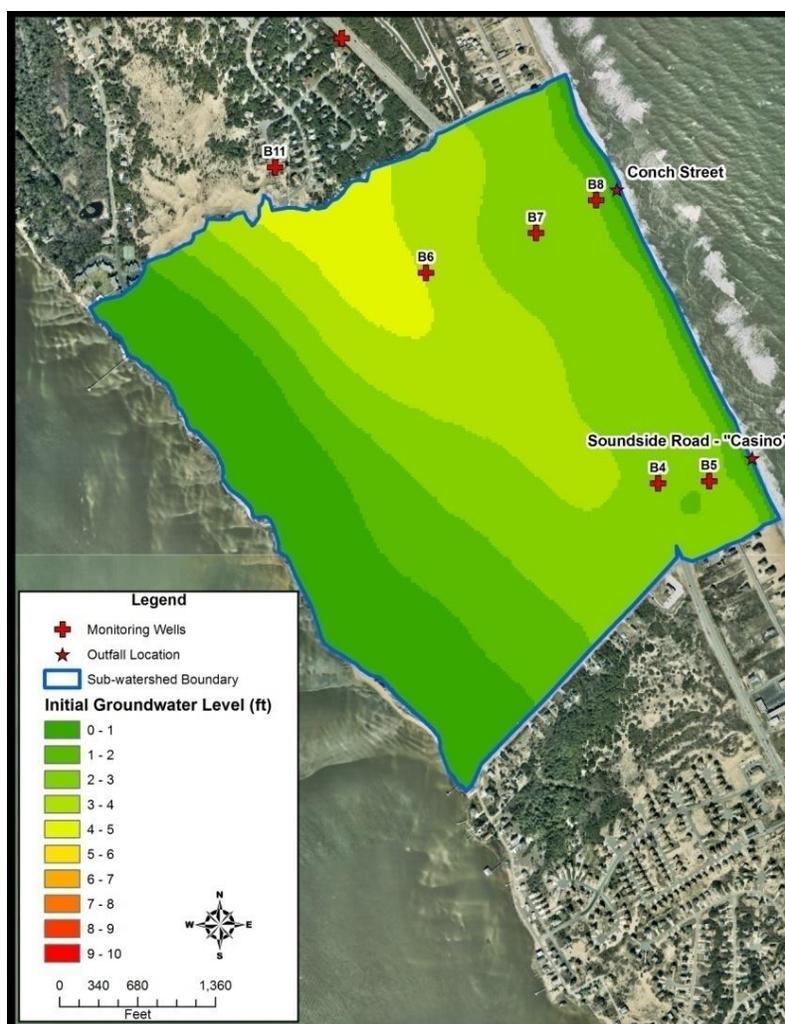
Initial groundwater level grids were generated using the measured groundwater level from the monitoring wells. **Figure 37** shows an example of initial groundwater level for Soundside/Conch Street sub-watershed. **Figure 38** presents the comparison between the measurements and modeled groundwater levels for wells B4 to B8 which located in Soundside/Conch Street sub-watershed. Overall, very good agreement between the model and observed results is also achieved. **Figure 39** shows the outfall flow rates comparison between measured and modeled results along with precipitation. Model predictions at Conch St Outfall match the two big rainfall events; while at the Soundside Rd Outfall, the flow rate on first big rainfall is much smaller than the second. Given the high local variability of rainfall patterns on the Outer Banks, it is very likely that the rainfall inputs from the monitoring station used in the model were different from what was actually experienced at the outfall, which is especially possible with such low measured flows.

**Figure 37. Initial Groundwater Level Data for Soundside/Conch Street, Tropical Storm Barry**

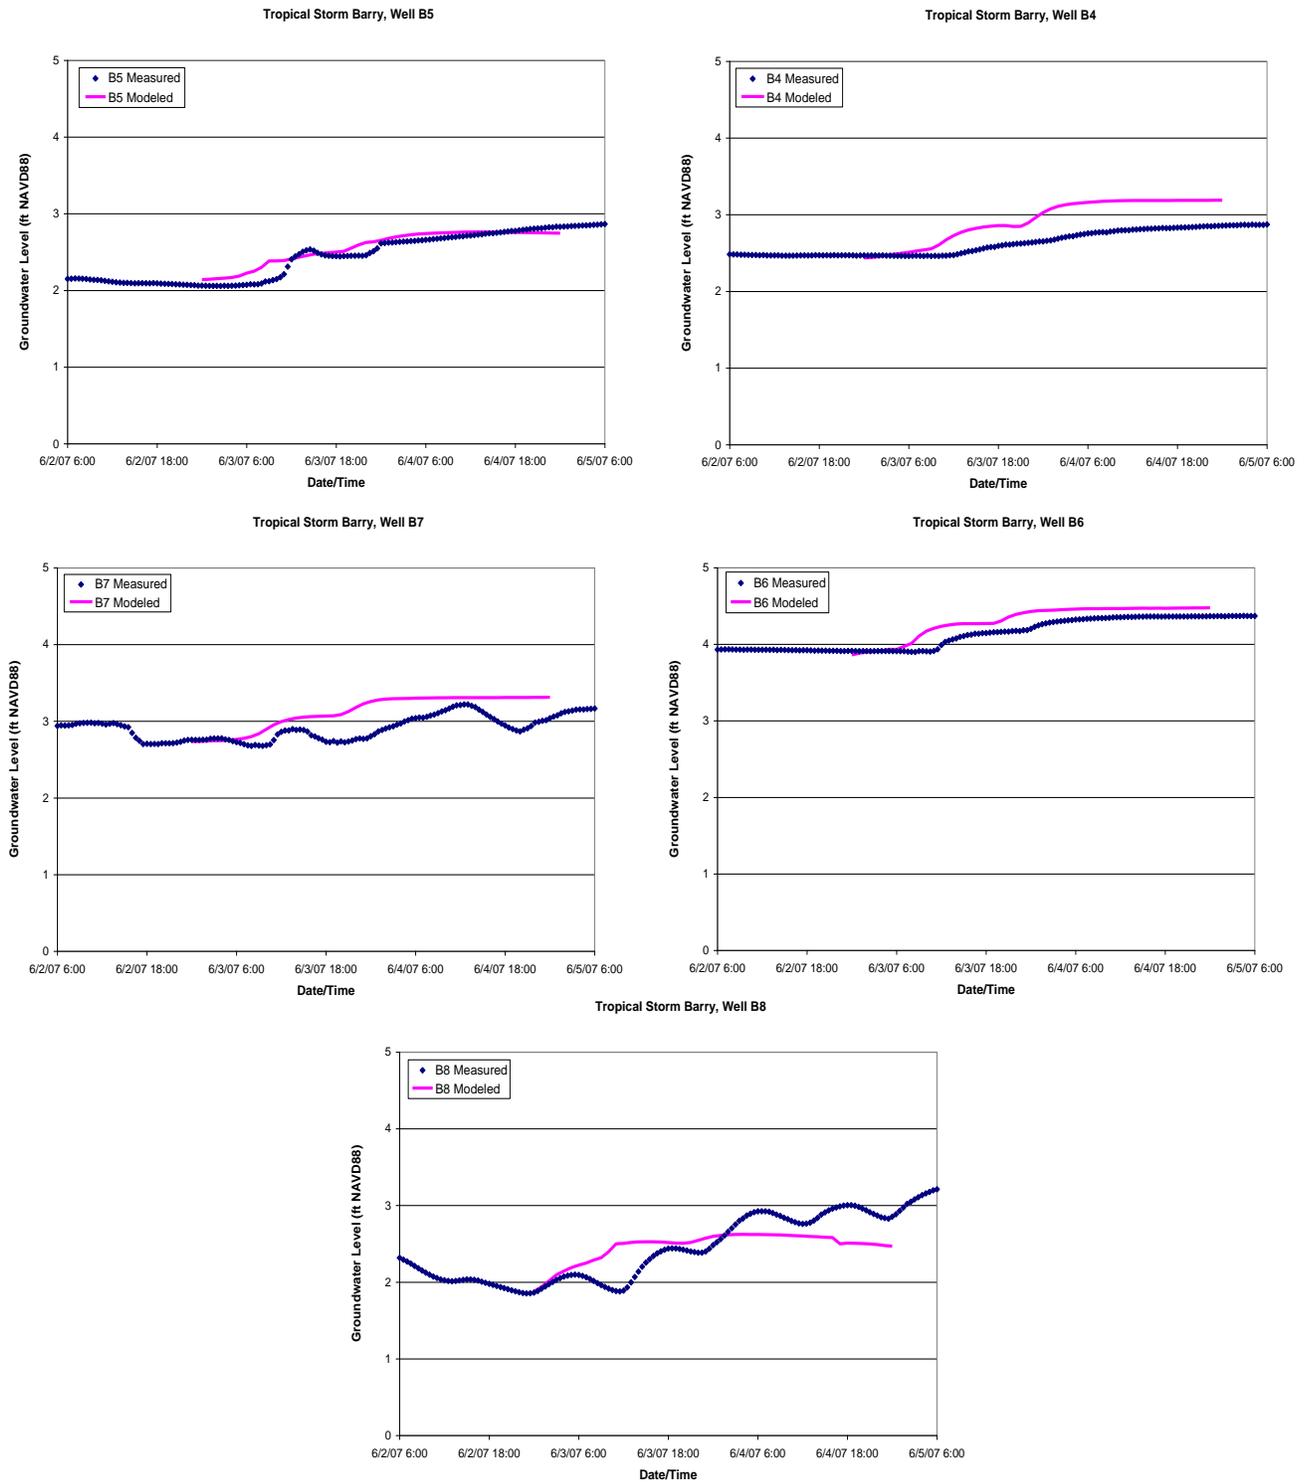
Figure 38. Groundwater Comparison Results from Calibration Run, Tropical Storm Barry

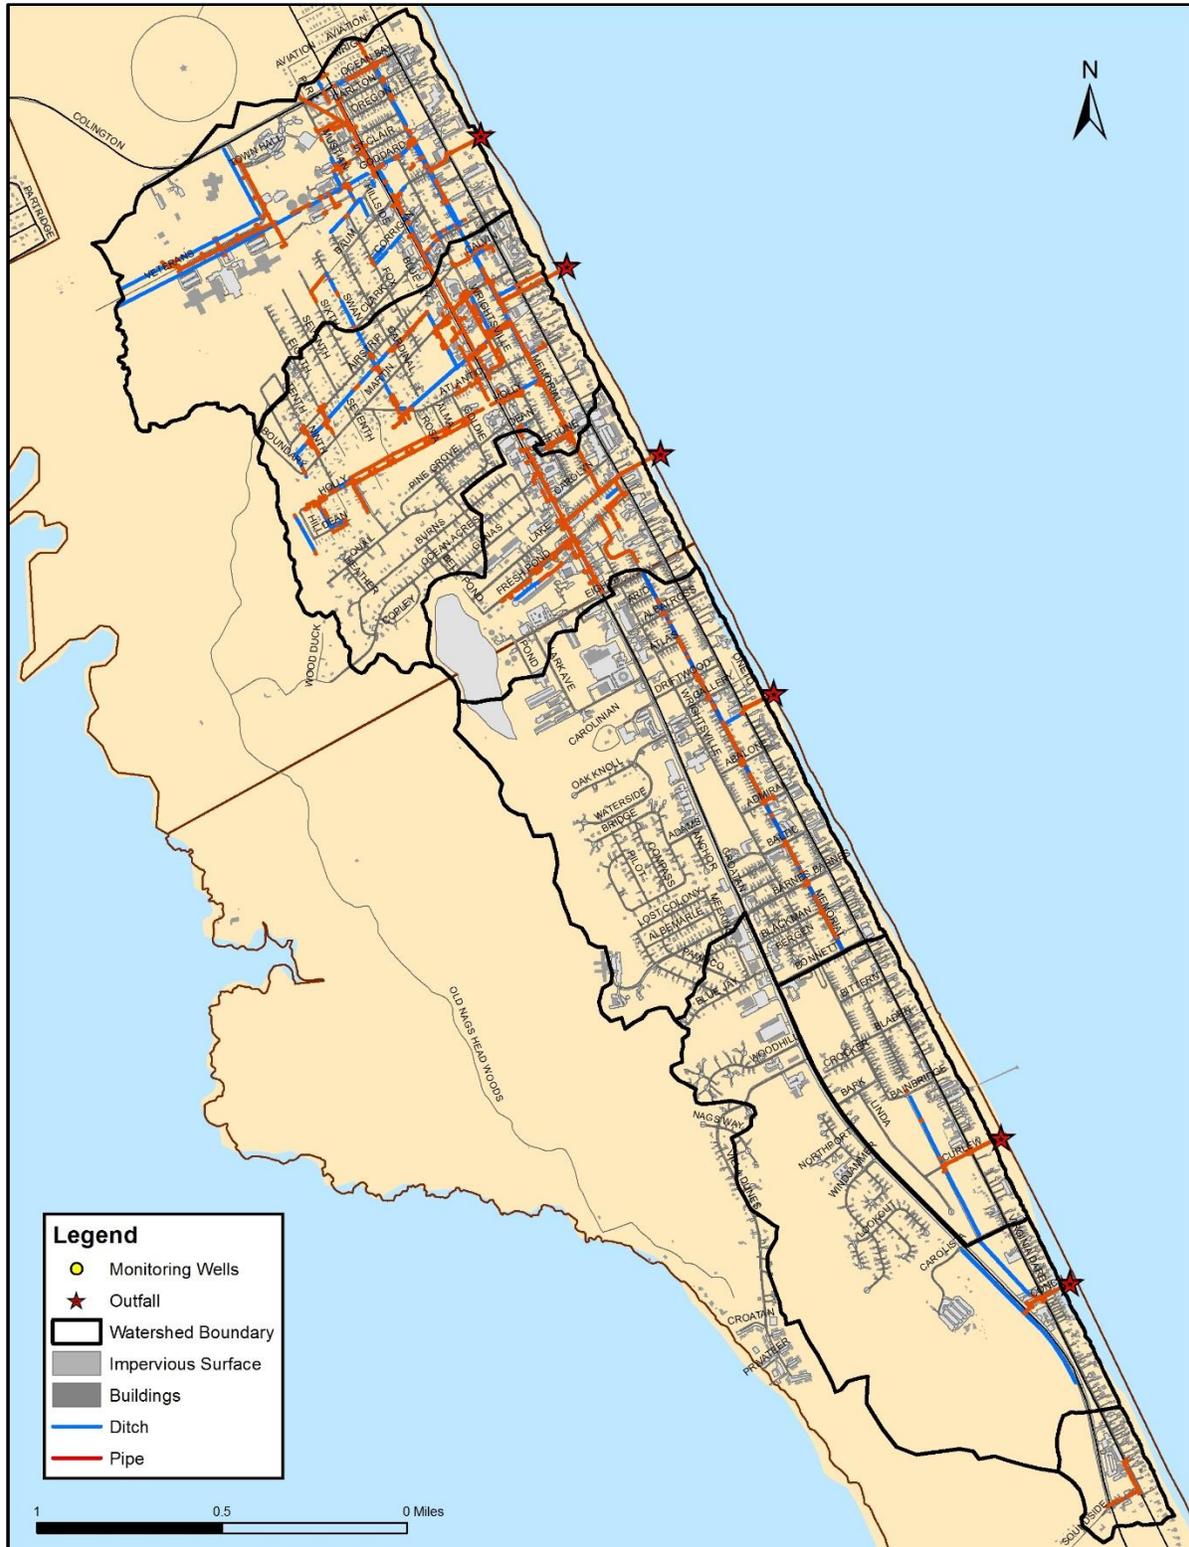
In 2012, improved topographic data and new GIS data for previously unmapped portions of the storm drain network obtained from the towns of Nags Head and Kill Devil Hills allowed for an improved delineation of the watersheds for the ocean outfalls. The delineation process began with the generation of a triangulated irregular network (TIN) from the most recent LIDAR data to represent the topographic surface. Watersheds were initially delineated based strictly on land contours and predicted surface flow patterns. Those initial delineations were then overlaid with all available information on the artificial drainage network of pipes and ditches. The artificial network was utilized to correct the watershed boundaries where it altered surface flow patterns. The updated watersheds for the seven northern outfalls are shown in **Figure 40**. The updated watershed were used for the remainder of the study, including the watershed characterizations and strategies presented below in Chapter 3.

Figure 40. Seven Northern Ocean Outfall Watershed as Revised in 2012

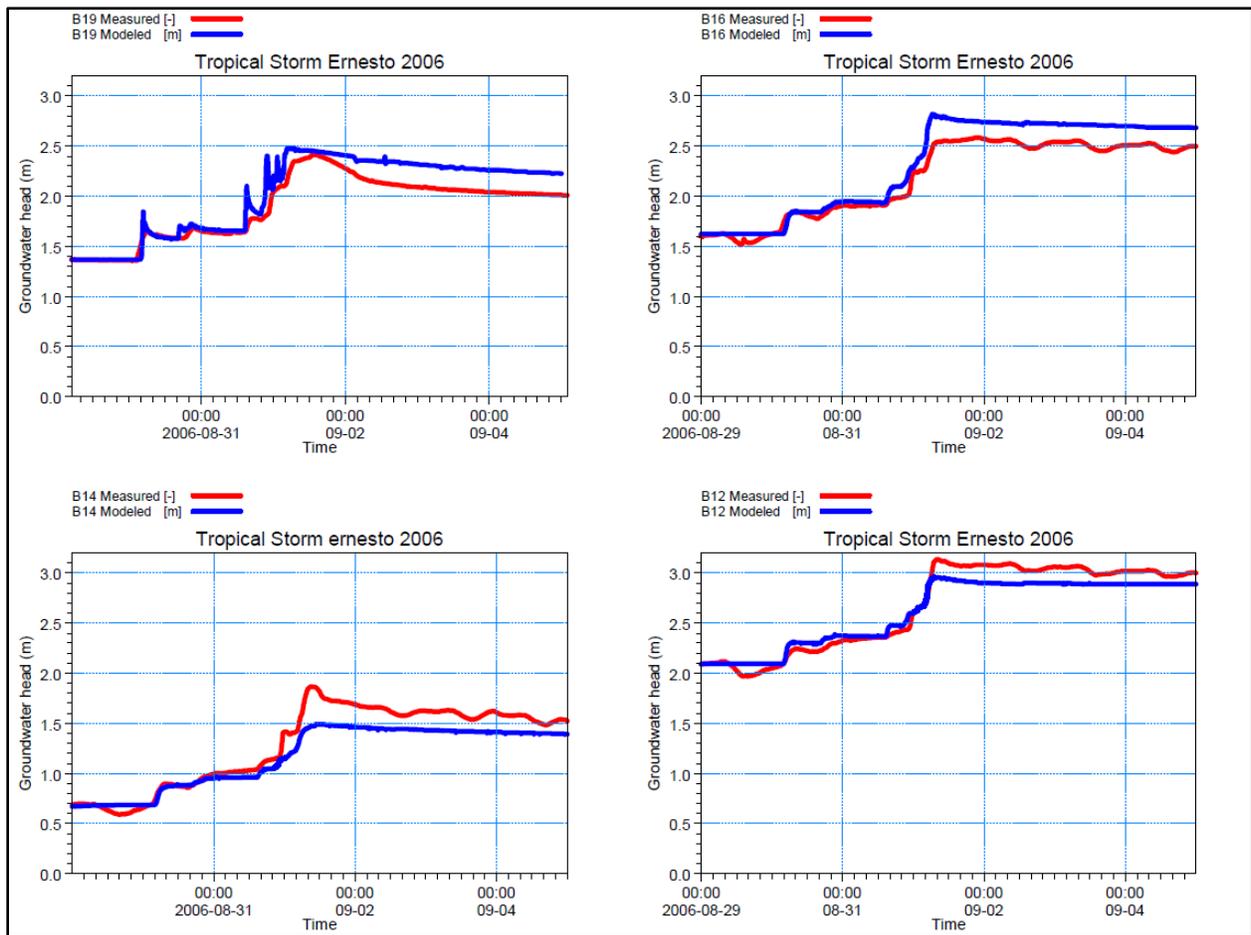
The updated watersheds were also utilized to do a minor update and recalibration and verification of the MIKESHE/MIKE11 modeling frame work used to simulate the hydrology and hydraulic behavior of the outfalls and their watersheds. On this occasion, actual data from Tropical Storms Barry and Hurricane Irene (August 27, 2011) were again used to recalibrate/re-verify the revised models. Calibration results for groundwater elevations as compared to actual levels recorded at four groundwater wells for Tropical Storm Ernesto are shown below in **Figure 41** and for Hurricane Irene in **Figure 42**. Calibration verification results for both MIKESHE and MIKE11 are presented in Appendix C.

**Figure 41. Predicted vs. Actual Groundwater Level Results from Calibration Run, Tropical Storm Ernesto**

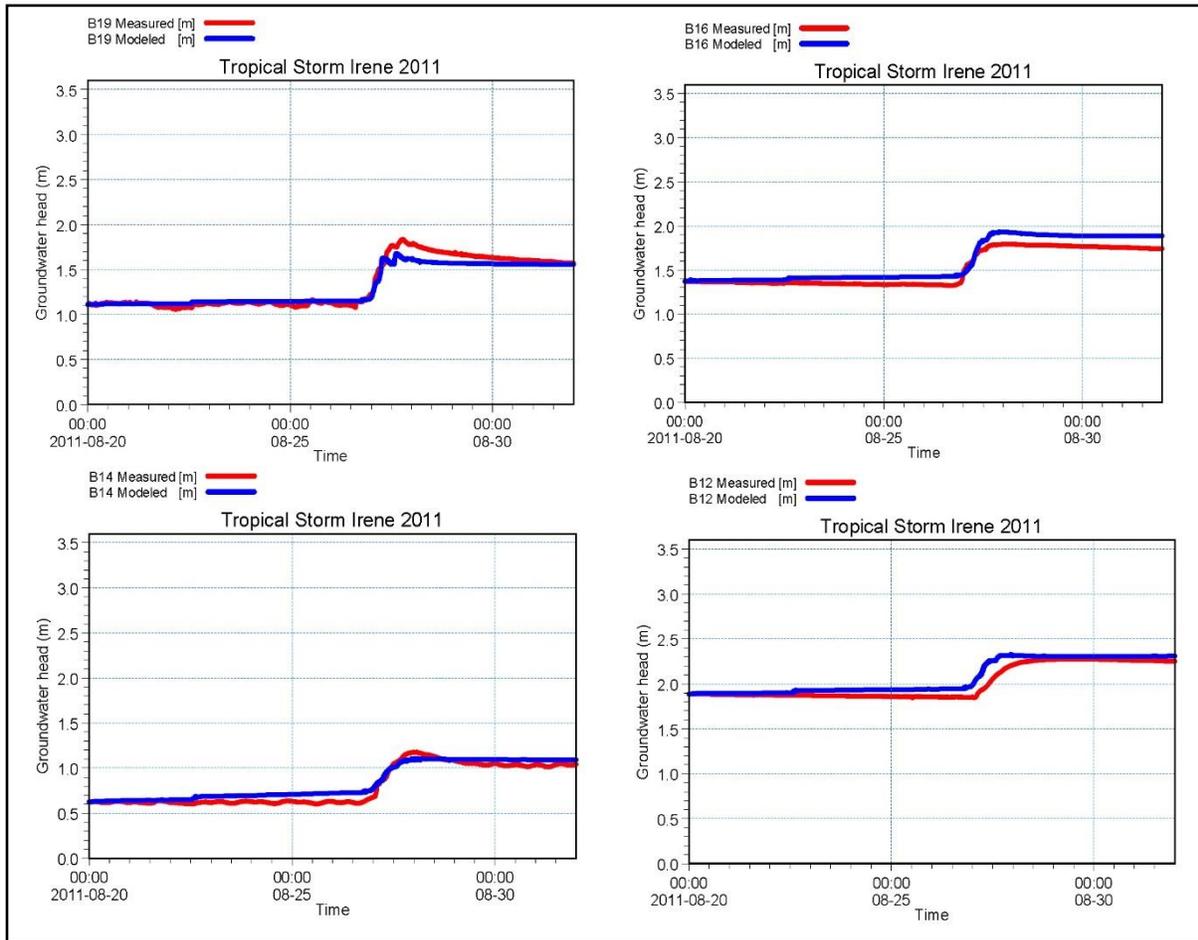
**Figure 42. Predicted vs. Actual Groundwater Level Results from Calibration Run, Hurricane Irene**
