# STORMWATER PILOT PROJECT FOR NCDOT MAINTAINED OCEAN OUTFALLS AND ASSOCIATED OUTLETS OCEAN OUTFALL MASTER PLAN

June 2016

North Carolina Department of Environmental Quality  
Division of Water Resources  
217 West Jones Street  
Raleigh, NC 27601

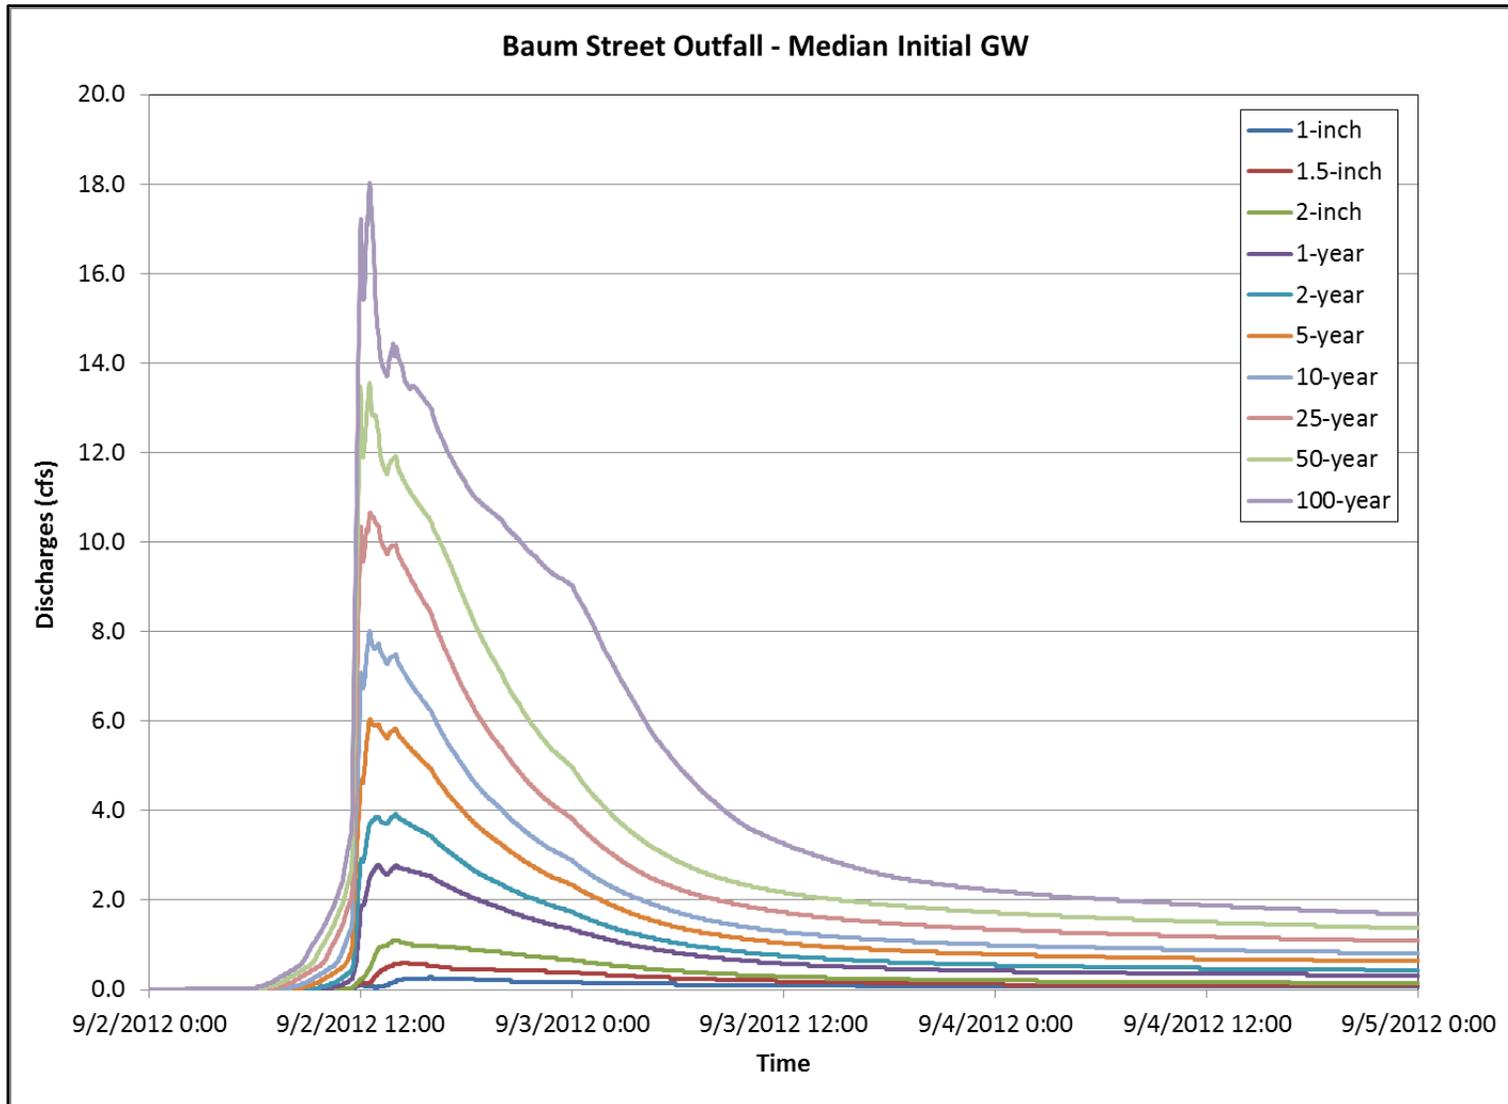
As shown in **Table 10** the model was run for each synthetic storm with an initial condition reflecting median groundwater level and again with an initial condition reflecting a 90<sup>th</sup> percentile groundwater level in order to examine the impact of high antecedent soil moisture conditions on the predicted hydrographs for each event. The predicted peak flow results from the Baum Street outfall prediction are shown in **Figure 44**. The variation in antecedent soil moisture conditions had the greatest effect on predicted flow for Baum Street. For all the other outfalls the difference was less than would be expected.

Figure 43. Predicted Storm Hydrographs for Baum Street Outfall with Median Groundwater Levels

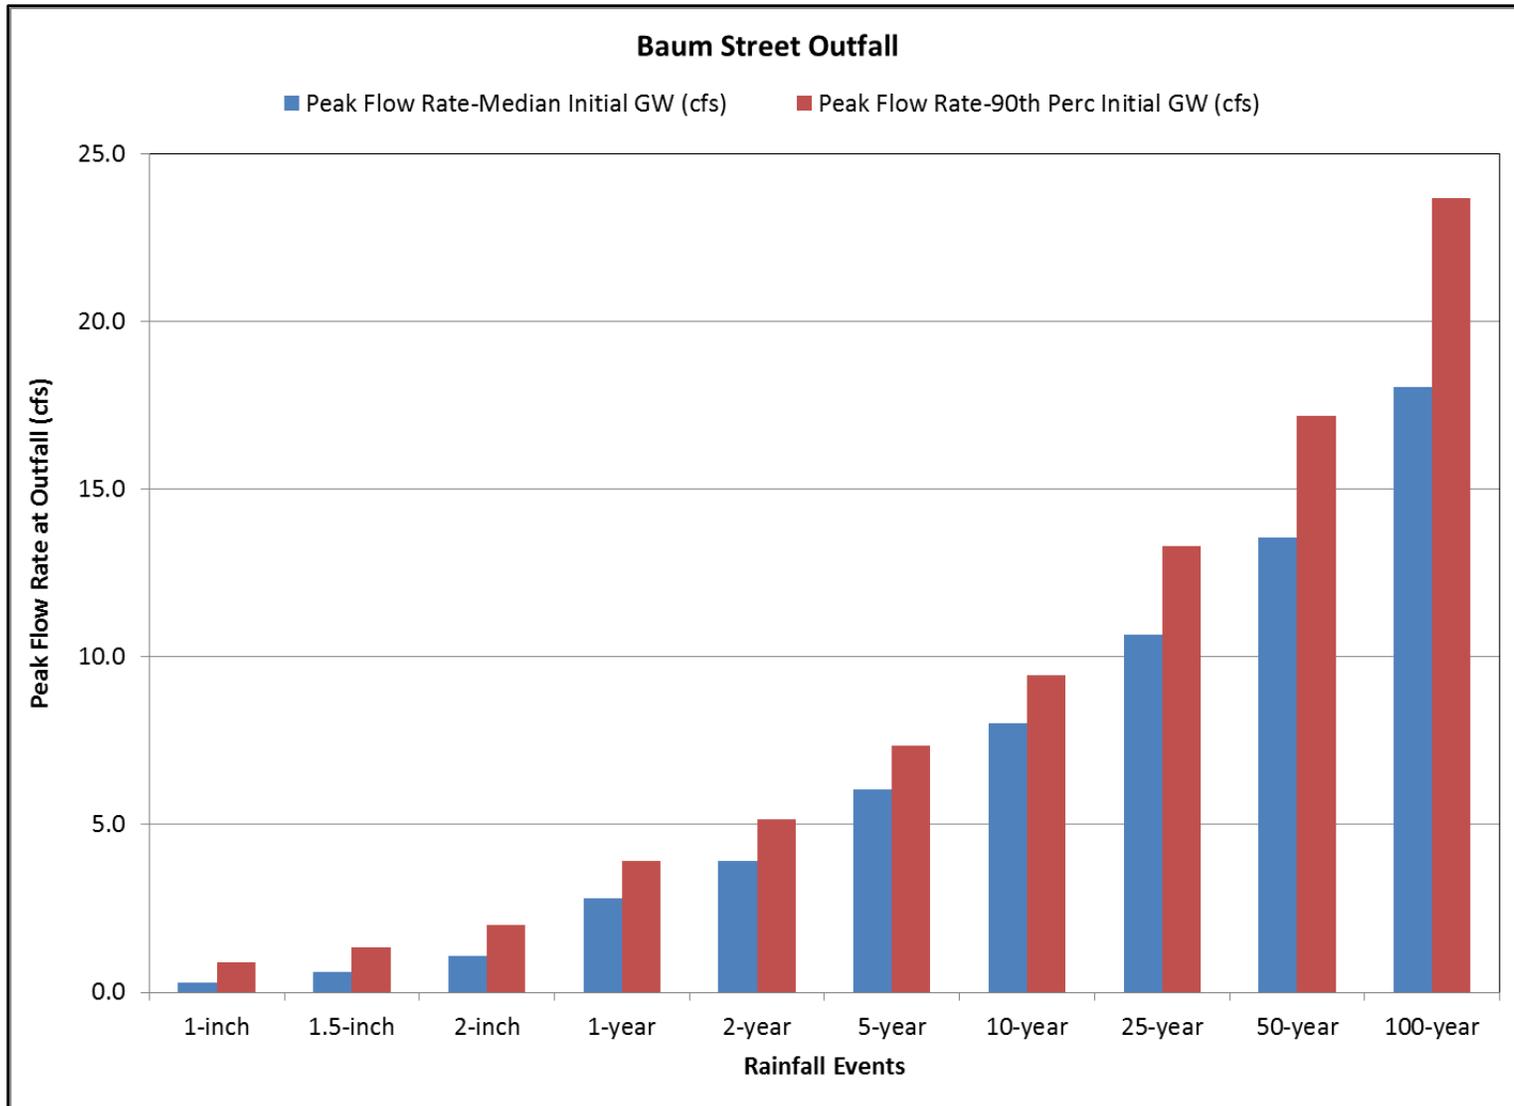
Figure 44. Predicted Peak Flows for Baum Street Outfall with Median and 90<sup>th</sup> Percentile Groundwater Levels

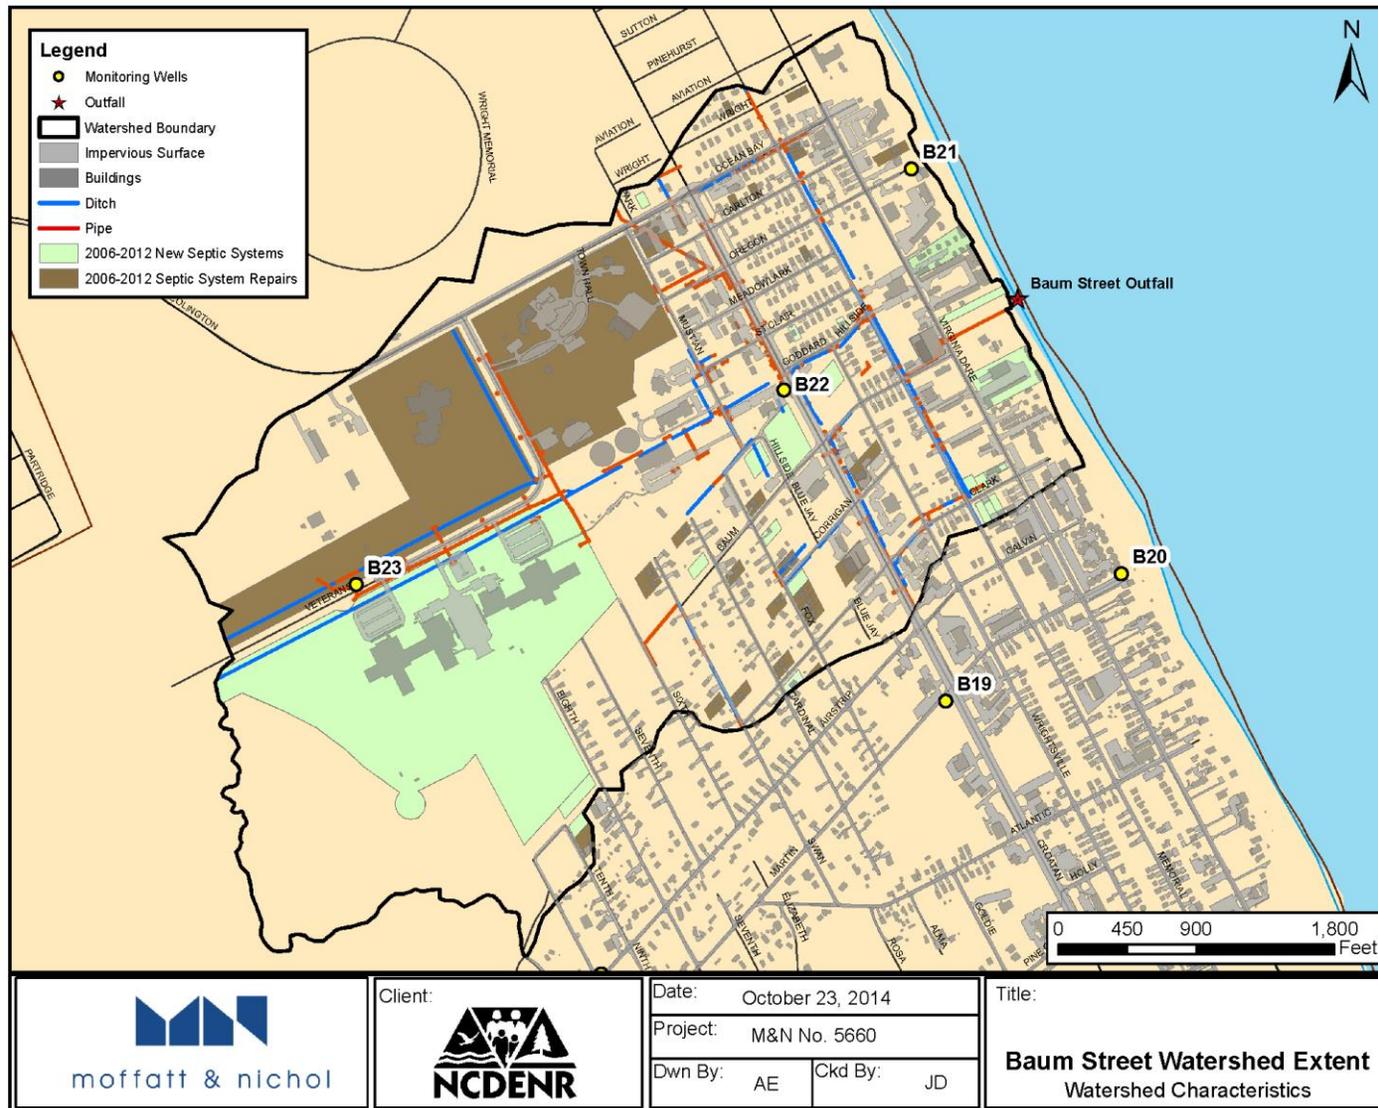
The Baum Street watershed contains approximately 16,020 feet of open channel ditch and approximately 40,997 feet of piping. Drainage network spatial data and detailed contours of the Baum Street watershed indicate that there is approximately 227 acres of the watershed drained by piping and open channel ditches. This area represents approximately 52% of the total watershed area and occurs primarily in heavily developed areas within the watershed. Stormwater runoff and pollutant loads in areas of the watershed where drainage infrastructure is well developed likely originate from built-upon areas such as parking lots and commercial facilities where build-up during dry periods and wash off in storm events are likely to be an important means by which pollutants are delivered to the ocean outfall. However, approximately a third of the watershed is residential development, with much of it occurring in hydric soil areas. In these areas, pollutant loading is likely influenced by groundwater interactions with septic systems and is more diffuse in nature.

Figure 45. Baum Street Watershed Extent Map

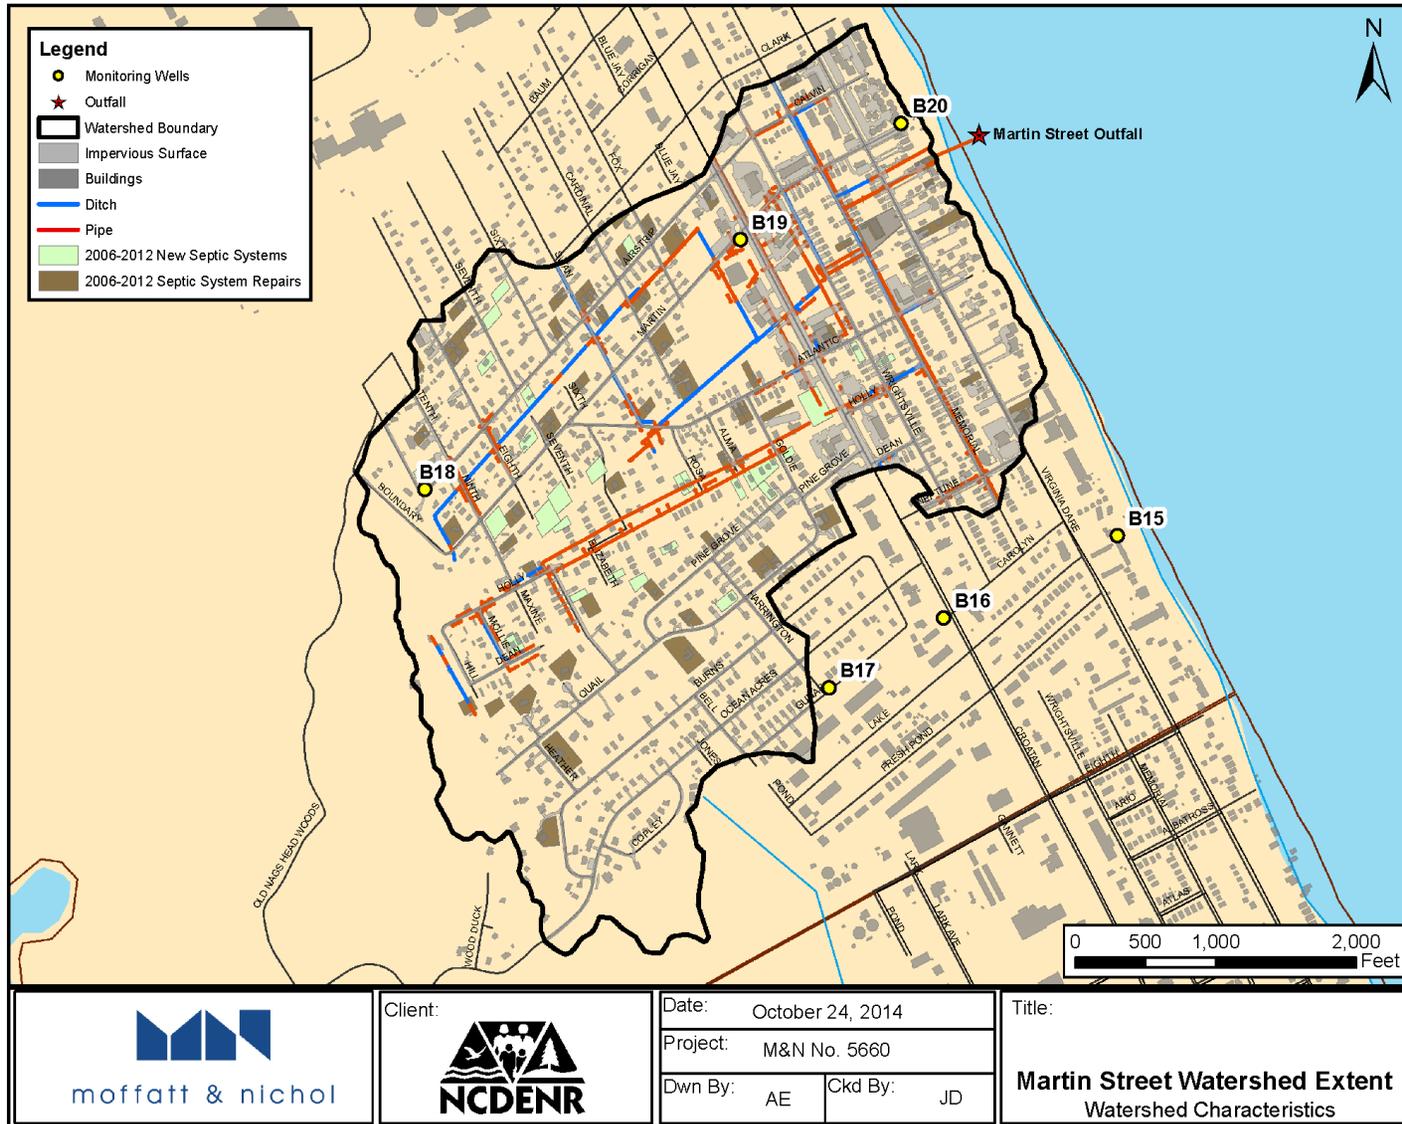
The Martin Street watershed contains approximately 9,821 feet of open channel ditch and approximately 60,598 feet of piping. Drainage network spatial data and detailed contours of the Martin Street watershed indicate that there is approximately 195 acres of the watershed drained by piping and open channel ditches. This area represents approximately 50% of the total watershed area and occurs primarily in heavily developed areas within the watershed. Stormwater runoff and pollutant loads in areas of the watershed where drainage infrastructure is well developed likely originate from built-upon areas such as parking lots and commercial facilities where build-up during dry periods and wash off in storm events are likely to be an important means by which pollutants are delivered to the ocean outfall. However, a significant portion of the watershed is residential development, with some areas of development located over hydric soils. In these areas, especially adjacent to the shoreline in the eastern portion of the watershed, pollutant loading is likely influenced by groundwater interactions with septic systems and is more diffuse in nature.

Figure 48. Martin Street Watershed Extent Map

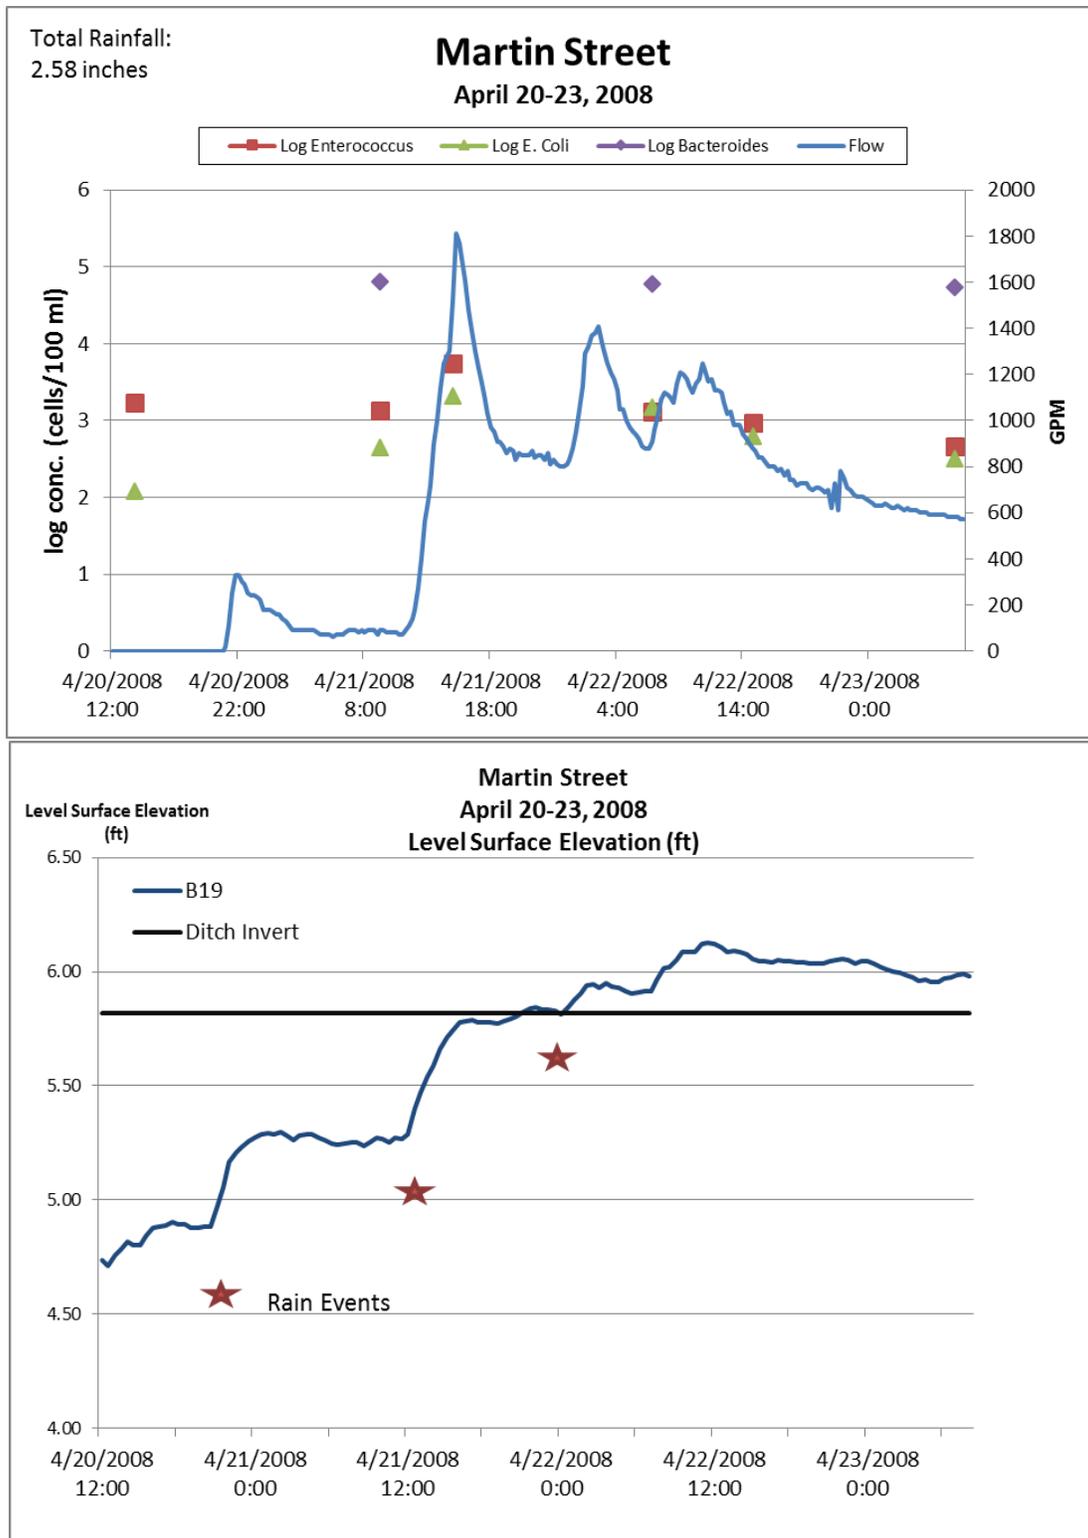
contamination, and during the strong increase in groundwater surface elevation, the fecal *Bacteroides* sp. concentrations remain high through the tail of the storm. This indicates the possibility that while Enterococcus and E. coli can be stemming from a range of sources over the duration of a storm, that during the late periods of a storm, the sources may be more likely to be septic or package treatment systems that are suffering from the high groundwater level interactions. This series of observations is only a trend, but it indicates the need for a more specific examination of groundwater/septic system interaction.

**Figure 51. Martin Street FIB Concentrations and Groundwater Surface Elevations for April 2008 Storm Event**

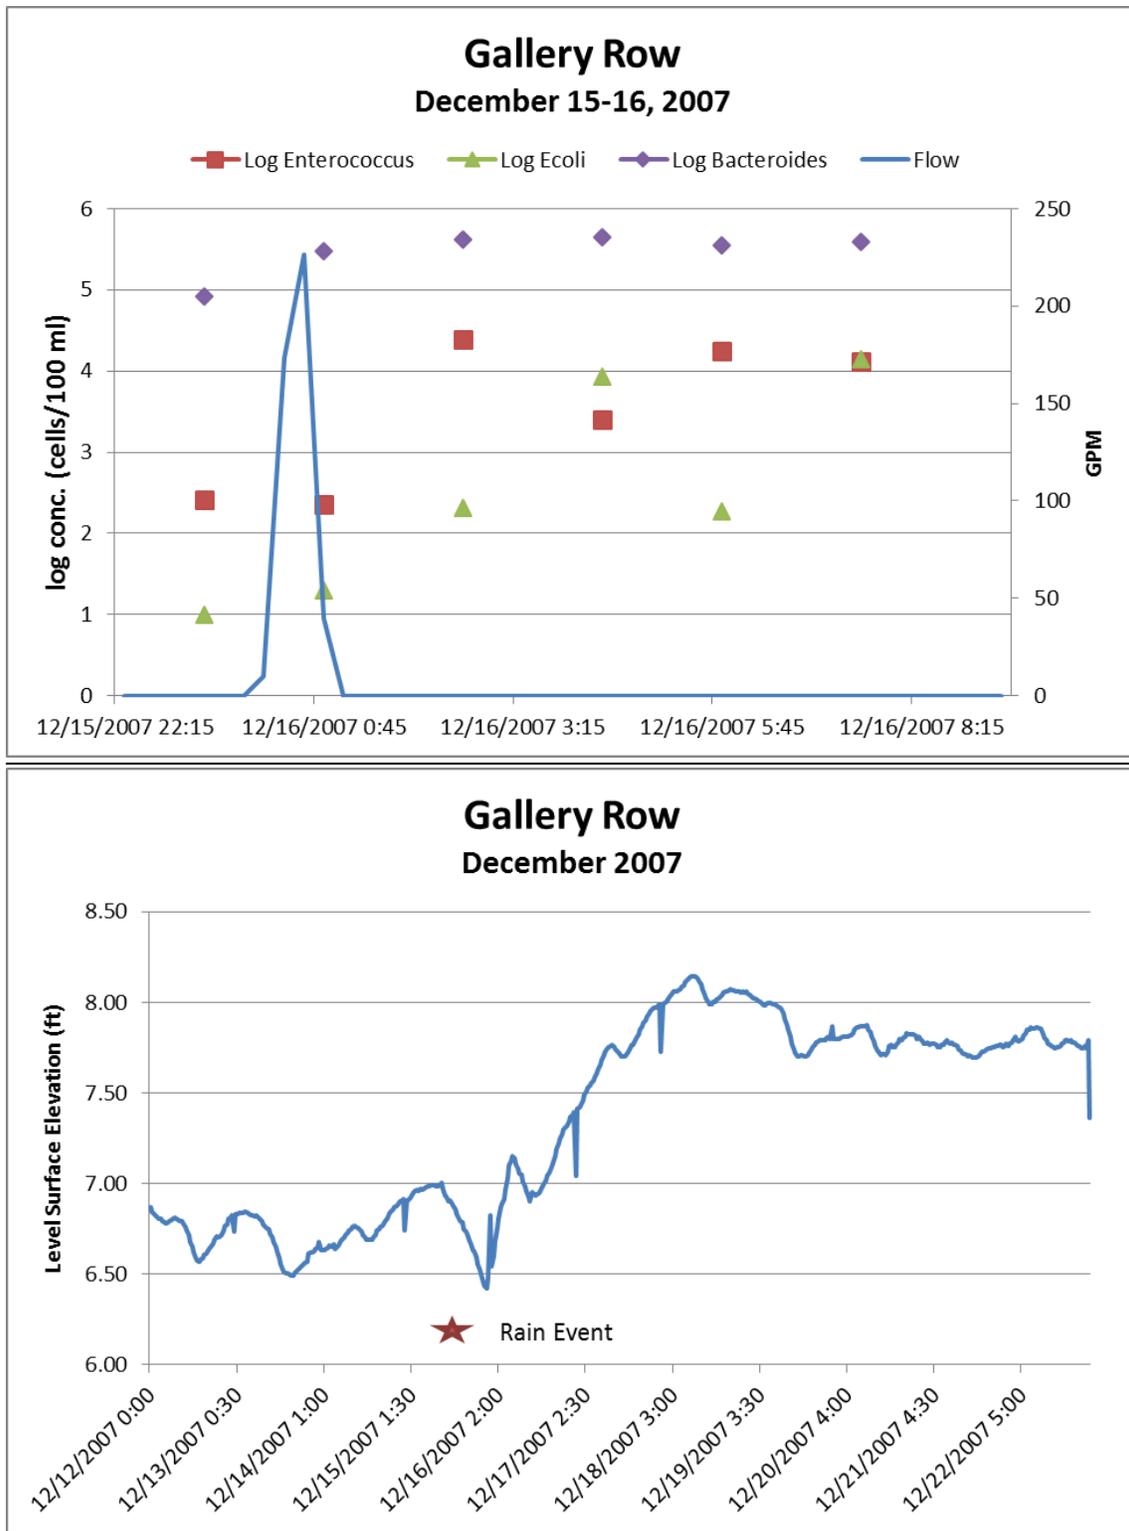
As indicated in the groundwater information for this watershed, there is an important dynamic between groundwater and fecal contamination in this system during storms. During the December 2007 storm, it can be observed from Figure 43 that during periods of groundwater increase after heavy rainfall (i.e. pulse of > 2 inches in December 2007), the *E. coli* and *Enterococcus* sp. concentrations increase to greater than 10,000 MPN per 100 ml. This also coincides with very high concentrations of Fecal *Bacteroides* sp. After the peak rainfall period, the Fecal *Bacteroides* sp. concentrations in the remaining four time points were all greater than 100,000 CE per 100 ml. These extremely high concentrations of both FIB and human associated molecular marker indicate the potential in this system for groundwater-septic system connections to be driving the delivery of fecal contamination to beaches.

**Figure 58. Gallery Row FIB Concentrations and Groundwater Surface Elevations for December 2007**

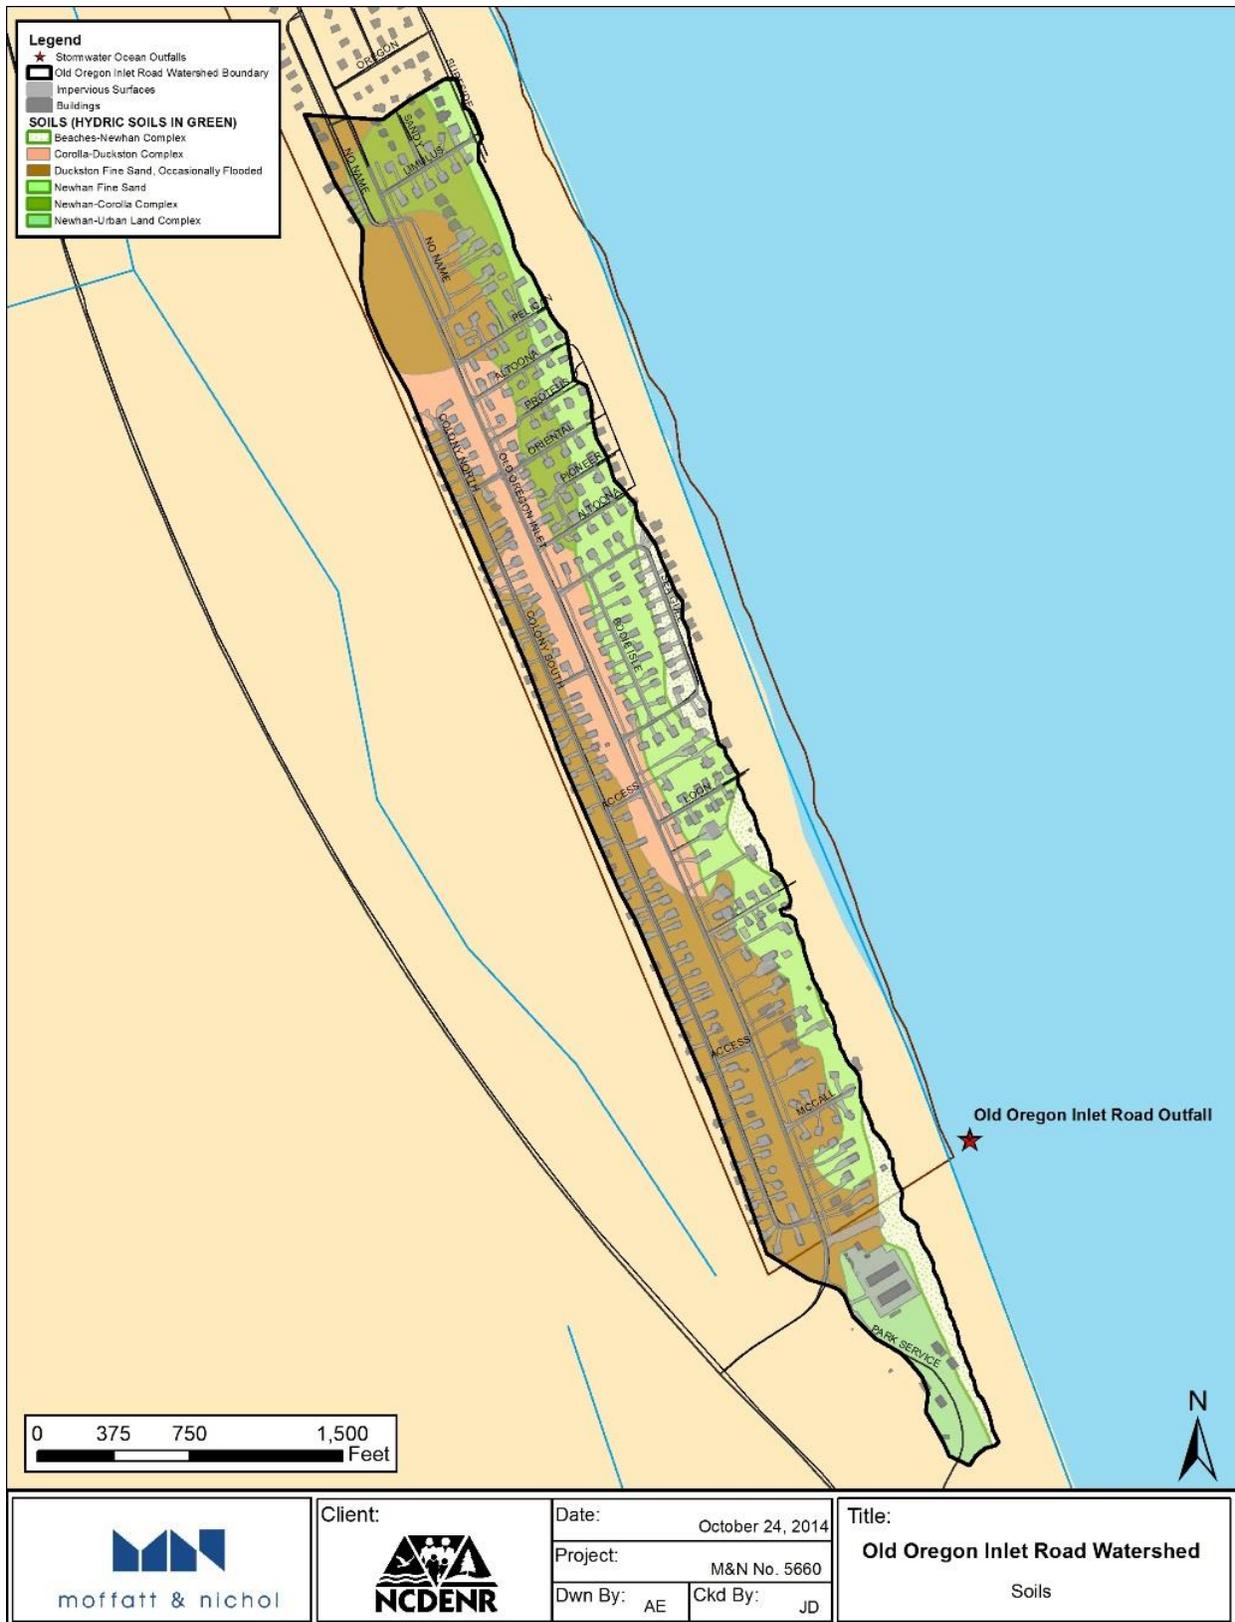
Figure 69. Old Oregon Inlet Road Watershed Soils Map

A summary of soils within the Old Oregon Inlet Road watershed is provided in **Table 31**. There are 54 acres of hydric soils within the watershed boundary and approximately 61 acres of non-hydric soils within the watershed. Hydric soils are generally located in the easternmost half of the Old Oregon Inlet Road watershed, with non-hydric soils located mostly in the western half. In areas where hydric soils underlay dense development, interactions between groundwater and septic systems are likely high. See **Figure 69** for Old Oregon Inlet Road watershed soils mapping.

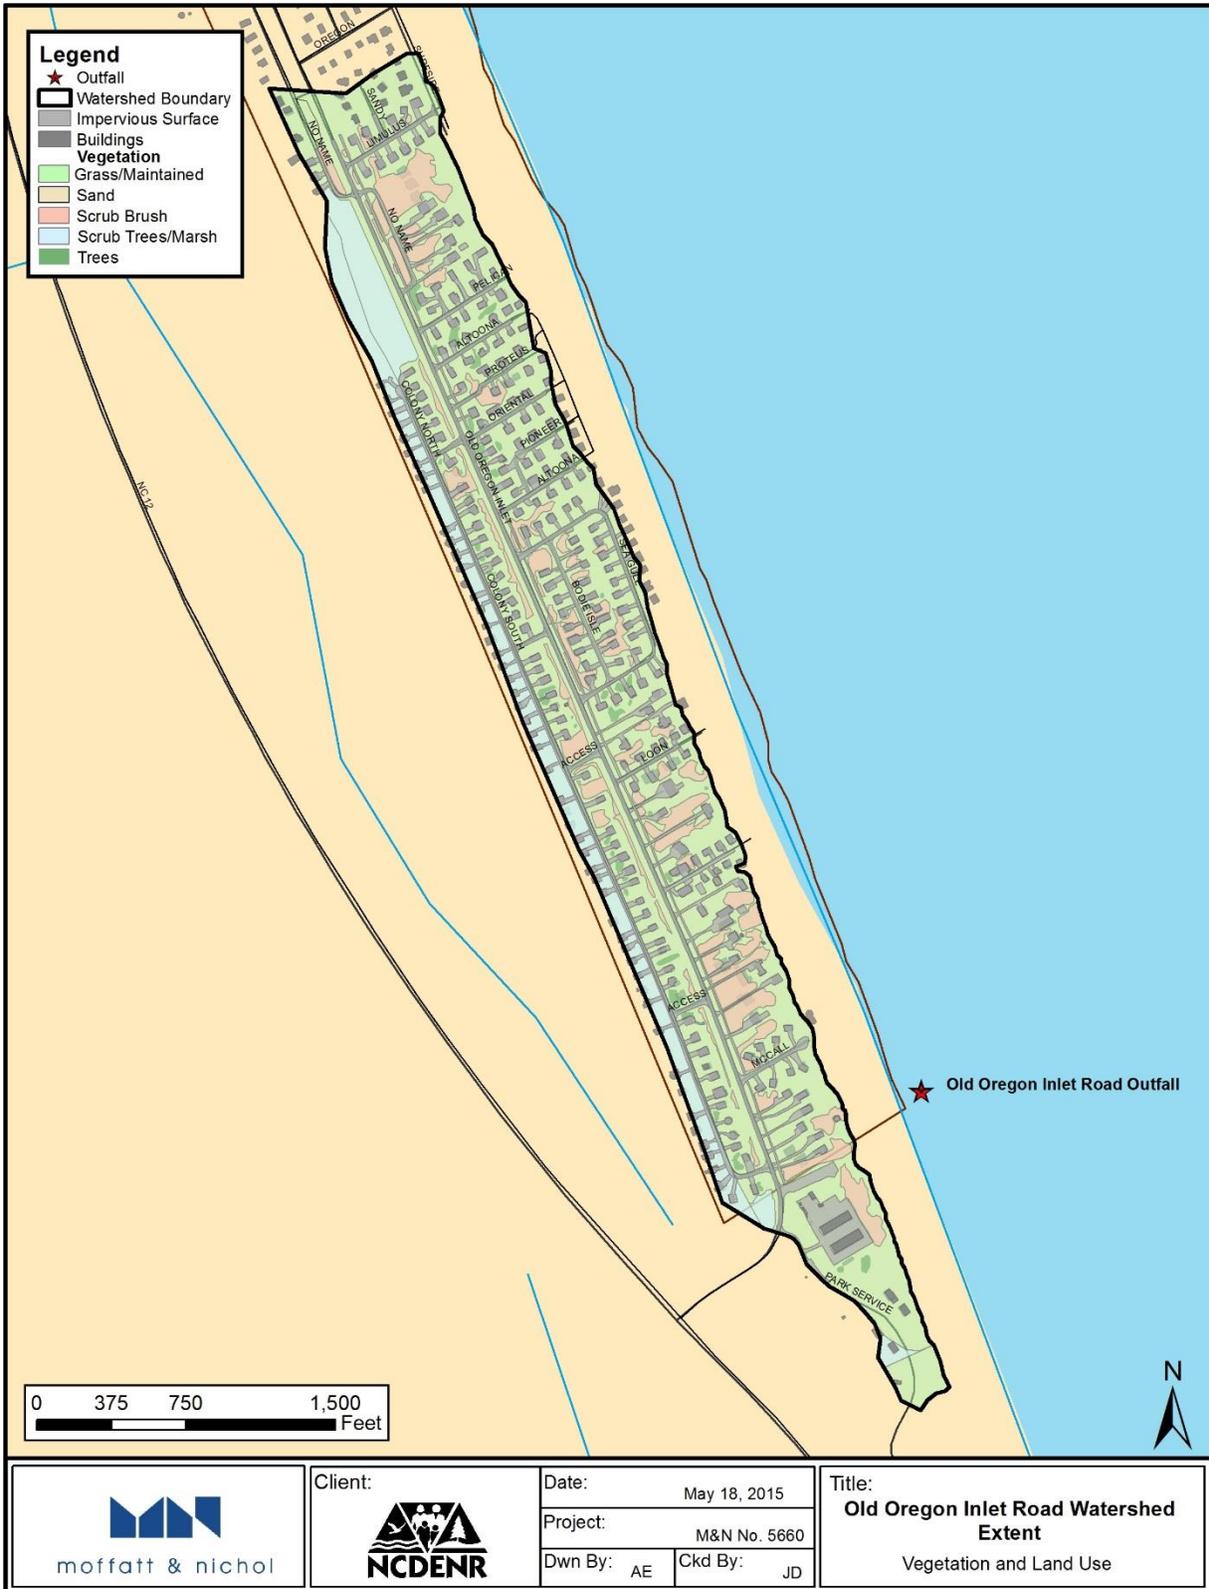
**Figure 70. Old Oregon Inlet Road Watershed Vegetation Map**

The Old Oregon Inlet Road watershed contains approximately 4.6 acres of trees, with most of it occurring in the western portion of the watershed. The remaining fragmented vegetated areas within the watershed are primarily grassed. Patterns of vegetation are mapped in **Figure 70**.

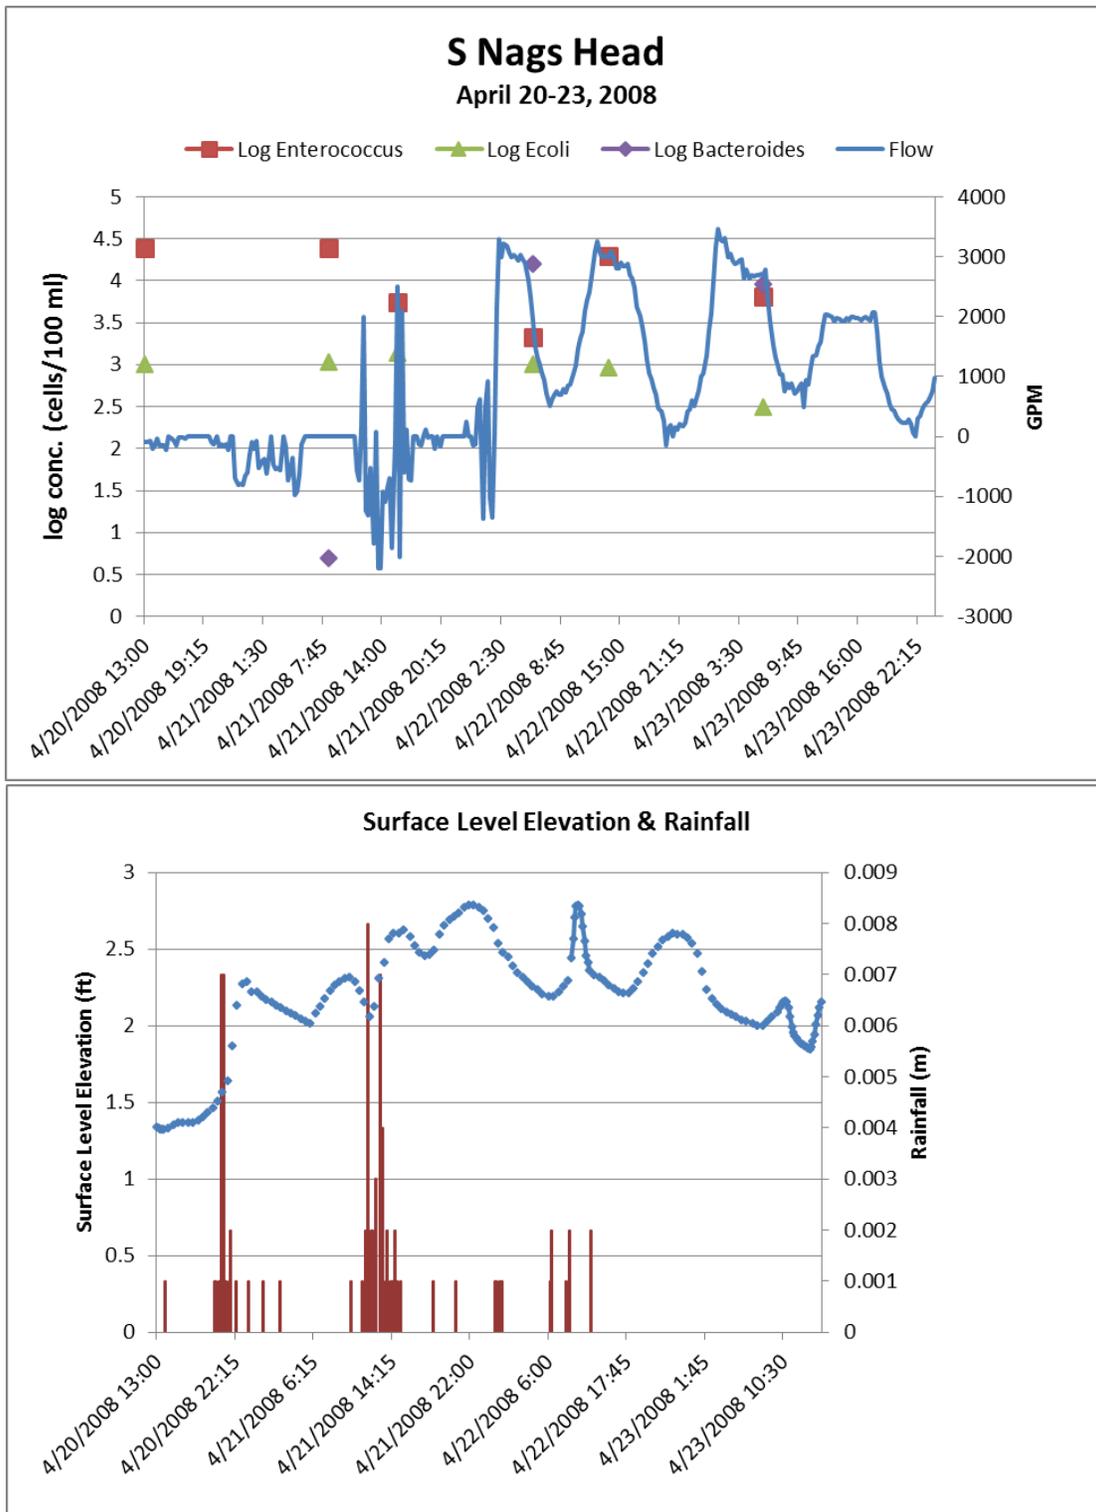
**Figure 71. South Nags Head FIB Concentrations and Groundwater Surface Elevations for April 2007 Storm Event**

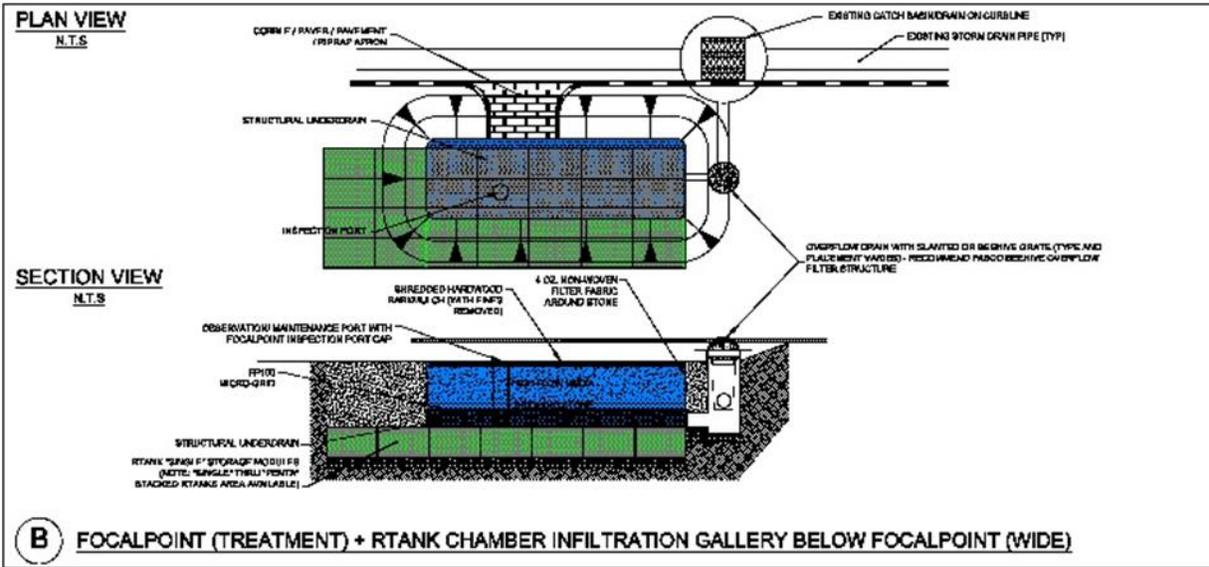
Figure 81. High Rate Infiltration Sand Filter Design (courtesy of FabCo Industries)

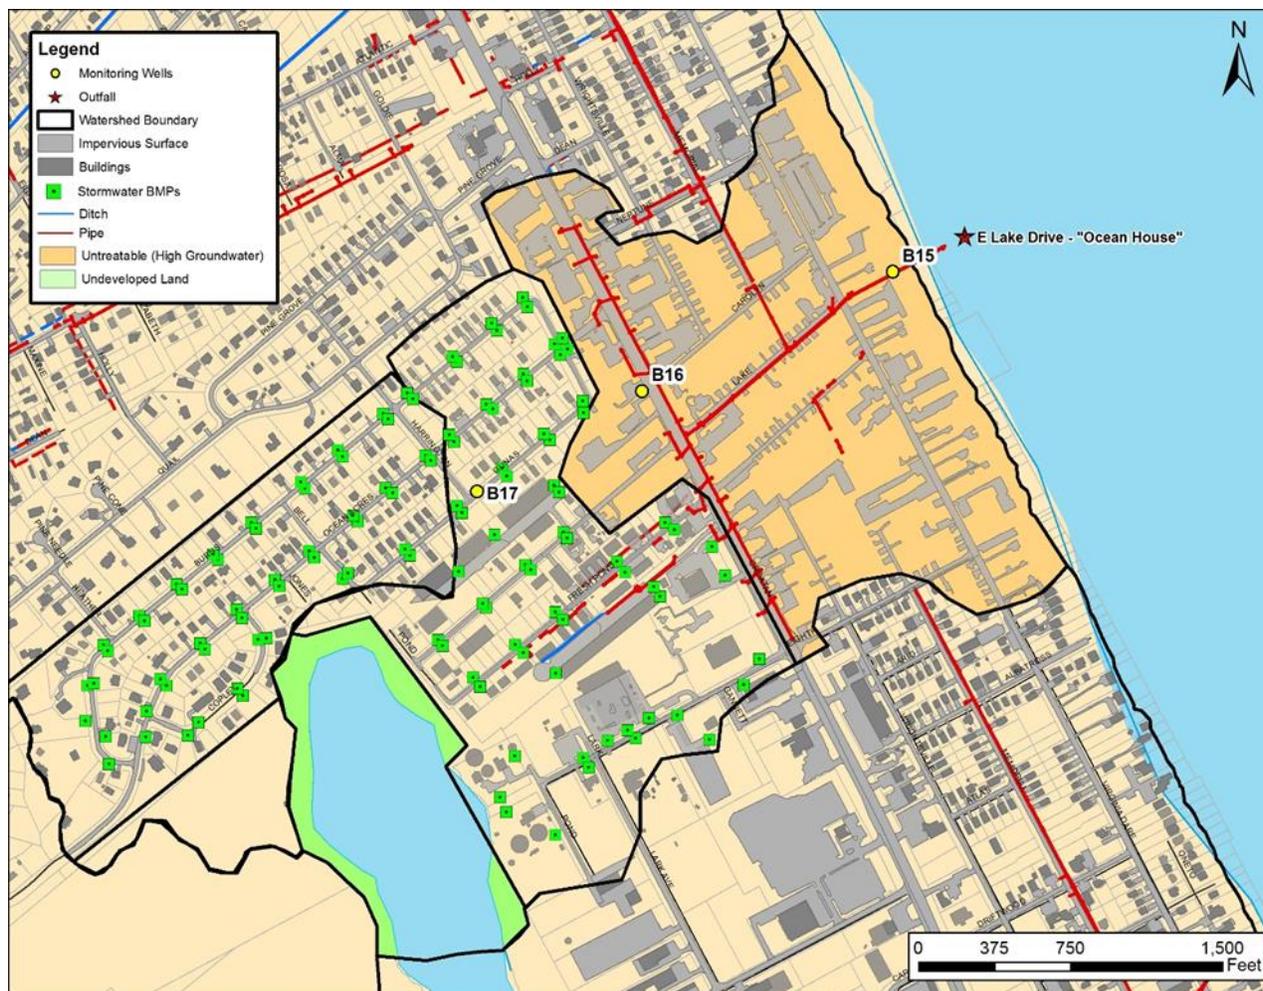
**Figure 83. East Lake Drive Watershed BMP Retrofit Scenario**

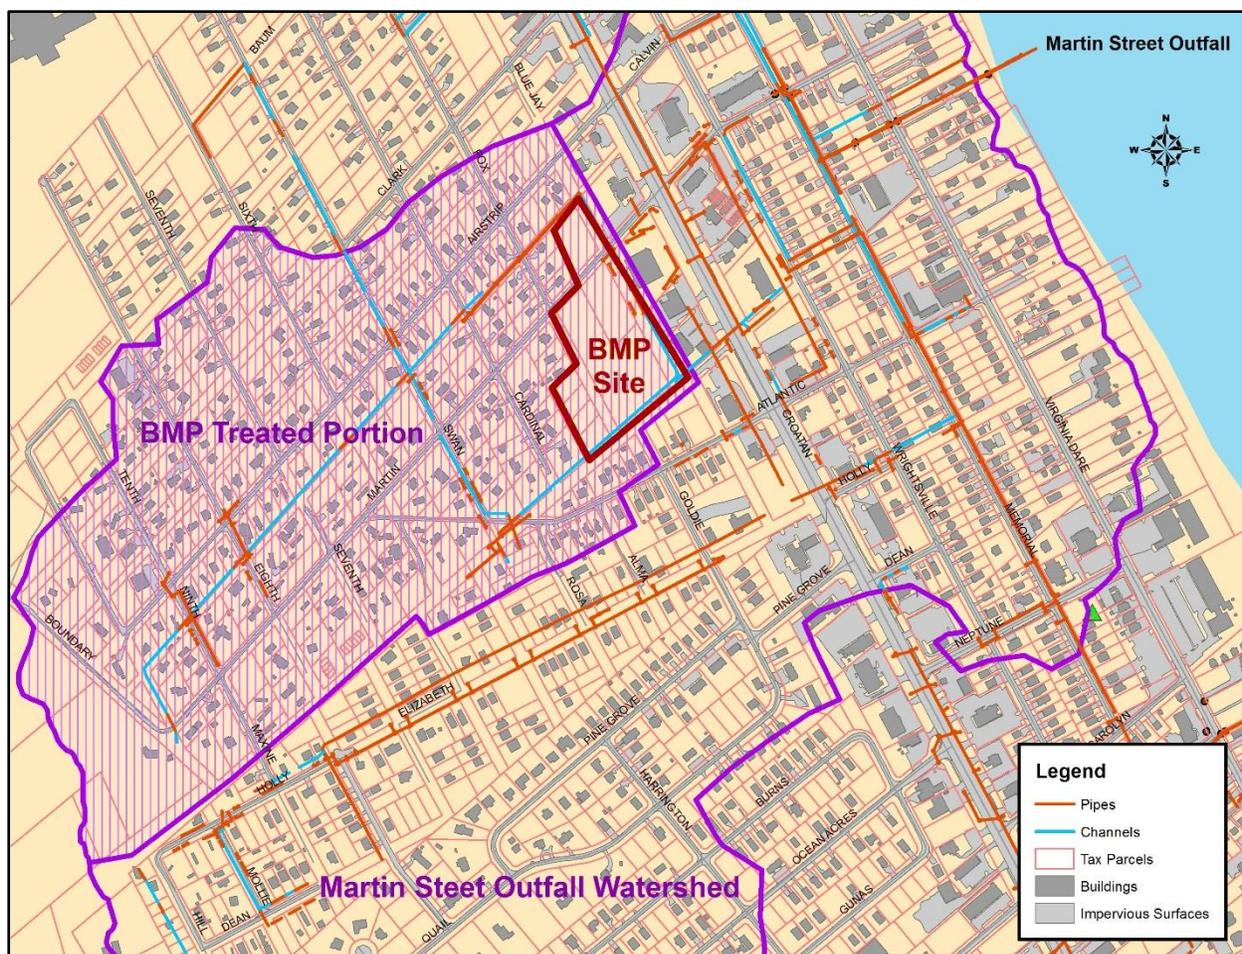
**Figure 84. Martin Watershed Regional BMP Retrofit Scenario**

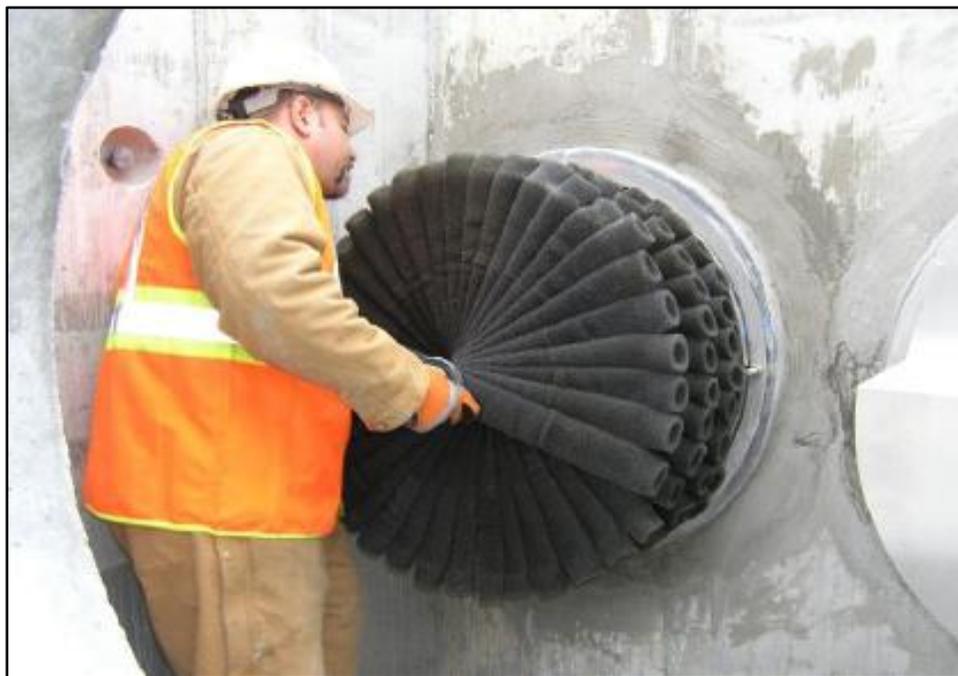
**Figure 85. Example of Recently Developed Proprietary FIB Treatment Media**

While only a limited degree of success was achieved in terms of load reductions for FIB with the Conch Street BMP, the difficulties with that device cannot be solely assigned to the performance of the Smart Sponge treatment media. Several aggravating factors including, but not limited to, tidal interference, sediment accumulation, and high incoming FIB loads acted together to impede the performance of the device. With that in mind, the real-world trials and evaluations of similar proprietary treatments systems should not be ruled out at this time. Since the time when the treatment system was selected for the Conch Street vault, numerous new types of treatment systems targeting bacterial pollution have been developed. For example, FabCo Industries has achieved high rates of bacterial pollutant removal (as high as 99%) with the helical configured contact media illustrated in **Figure 85** and **Figure 86** below. As with this helical treatment system, most of the new media types developed since implementation at Conch Street are lighter, easier to handle, and less expensive than the Smart Sponge media. However, data from closely monitored real-world applications remains to be very rare for all treatment media types. Prior to the selection of any new propriety treatments system, it is recommended that a full literature review on the availability and performance of such systems be conducted, as was conducted when the media for the Conch Street BMP was selected.

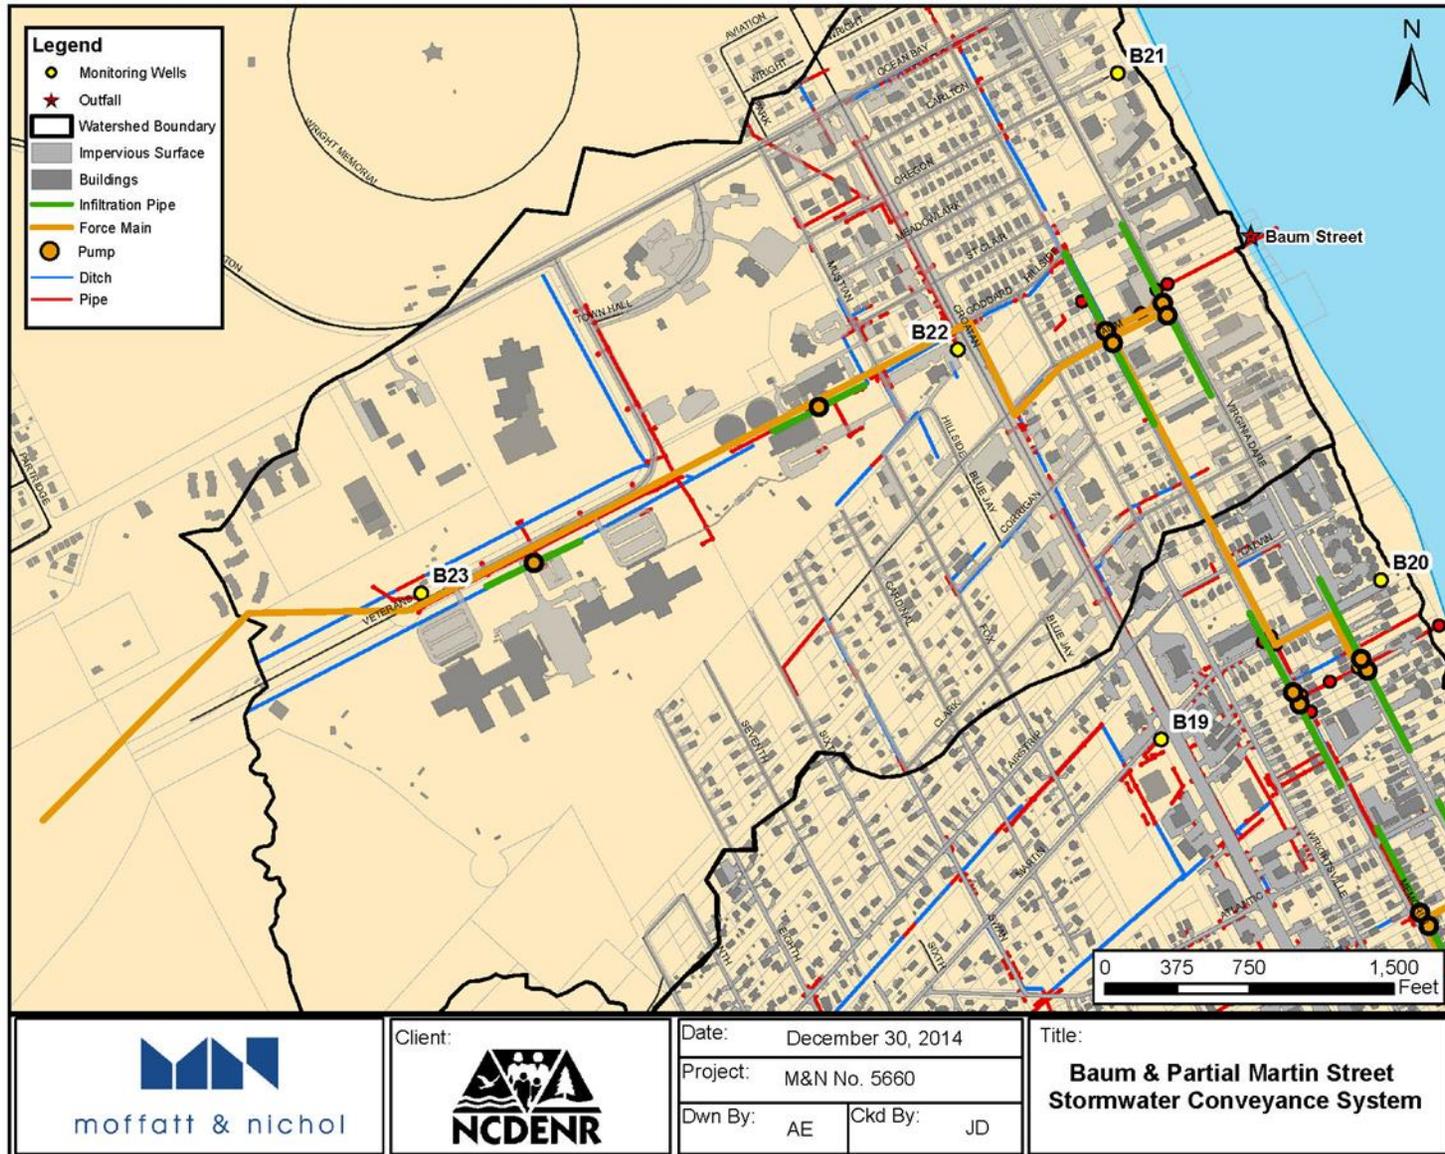
Figure 87. Baum/Martin Street Groundwater Drawdown System
