# STORMWATER PILOT PROJECT FOR NCDOT MAINTAINED OCEAN OUTFALLS AND ASSOCIATED OUTLETS OCEAN OUTFALL MASTER PLAN

June 2016

North Carolina Department of Environmental Quality  
Division of Water Resources  
217 West Jones Street  
Raleigh, NC 27601

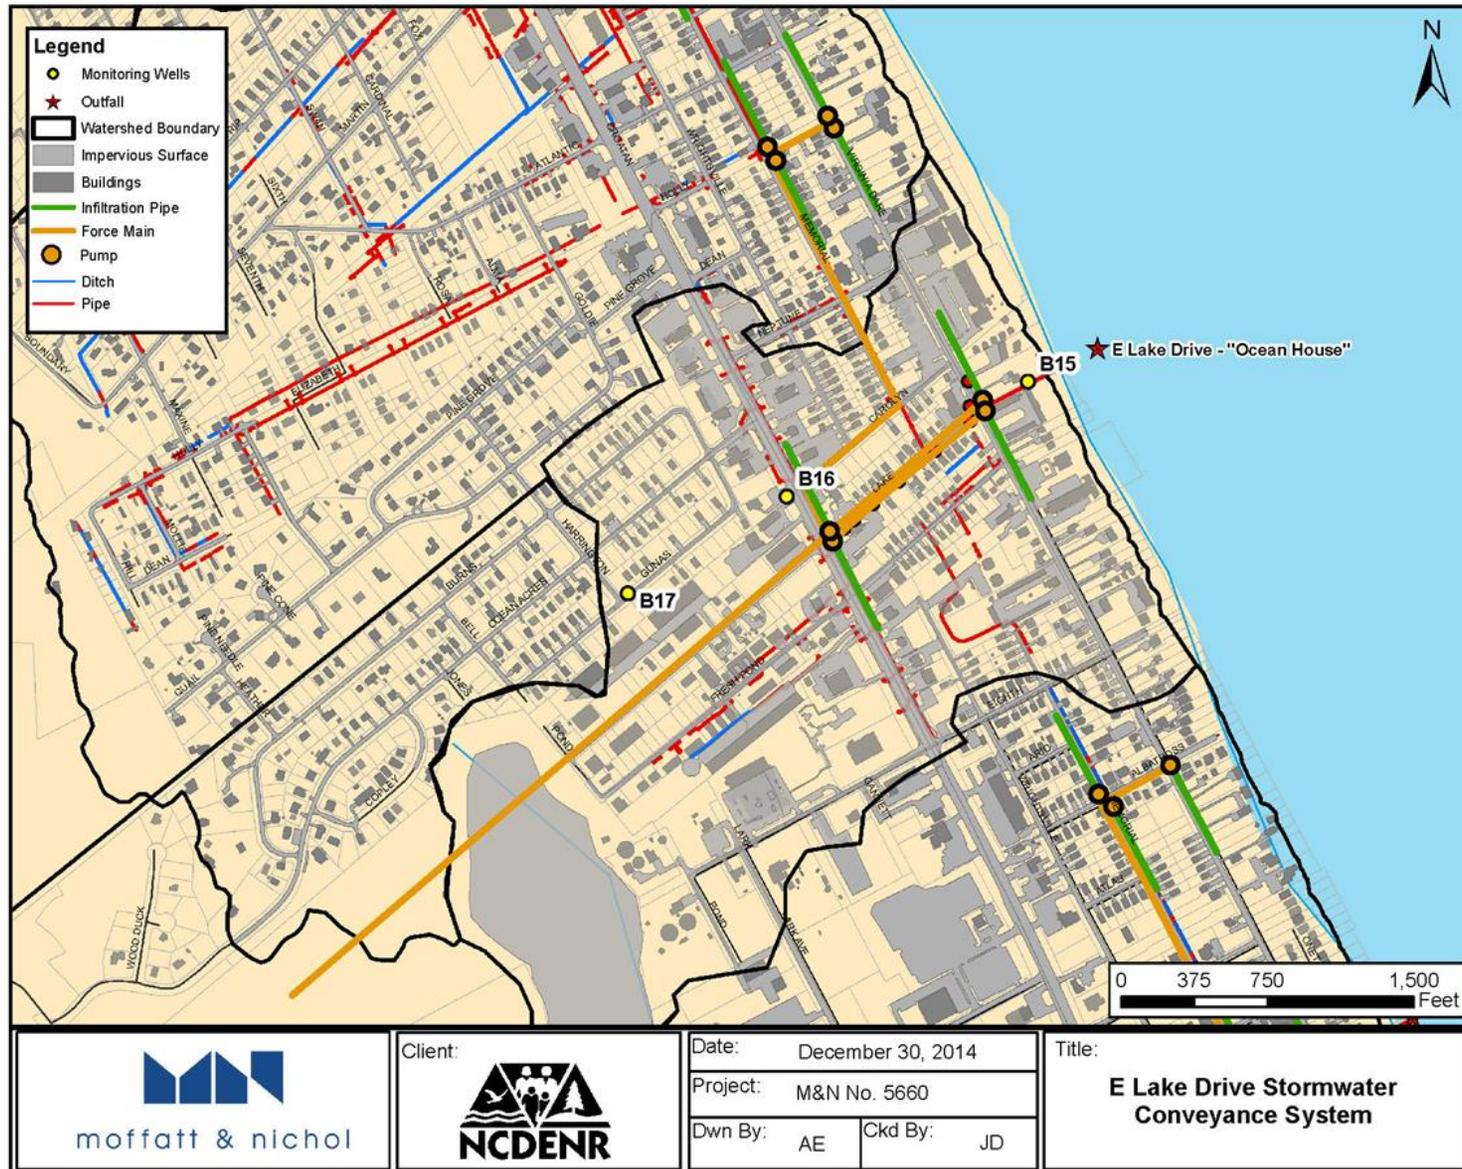
Figure 88. East Lake Drive/Martin Street Groundwater Drawdown System

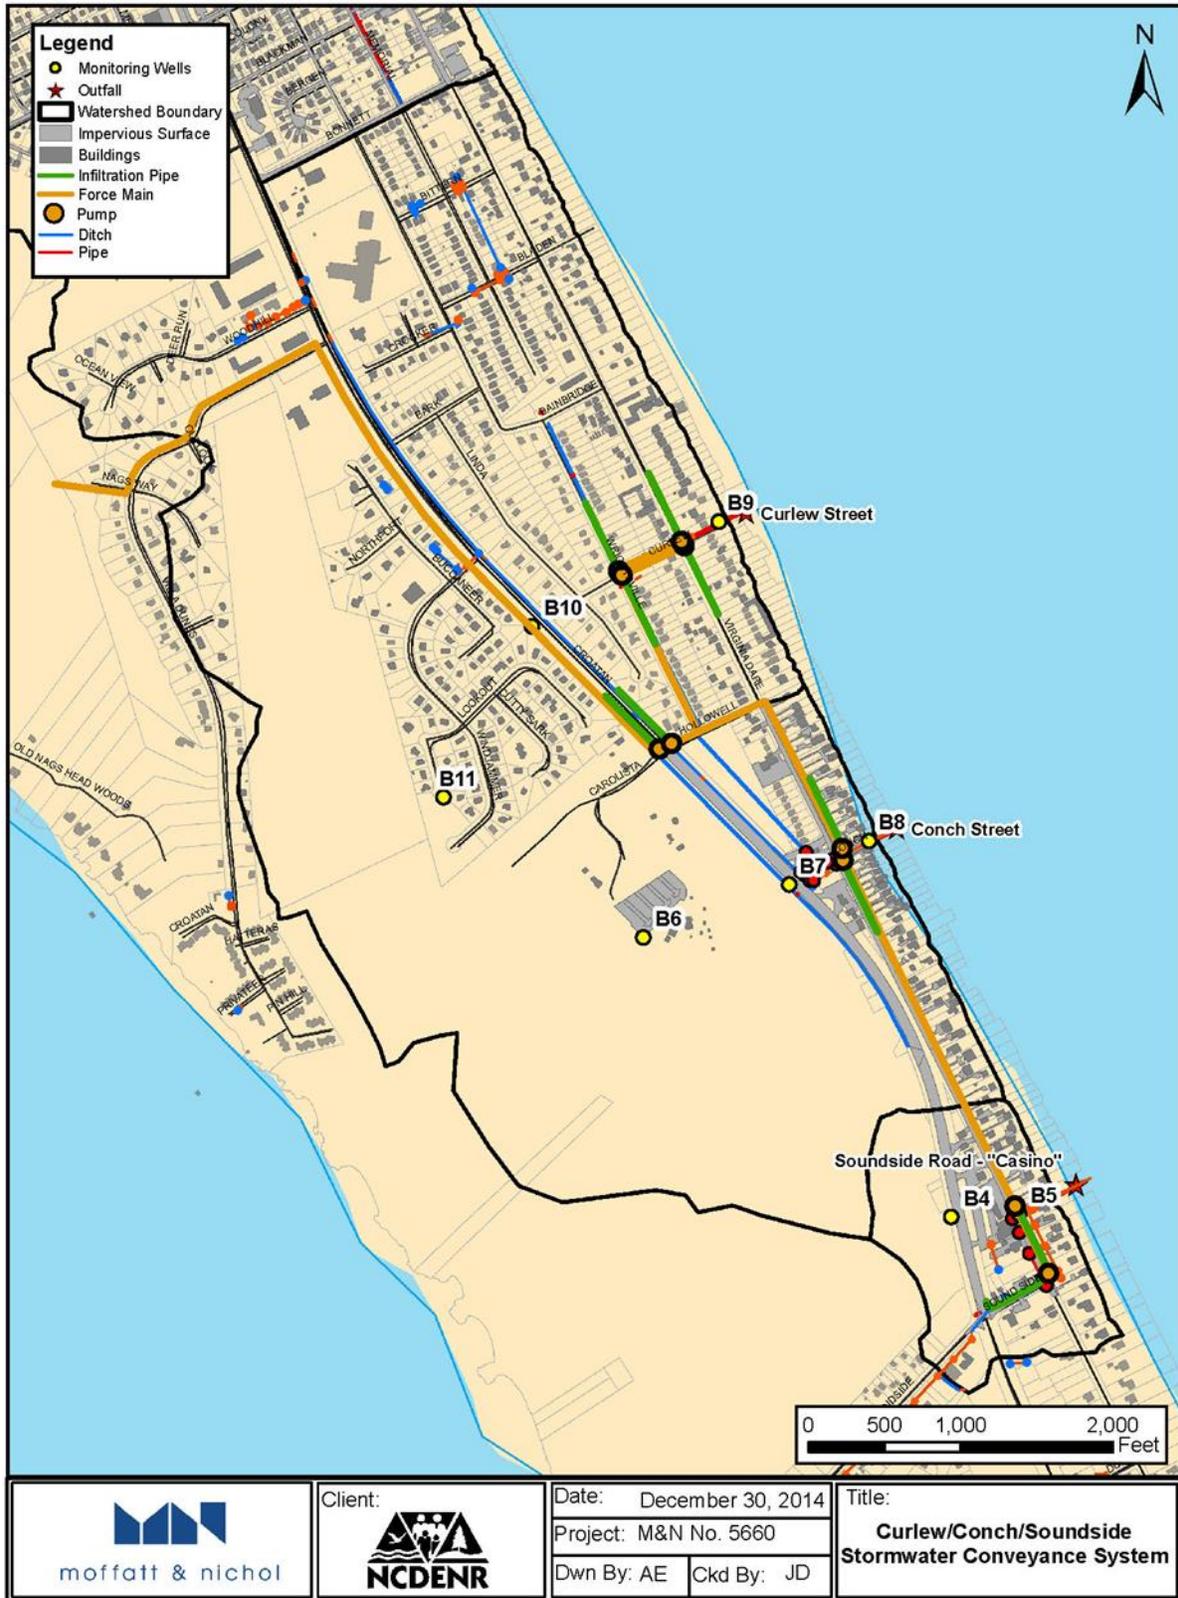
Figure 90. Curlew/Conch/Soundside Groundwater Drawdown System

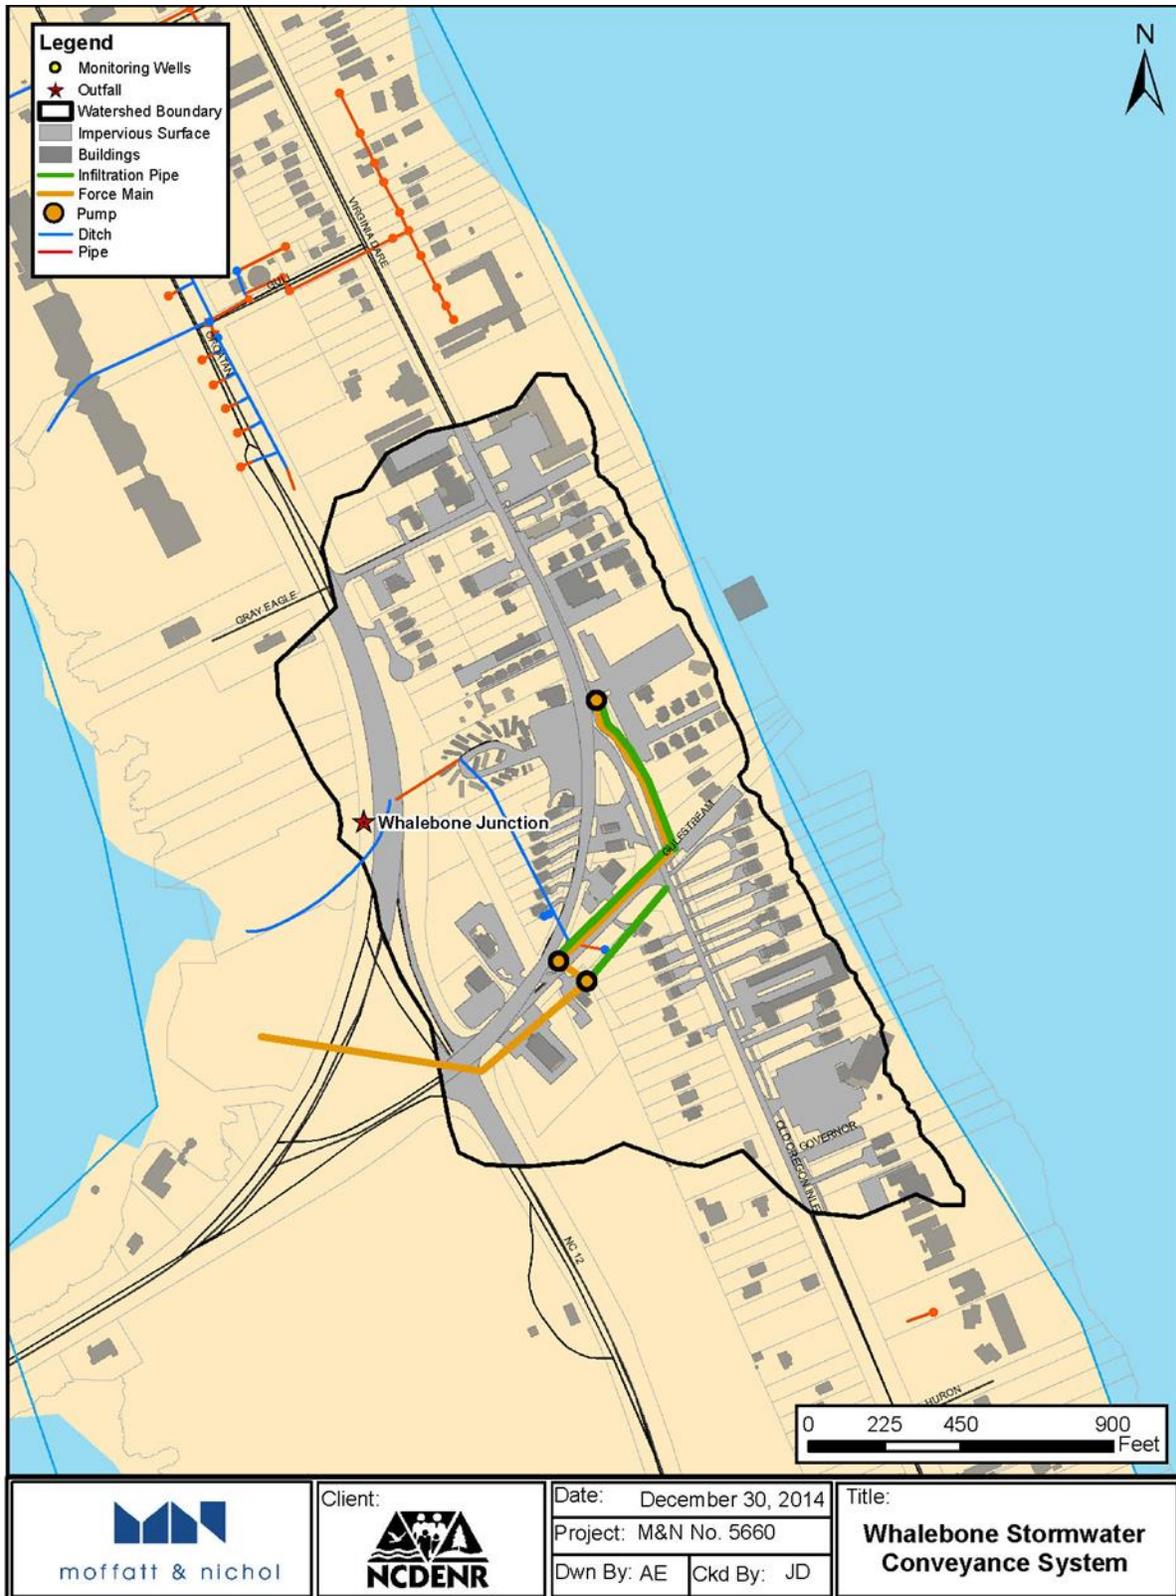
Figure 91. Whalebone Junction Groundwater Drawdown System

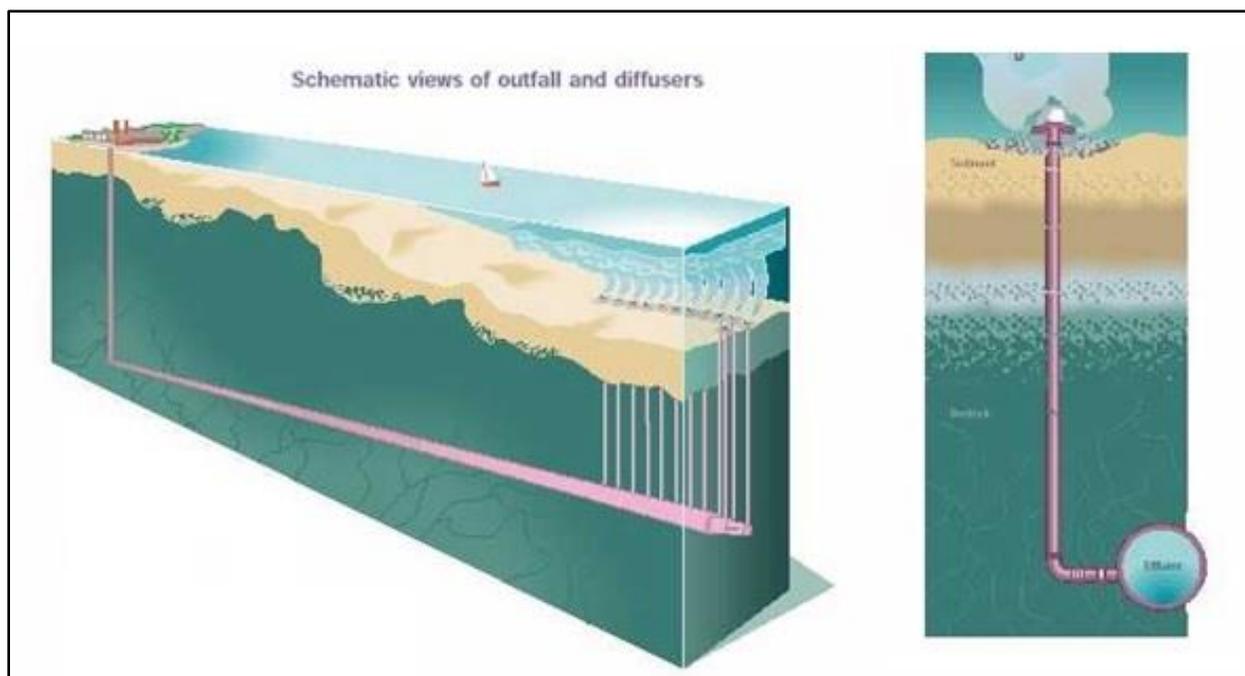
**Figure 93. Conceptual Illustration of Deep Water Ocean Outfall**
